# **LIMITED ENVIRONMENTAL SITE EVALUATION**

**2824 AND 2828 NORTH NEVADA STREET**

**ALLWEST Project No. 219-211E2**

**Date: MARCH 25, 2020**

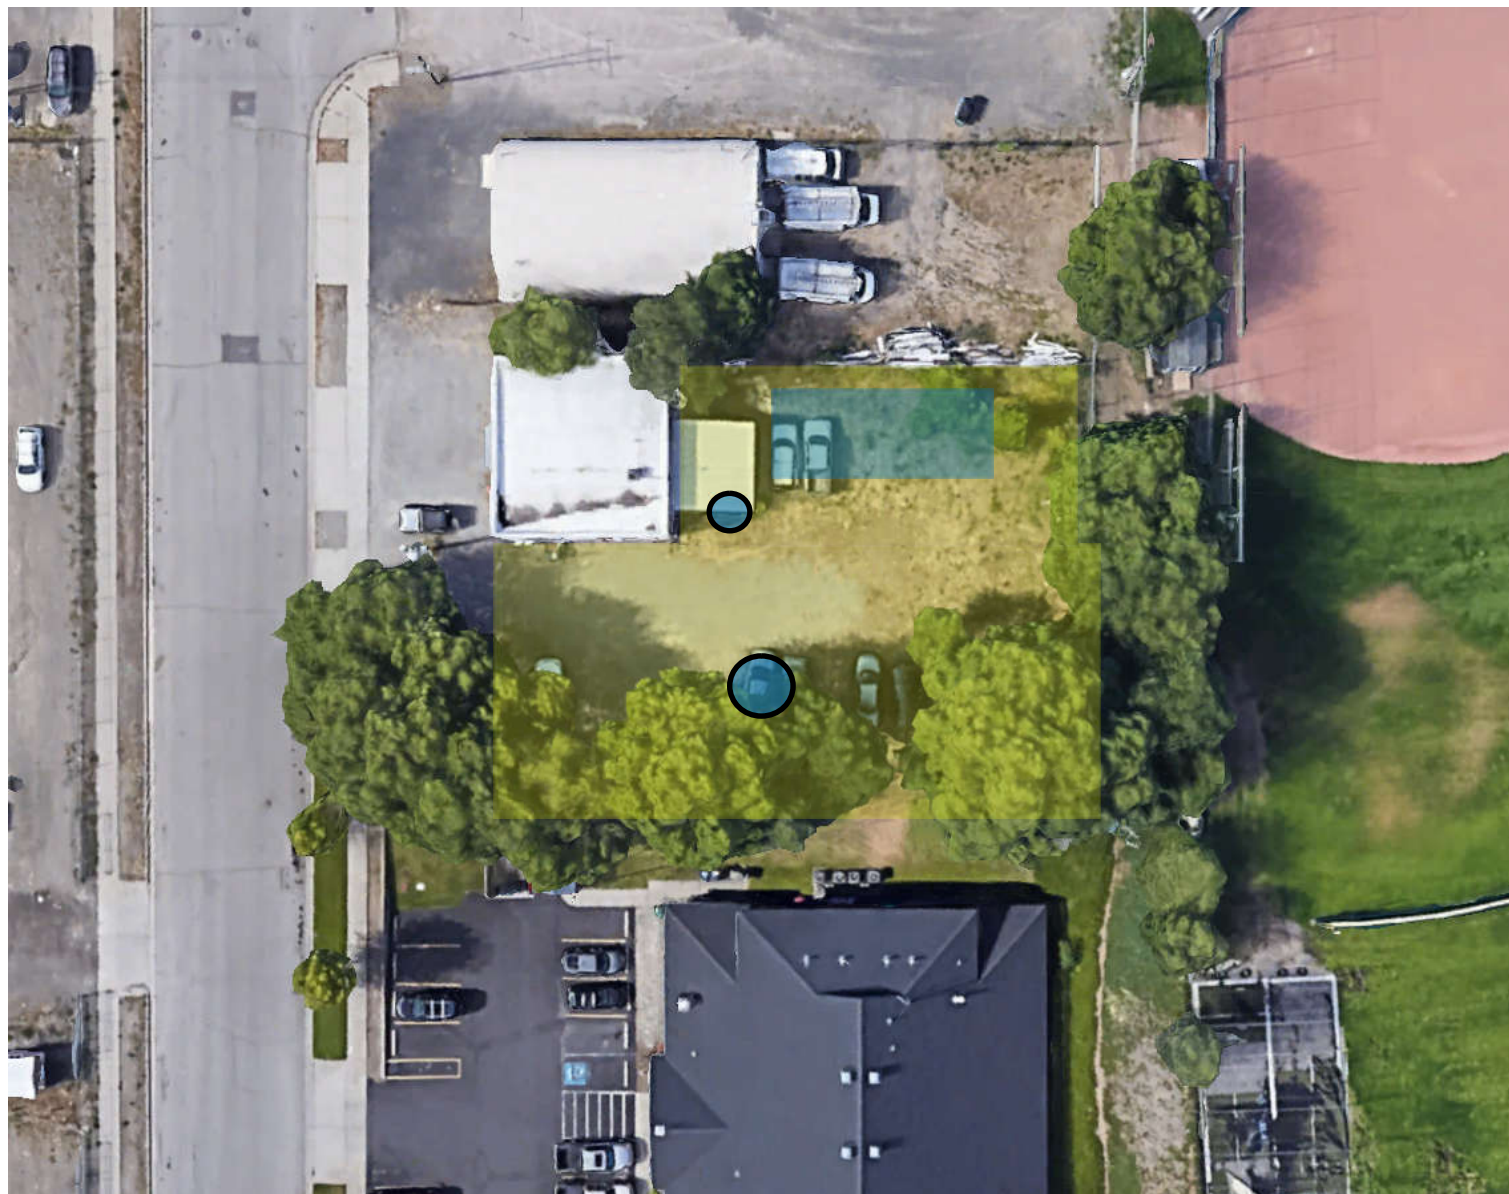
#### FIGURE A-2 EXPLORATION MAP

ALLWEST subcontracted for Northern Lights Drilling to perform drilling and soil sampling around two areas of interest. We observed a metal ring exposed at the surface on the north side of the site and a small concrete pad on the south side of the site. No UST was identified by the GPR in these locations however, drilling was performed to verify. We observed 4 borings at the north location and 4 at the south location from 8 to 16 feet below the surface. No evidence of a UST or UST backfill material (sand) was encountered in either location. explorations were performed at the locations identified on Figure A-2 (Exploration Map).

In addition, we interviewed a former site owner who recalled the filling of the reported UST with sand. The former owner identified an approximate area he suspected the tank to have been in located when filled in 1986. ALLWEST subcontracted for a contractor to excavate the suspected area for evidence of the tank or contamination. Following extensive exploration, no UST or contamination or backfill sand was identified.

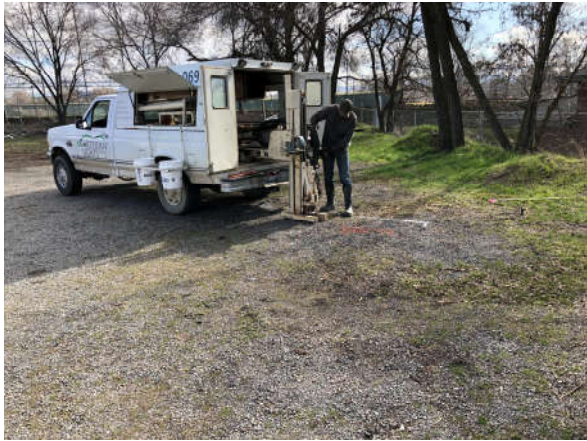
**Photo #1** View of suspected UST area south side of property.

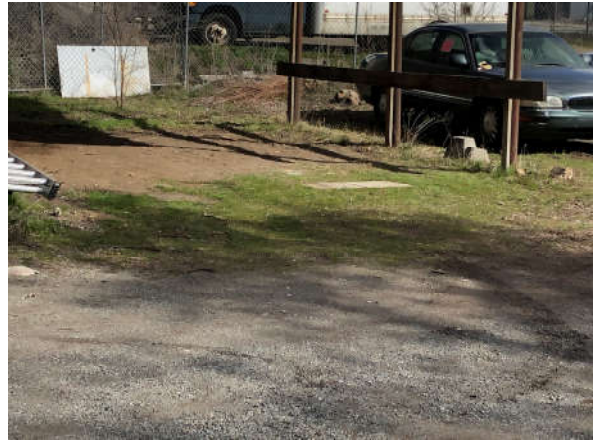
**Photo #2** View of suspected UST area north side of property.

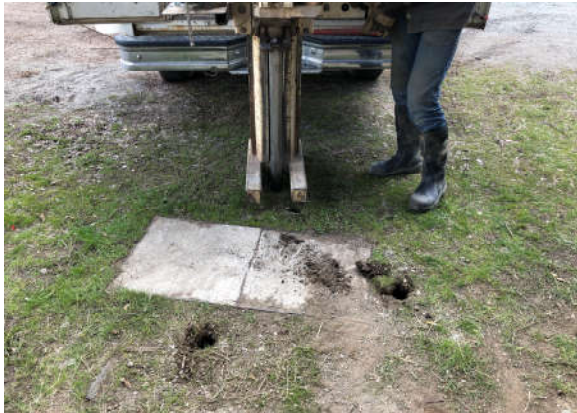
**Photo #3** View of suspected UST area north side of property.

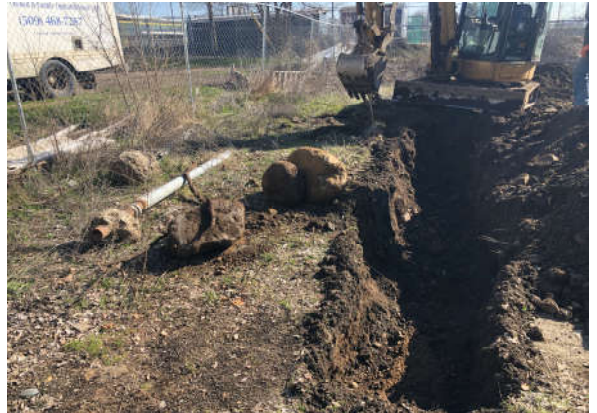
**Photo #4** View of trench excavation north side of property.

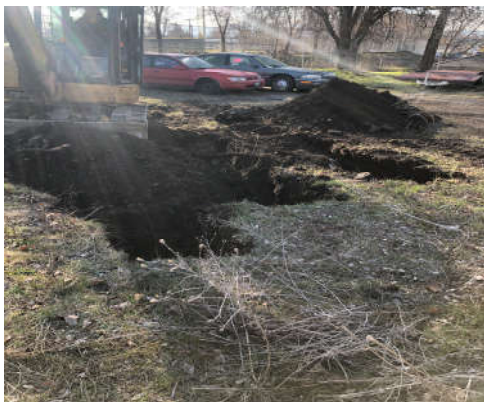
**Photo #5** View of excavations north side of property.

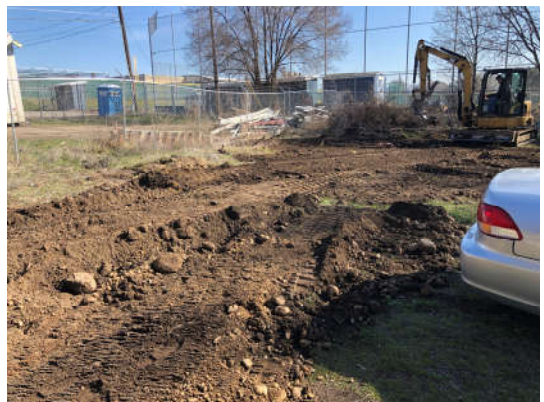
**Photo #6** View of excavation area north side of property.
