**RE: Hazardous Materials Survey Services (Asbestos / Lead Based Paint / Mold)
Gonzaga Haven
NE of North Foothills Drive and North Hamilton Street
Spokane, Washington
ALLWEST Project No. 219-211E**

ALLWEST is pleased to present this Hazardous Materials Survey report for the above referenced Site.

Site Photographs
Site Name: Gonzaga Haven
ALLWEST Project No. 219-211E
Date Taken: September 4, 2019

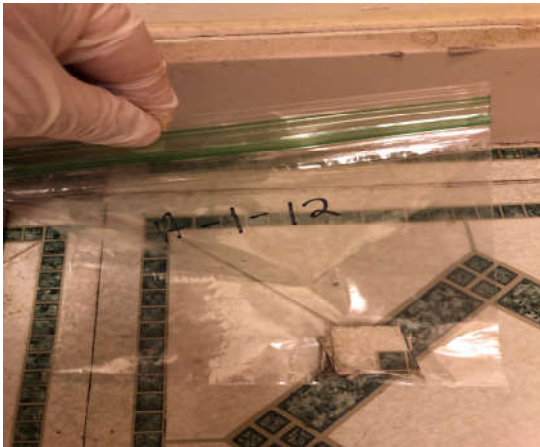
Photo #1 View of VFT in 1st floor restroom in building #1 at 2824 N. Nevada.

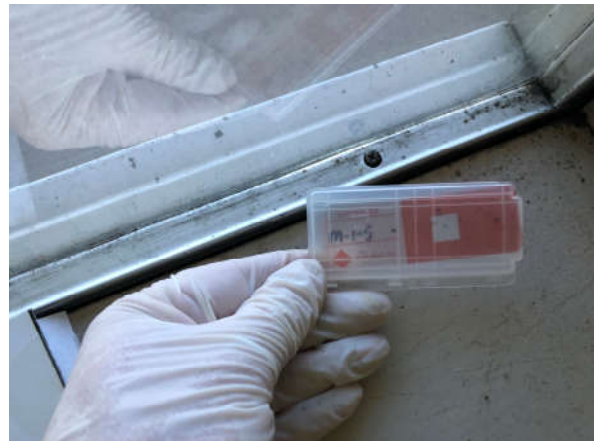
Photo #2 View of mold on window seal in building at 920 Wolverton Court.

- We recommend that mold be removed by a licensed contractor experienced in mold removal. All federal, state and local regulations should be followed during removal.

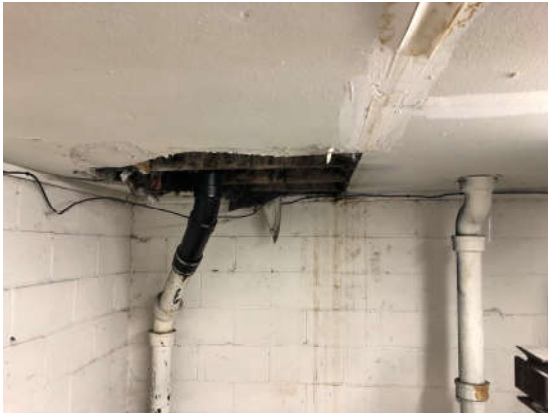
- Visible indications of microbial growth (discolored or stained areas) were observed in all three buildings. The most extensive mold observed was in the loft

area of building #2 at 2828 North Nevada Street. The mold appears related to water intrusion as seen on photos three (3) and four (4) on the Photolog attached to this report. The remaining mold observed appeared less extensive and was located in the breakroom (wall & air duct) and window seal (2nd floor) in building #1 at 920 East Wolverton Court. In addition, mold was identified in the loft and utility room in building #3 at 2824 North Nevada Street. We also observed mold in the shop area of building #3 as seen on photo 8 on the attached Photolog.

Photo #3 View of mold in loft at 2828 N. Nevada.

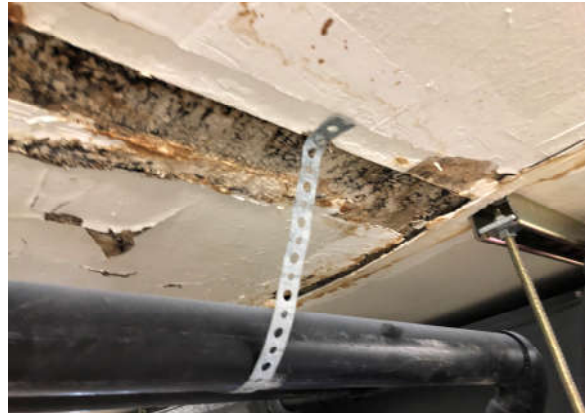
Photo #4 View of mold in loft at 2828 N. Nevada.

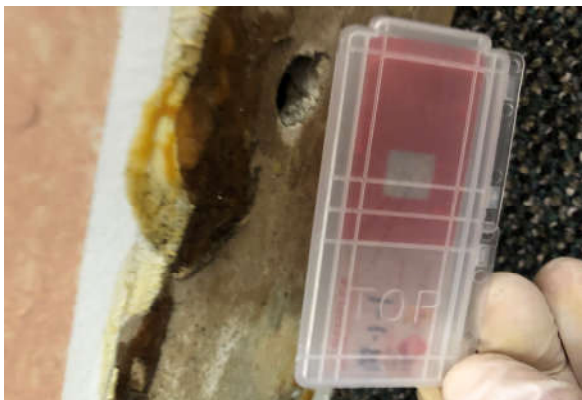
Photo #5 View of mold in breakroom at base of wall at 920 Wolverton Court.

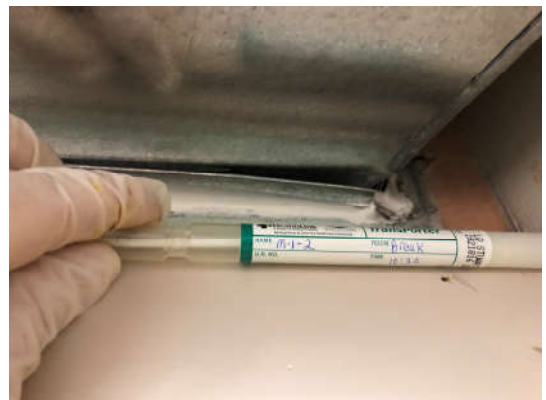
Photo #6 View of mold around air duct at 920 Wolverton Court.

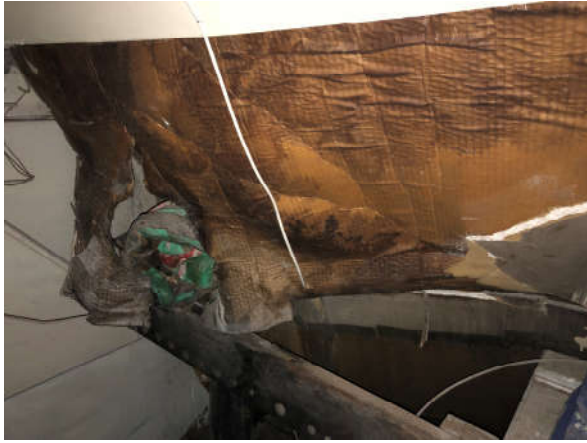
Photo #7 View of mold observed in loft of building #3 at 2824 North Nevada Street.

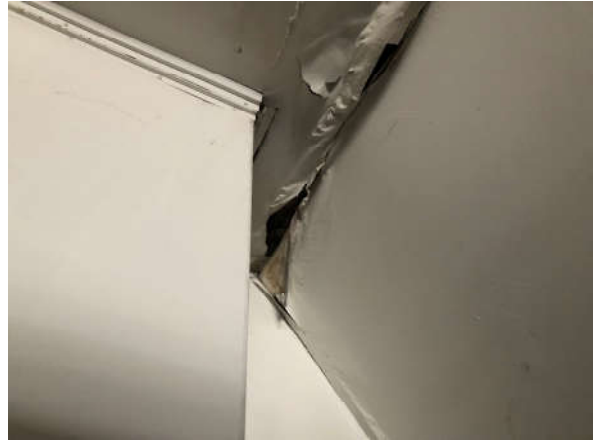
Photo #8 View of apparent mold and water intrusion in the shop areas ceiling at #3 at 2824 North Nevada Street.
