January 10, 2022
Revised from December 29, 2021

Project G19903

PROJECT: Kosta Plat – 60-lot Subdivision – Nettleton and Cochran, Spokane, WA
SUBJECT: Geohazard Evaluation (Revision 1)

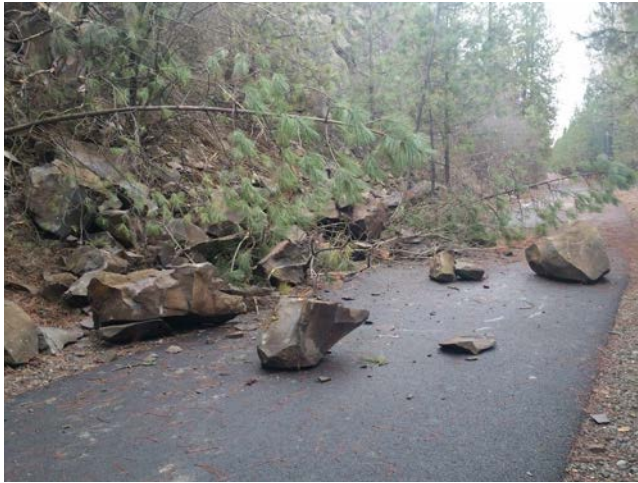
In 2015, we provided preliminary evaluation of a rockslide that closed Fish Lake Trail immediately downhill from the middle of this project, as shown in the image below. The 2015 study concluded that the failure occurred as a result of seepage and erosion along the contact between the Latah sediments and overlying basalt. Undermining of the basalt resulted in a loss of support and subsequent failure along vertical columnar joints in the basalt cliff above the trail.

Rockslide in 2015 on Fish Lake Trail downhill side of project

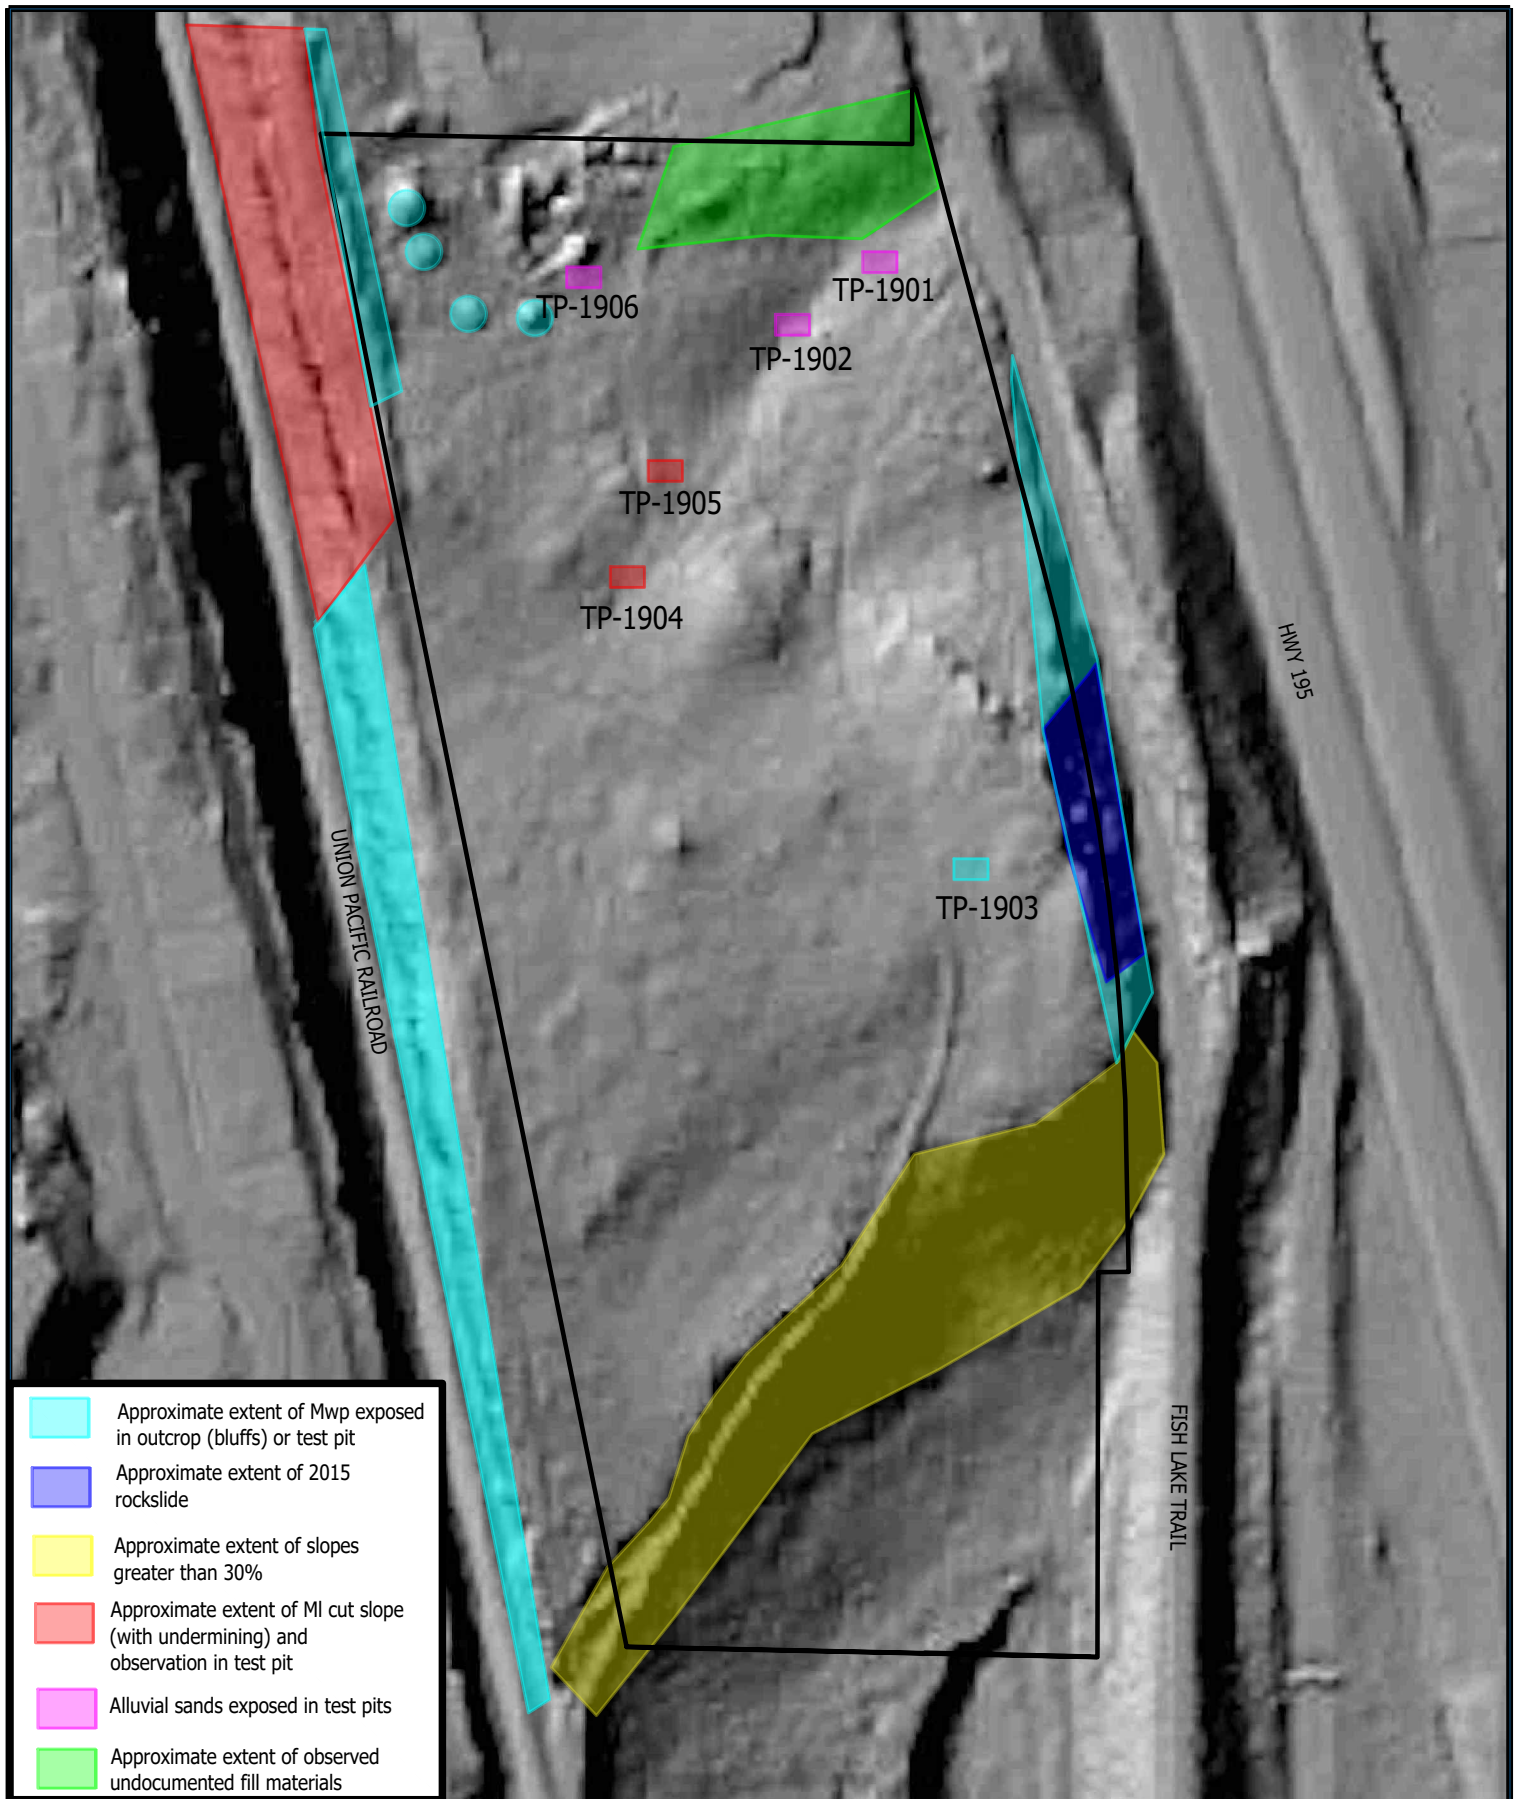
Geologic hazard components are depicted in the attached *Figures*.

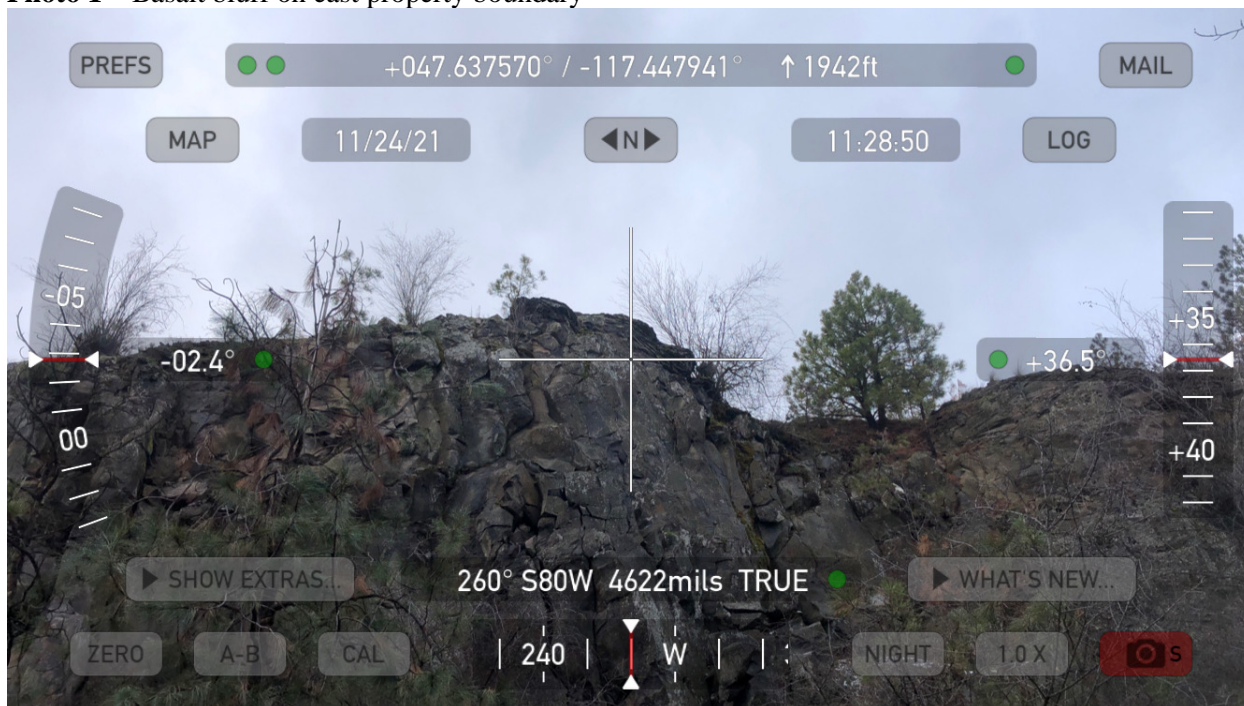
Along the east property line, the site borders a cut from a historic railway alignment now repurposed as the paved Fish Lake Trail. Vertical cuts were made into basalt bluffs. These outcroppings consist of columnar jointed *Mwp* that formed 20 to 40-foot vertical bluffs. Columnar joints ranged from 4 to 6 feet in spacing. At the base of the bluffs were talus slopes consisting of large angular basalt cobbles and boulders. The total height of the bluffs and talus slopes ranged from 38 feet at the northern extent to 58 feet at the highest point near proposed Lot 22. An exposure of the Latah Formation (MI) was observed between the columnar bluffs and talus slope as shown in *Photo 4*.

Photo 1 – Basalt bluff on east property boundary

Permanent constructed slopes should be limited to a maximum inclination of 2H:1V unless designed by an engineer registered in the State of Washington. Vertical rock cuts exist which pose risks from falling rock. Ice wedging continuously causes highly fractured basalt to spall from rock faces which accumulate as talus. Talus slopes should be left undisturbed or inclined to maximum slopes of 1.75H:1V.

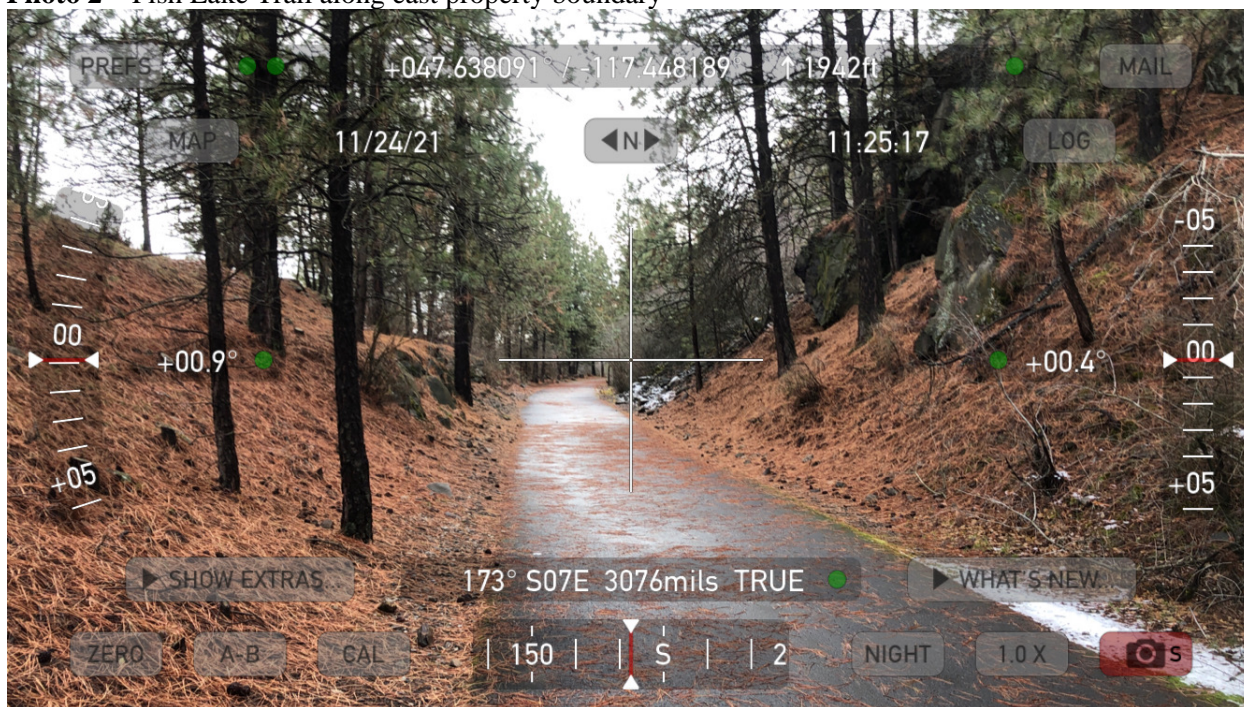
Photo 2 – Fish Lake Trail along east property boundary

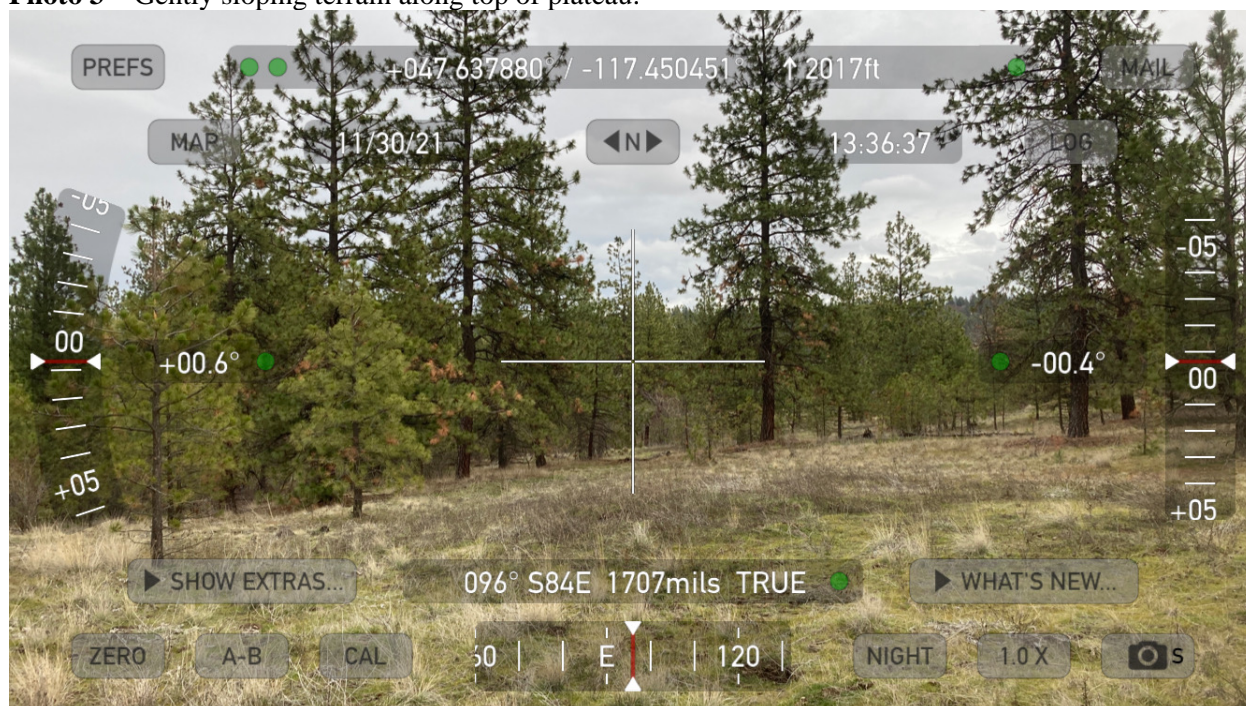
The plateau that forms the central portion of the site consists of proposed lots 6 to 13, 44 to 53, and 22 to 26. This plateau consists of undulating terrain that generally slopes up from east to west. Numerous outcroppings of *Mwp* were observed in the northwest portion. Along the southern edge, the plateau slopes downward from the southern portions of lots 15 to 21. Surface exposures of colluvium and talus were observed in this area. Vegetation consisted of dense understory beneath mature coniferous trees. The slopes ranged from 50 to 70 percent (27 to 35 degrees) along the plateau margin and shallowed near the toe at 20 to 25 percent (11 to 14 degrees). These slopes approach the margin of the WSDOT borrow pit near the southern site boundary.

Photo 3 – Gently sloping terrain along top of plateau.

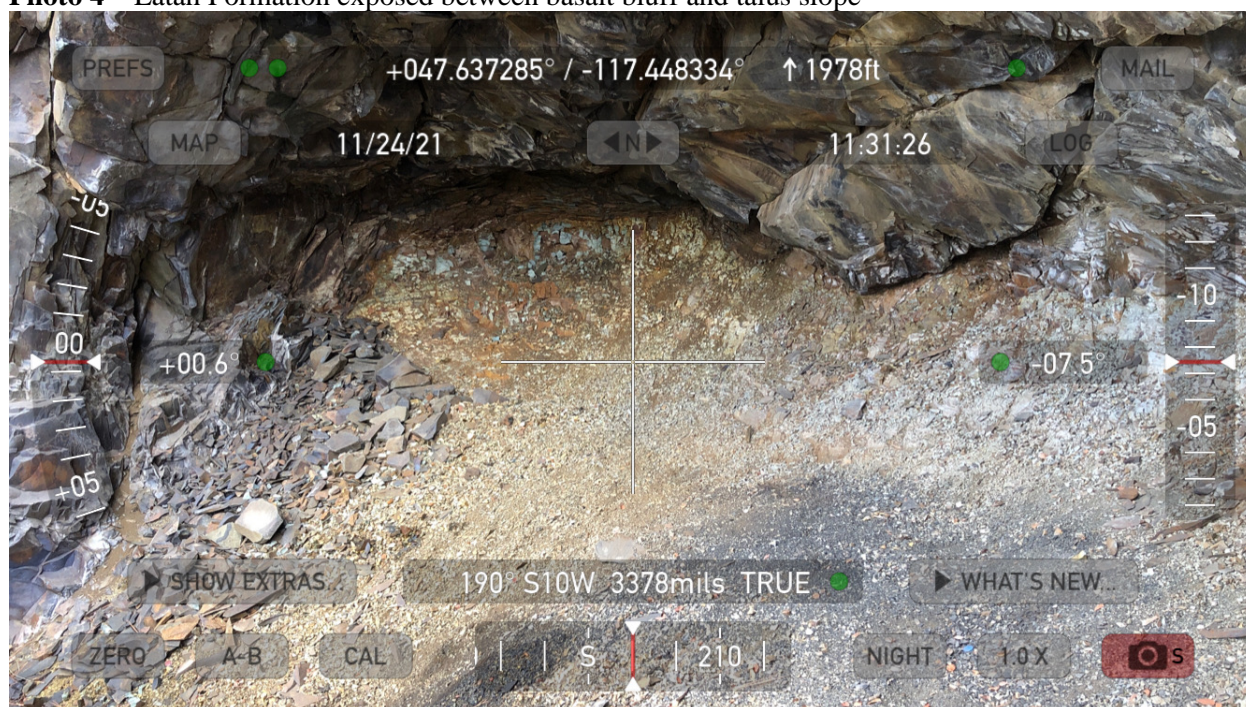
The *MI* generally underlies the basalt plateau and exposures are visible around the plateau. Most of the *MI* is covered with talus or topsoil. *MI* was encountered below topsoil in test pit 1904 (TP-1904) and TP-1905 in the center of the site as described in the previous report. Exposed clay, silt, and sand of the *MI* formation should not be disturbed. If encountered in excavations for development or utilities, the geotechnical engineer should be notified to evaluate potential instabilities of the formation and overlying soil and rock.

Photo 4 – Latah Formation exposed between basalt bluff and talus slope

If Latah is exposed or encountered in development areas, a geotechnical engineering evaluation is recommended.

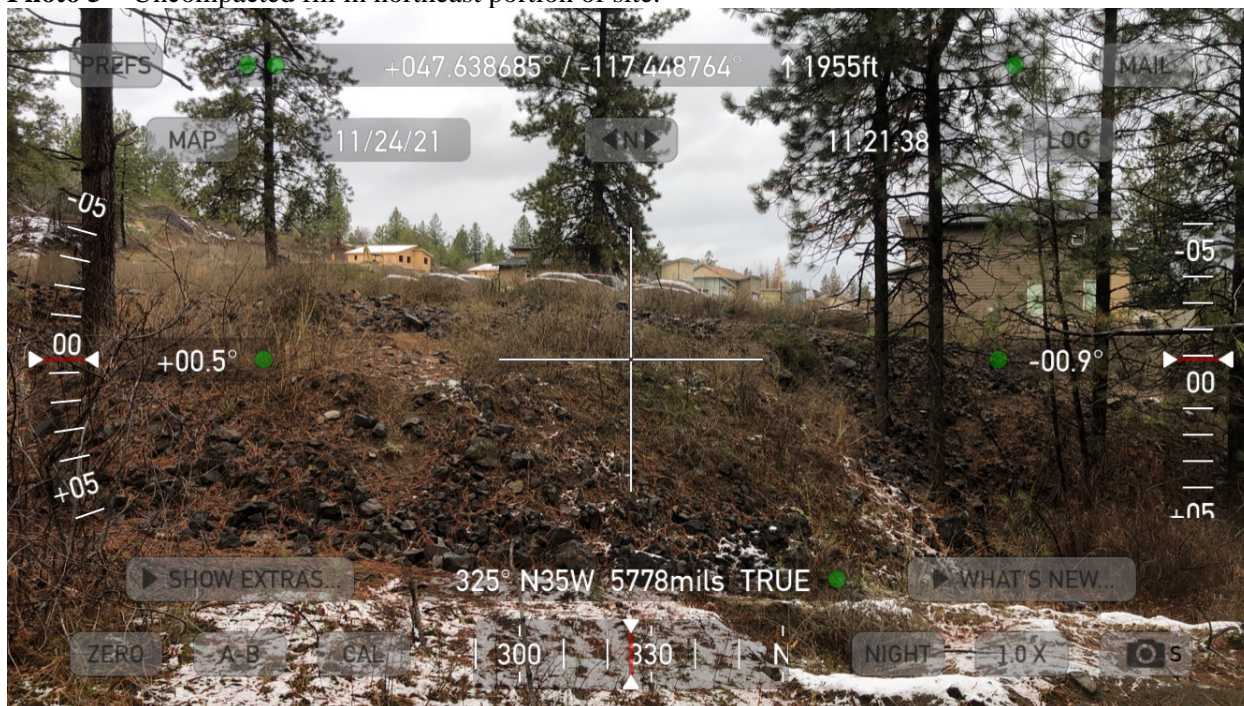
Within the northeast corner, undocumented fill materials were noted at ground surface. These materials consisted of angular basalt cobbles and boulders mixed with silts and sands. The extent of the fill materials was estimated to range from 5 to 20 feet in thickness and covering an area roughly 80 by 250 feet at the southeast end of 17th Avenue.

Undocumented fill is limited to a relatively small area at the north end of the project site. It should be evaluated by the geotechnical engineer for potential re-use as compacted structural fill or landscaping materials. No record of compaction testing was provided or readily-available to our knowledge for the undocumented fill materials.

Photo 5 – Uncompacted fill in northeast portion of site.

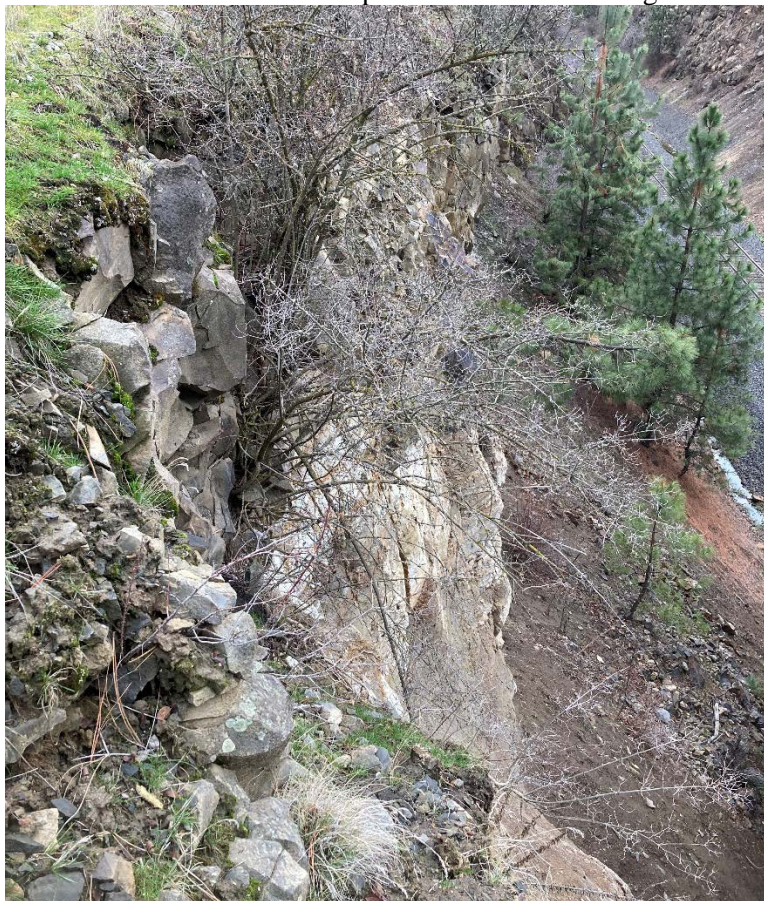
Photo 6 – Latah Formation exposed below basalt along BNSF railway.
