Appendix D

Corrosion Testing and Analysis Results

LATAH BRIDGE CORROSION CONDITION AND EVALUATION STUDY

December 16, 2011

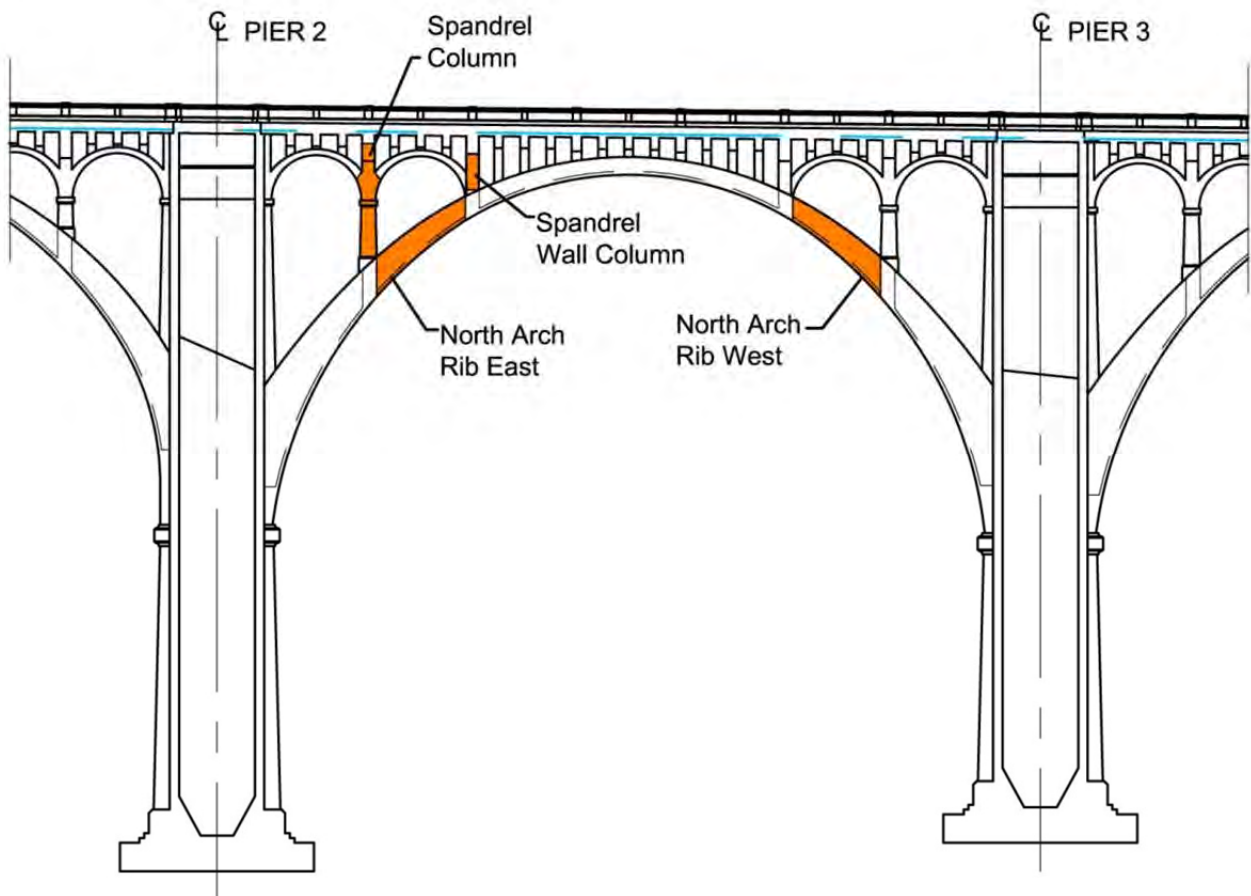
Figure 1 - Potential Test Measurement Locations

The following figure summarizes the areas where potential measurements were taken on the substructure. Testing of the deck was not possible because of asphalt pavement. Because of lift equipment availability and traffic control limitations, spandrel columns were tested on the south side of the bridge and arches were tested on the north side. The areas tested for corrosion activity were selected because their locations were subject to water runoff as shown in Photograph No. 1. Water runoff can be identified by the dark staining of the concrete surface.

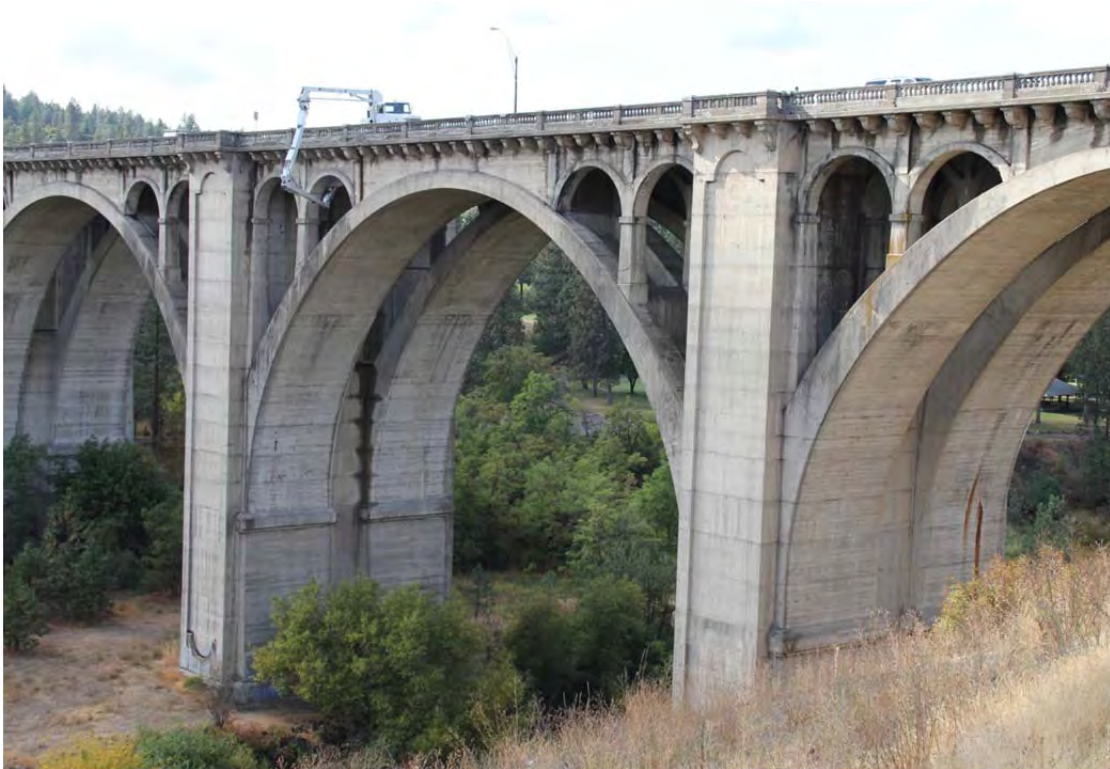
Photograph 1 –Water runoff areas between spandrel wall column and pier.

Photograph No. 1 shows the concrete staining that has occurred from deck water runoff or leakage. The majority of the water appears to be leaking from the deck at the spandrel wall column on the left. The intermediate arches tend to concentrate the water at the spandrel wall columns and spandrel columns. The upper part of the arch rib also shows staining that result from water running over the arch and its dissipation as it moves from the upper half of the arch to the lower half. Concrete disbondment is generally occurring at the spandrel wall columns, corbels, and intermediate arches as shown in Photograph No. 3.

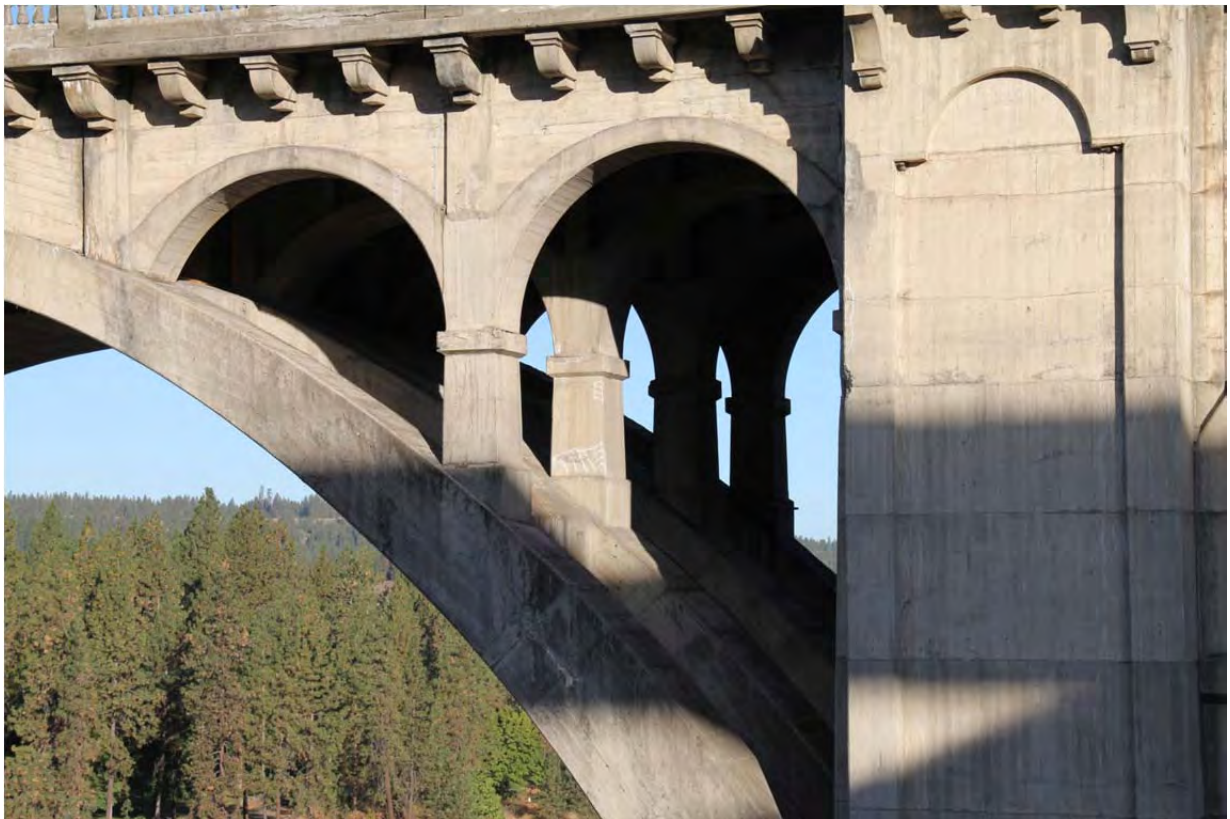
Photograph 2 - Spandrel Columns and Intermediate Arches

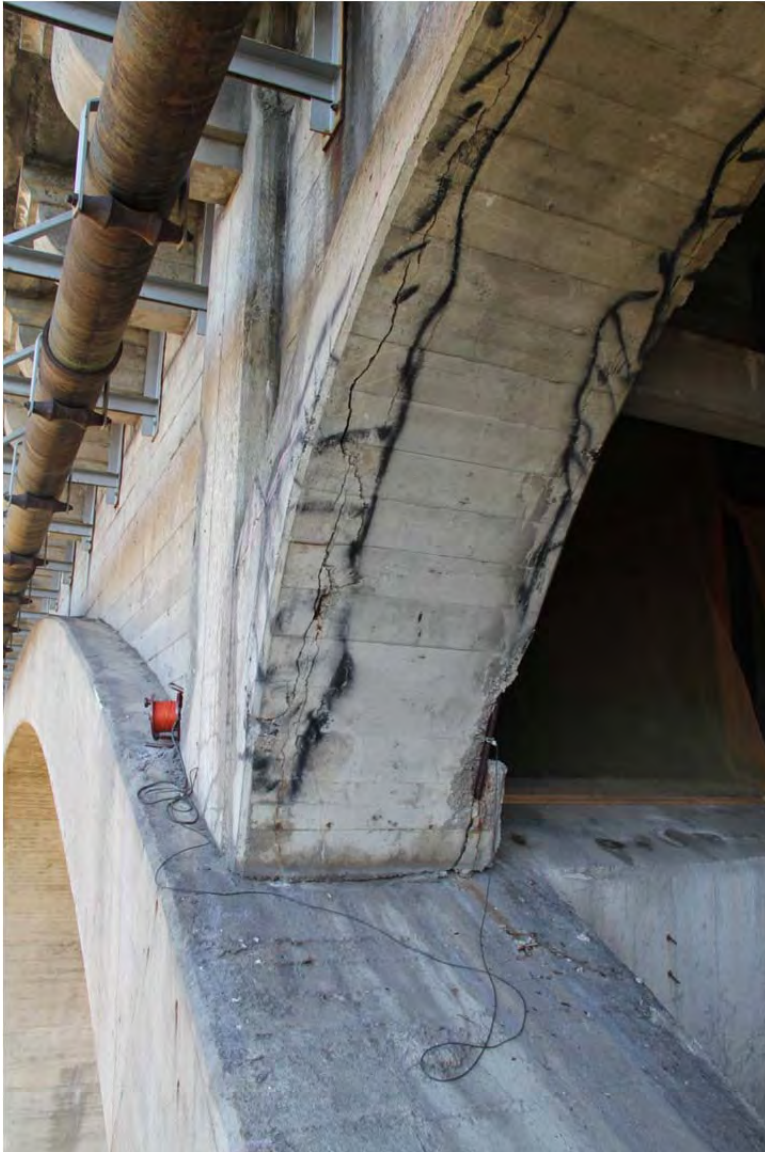
Photograph 3 - North Spandrel Wall Column Delaminations on Intermediate Arch Corners

the delaminations of the concrete on the interior corner of the arch. This area of the arch is protected from water runoff and yet corrosion was occurring. Depth of concrete cover was less than 1.5 inches and may have been further reduced by the chamfered corner. Corrosion was also observed at honeycomb areas in the concrete that may be associated with carbonation.

The delaminations shown in Photograph No. 3 illustrate a common observation throughout the substructure. Spalling of chamfered concrete edges where concrete cover is reduced over the stirrup reinforcement.

While the delaminations are caused by corrosion of the steel reinforcement, in some cases the cause does not appear to be chloride related corrosion. Lack of concrete cover was also a factor in

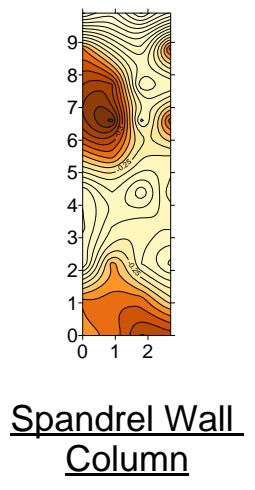
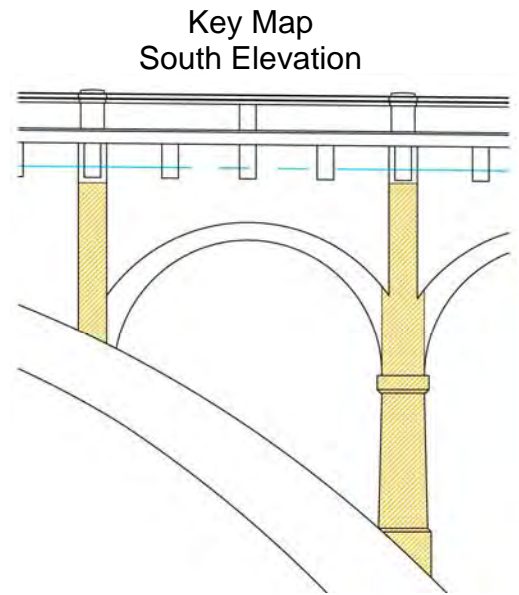
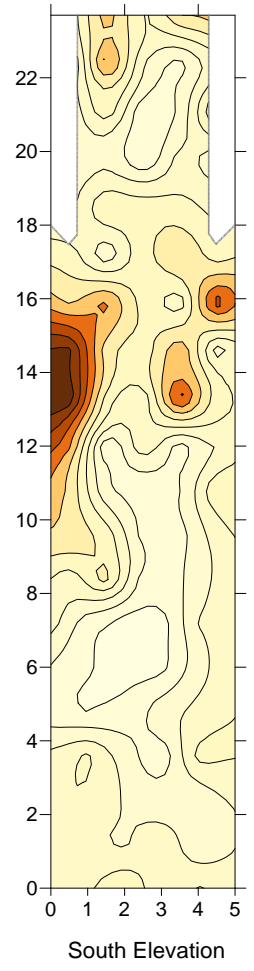
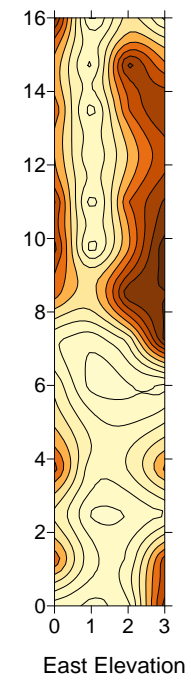
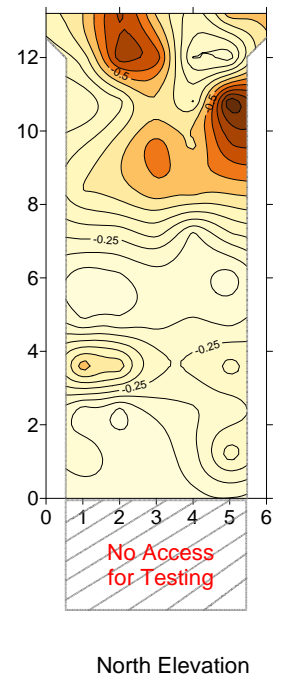
Figure 2
Latah Bridge
Spandrel Wall and Column
Corrosion Potentials

Reinforcement corrosion potentials were measured on the spandrel wall column and spandrel column on the south side of the bridge. Figure 2 shows the resulting corrosion activity on the surfaces measured. Potential measurements were obtained on all four sides of the spandrel column, but only on the south elevation of the spandrel wall column.

While some localized corrosion activity was detected with the potential measurements, a majority of the spandrel column and spandrel wall column were not corroding. Where corrosion was detected, it was located on the corners of the columns where concrete cover over the reinforcement appears to be less than 1.5 inches as recommended by ACI. Where cracking and delaminations were observed on the column, they corresponded with corrosion activity indicated by the potential measurements.

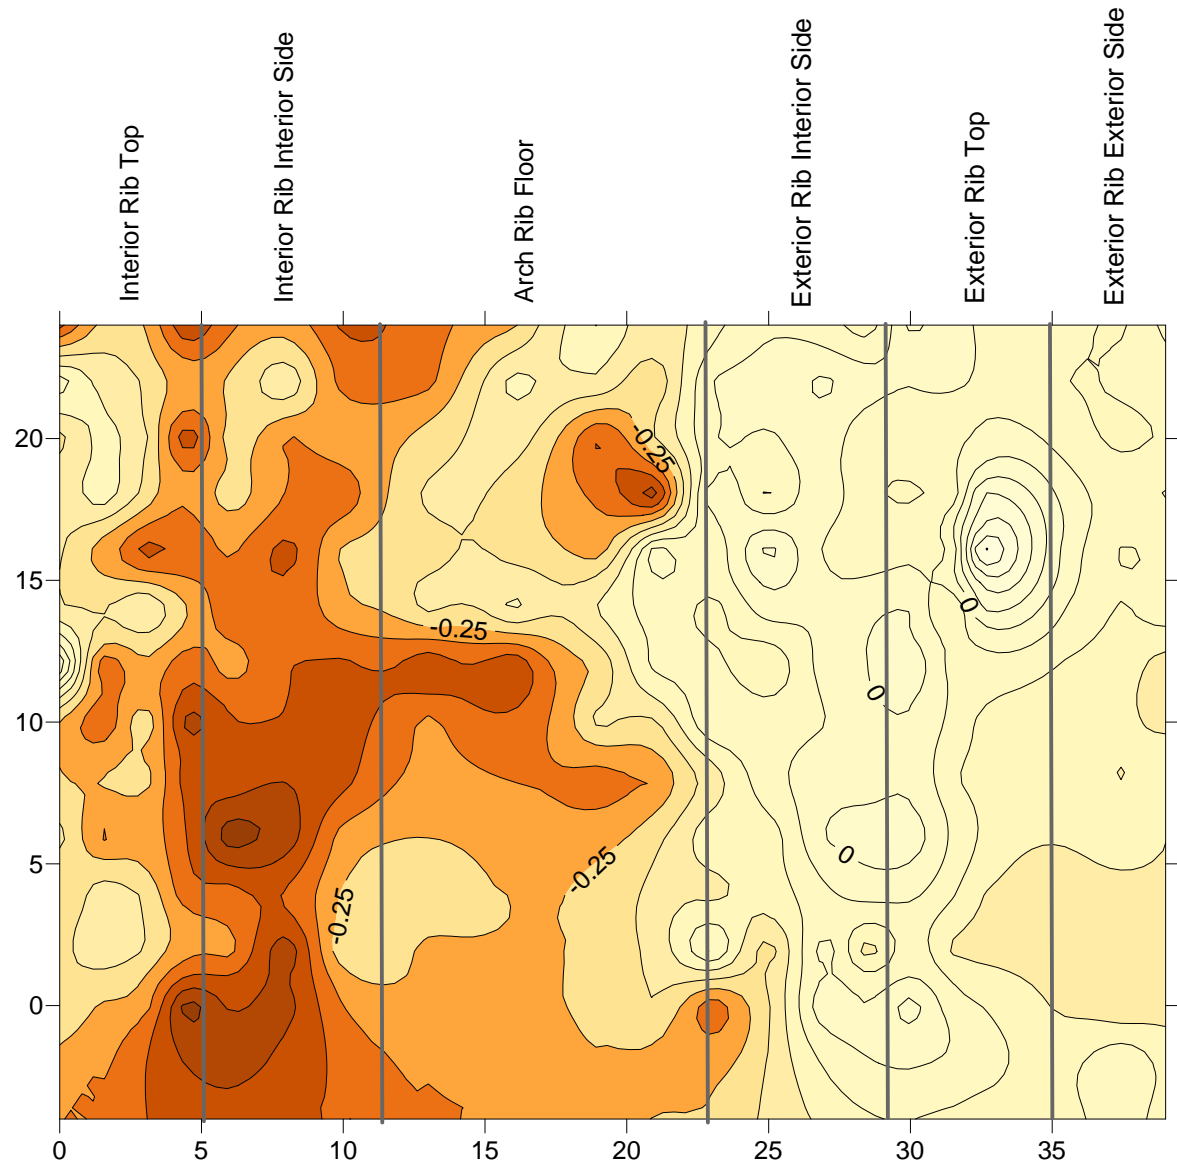
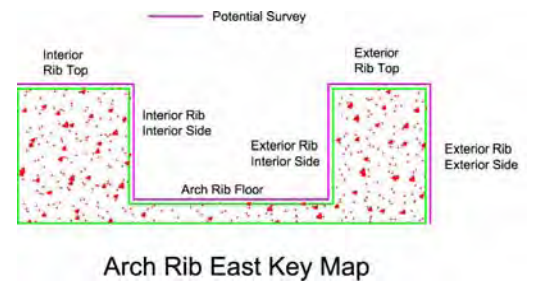
Latah Bridge
North Arch Rib East End
Corrosion Potentials

Corrosion activity on the arch ribs was limited to the interior arch rib on the east half of the bridge between Pier 2 and 3 as shown in Figure 3. Corrosion activity is classified as initial to active corrosion, with localized areas of advanced corrosion. Although corrosion activity was detected through the potential survey, no delaminations were associated with the corrosion activity.

Most of the corrosion was located on the interior rib top corner and the interior rib north side. While a depth of cover survey was not performed, it would appear based on the sheltered protection provided to the interior rib that corrosion activity may be due to insufficient cover and carbonation of the concrete.

A single chloride test was conducted on the north arch east end as Powder Sample No. 12. Chloride results indicated that chlorides were at corrosive levels below the spandrel wall column on the exterior surface of the arch. This is an area where water runoff from the deck would affect the arch condition. While the chloride levels exceeded corrosion thresholds, the corrosion potentials did not indicate that corrosion activity was occurring.

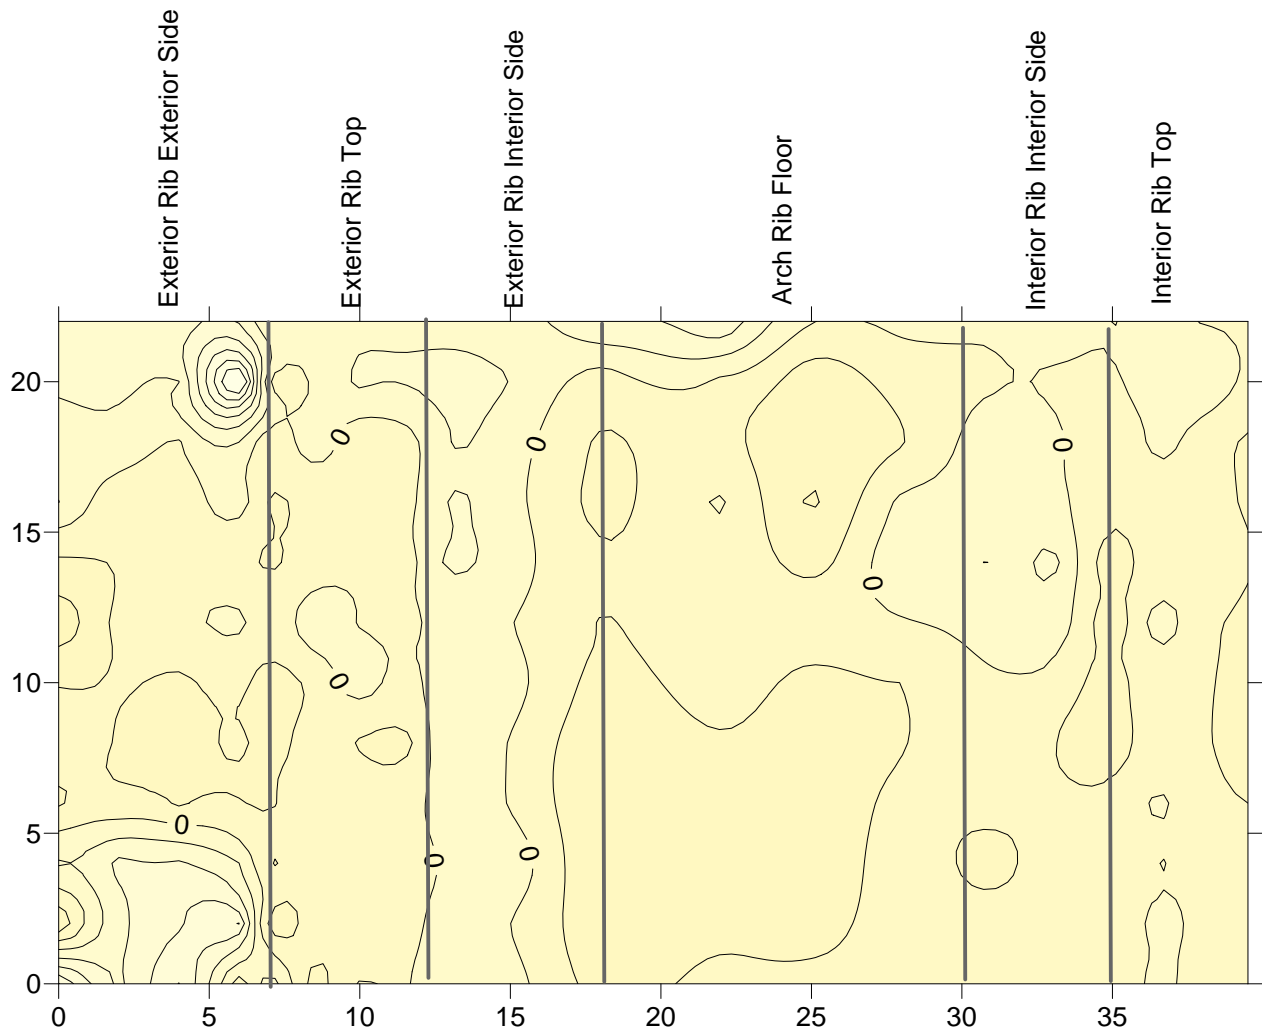
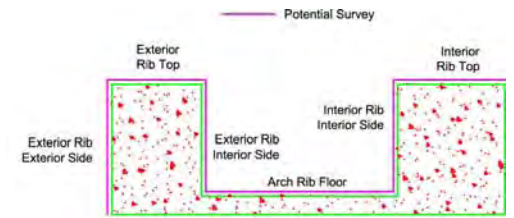
The west end of the north arch rib did not show any corrosion activity as shown in Figure 4. Visual observations showed no evidence that corrosion activity was occurring. Chloride testing was not performed on the west half of the north arch rib.

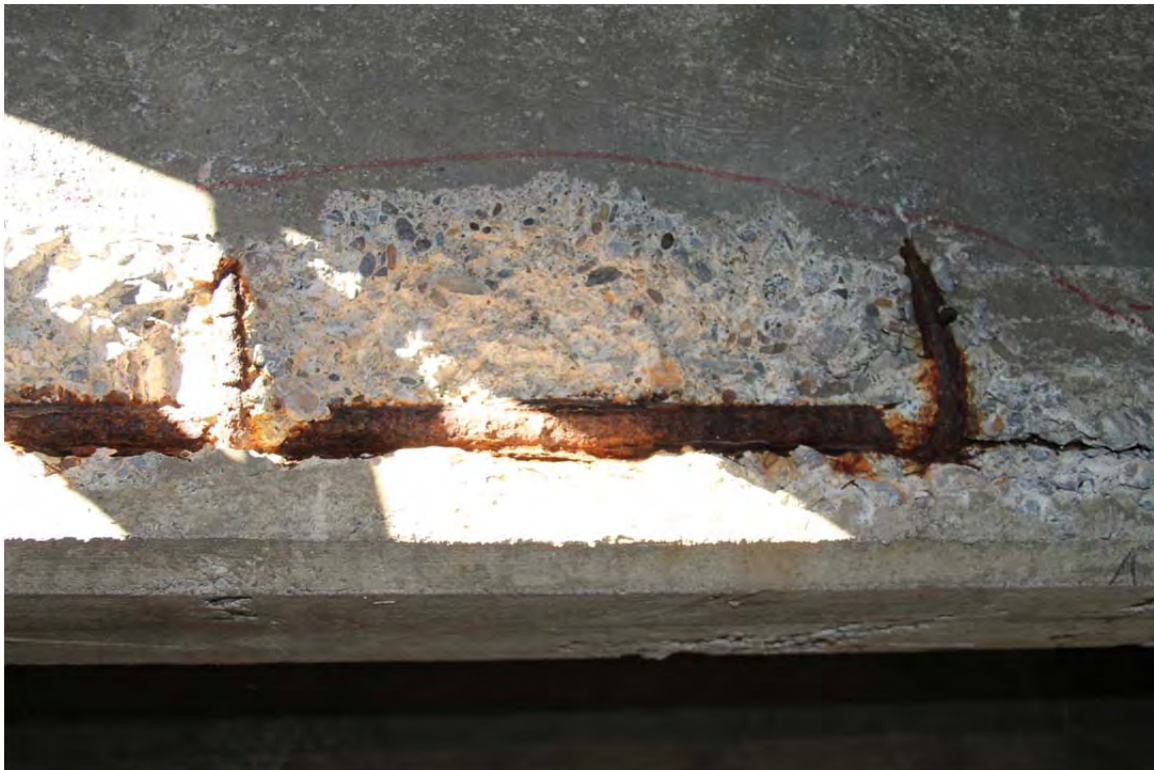
Interior inspection showed leakage from the manholes and drain piping was causing corrosion of the floor beams. Chloride testing showed that the corrosion was not caused to chlorides. However, the magnitude and extent of corrosion would indicate that chlorides had an effect on the corrosion in combination with limited concrete cover. Photograph No. 4 shows the floor beam corrosion observed inside Pier No. 2.

Photograph 4 - Pier 2 Interior Floor Beam Corrosion

Notice in Photographs 4, 6 and 7 that the stirrups have less than ½ inch of concrete cover. Corrosion of the stirrups and the resulting cracking would allow water and salt to more readily attack the longitudinal bars and cause delamination of the concrete on the bottom of the floor beams.

Corrosion on with the floor beams appeared to be isolated to the leakage areas within the piers at drains and manholes. The recommended method for rehabilitation of the deck would also resolve the pier floor beams.

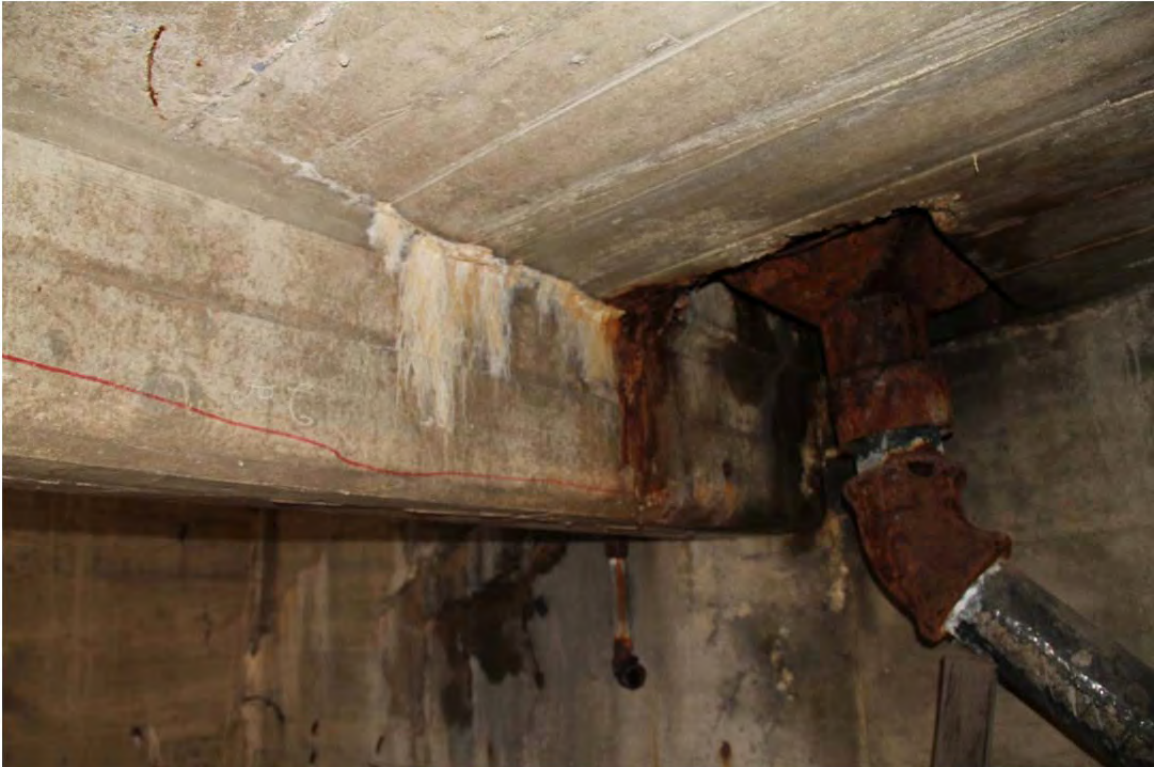
Photograph 5 - Corrosion in Pier 2 at drain pipe leakage

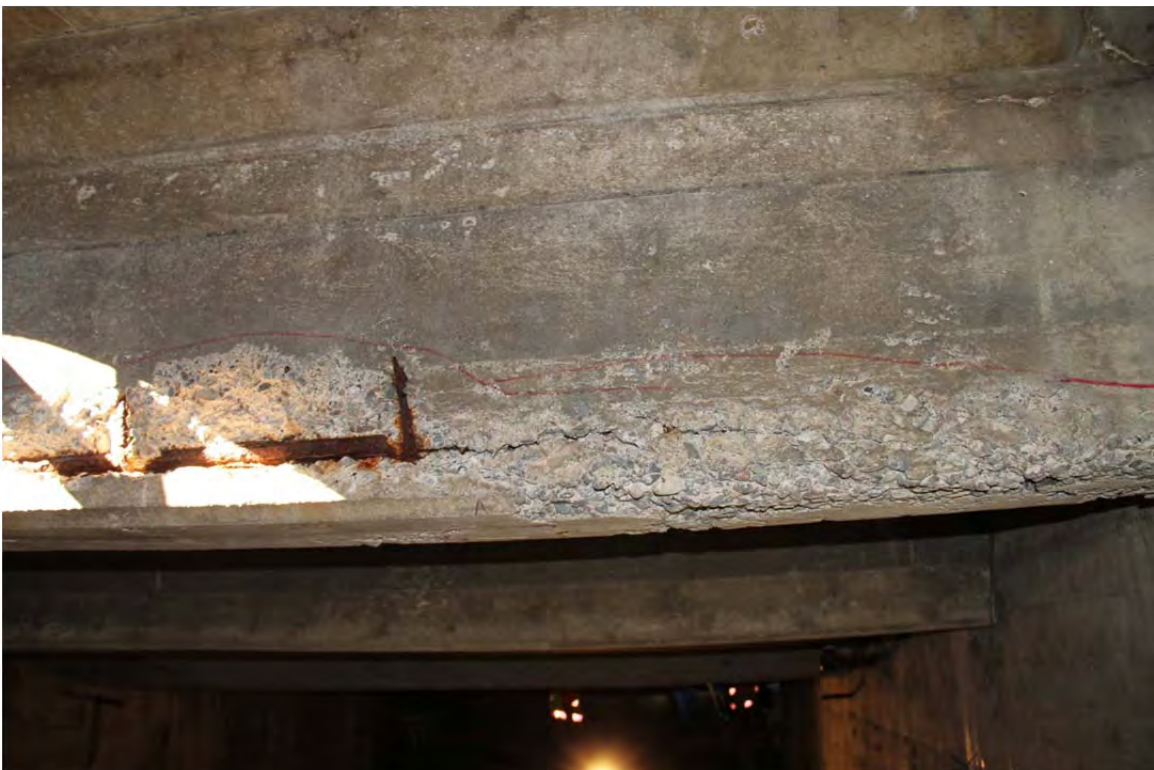
Photograph 6 - Corrosion and Delamination at honeycombed concrete

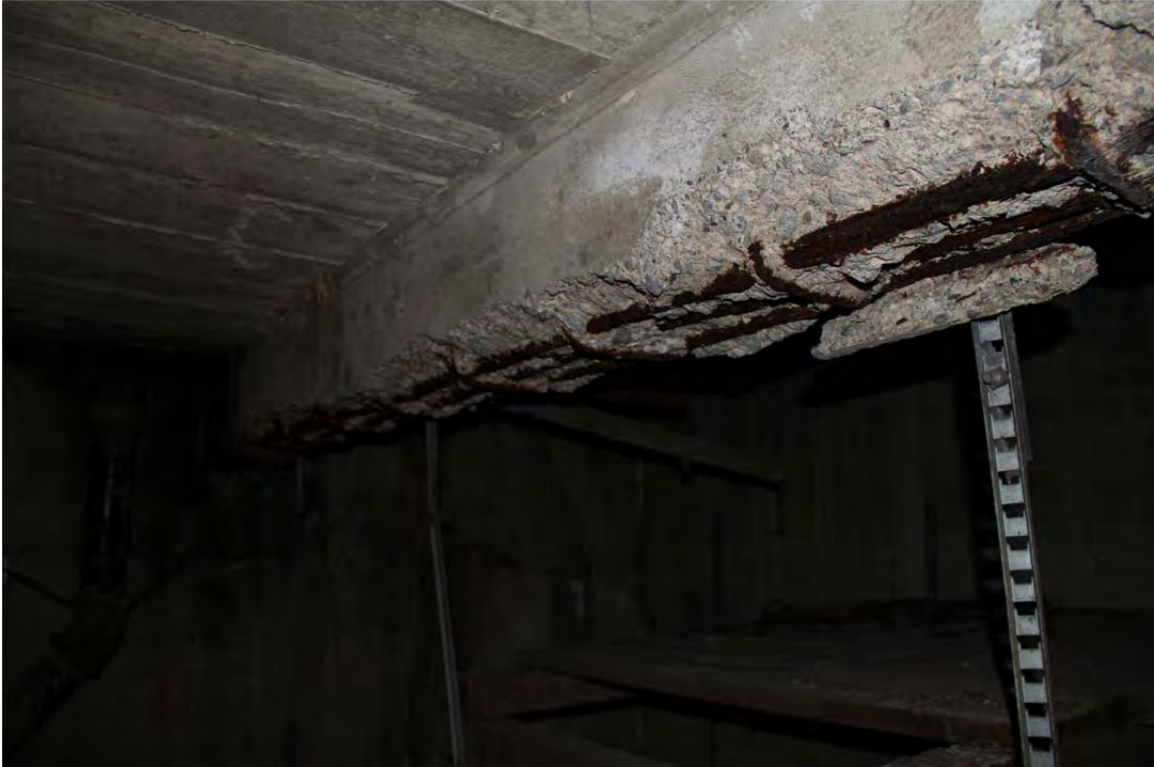
Photograph 7 - Delamination on bottom of floor beam
