Latah Bridge Inspection Report

Bridge Inspection Report – Final

In-Depth Inspection of Span 3 & Pier 2 and Cursory Overall Inspection

Latah Creek Bridge

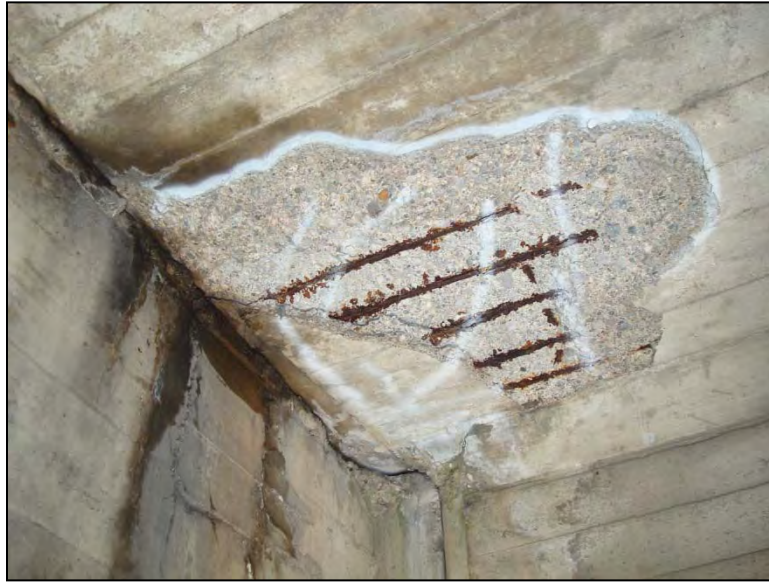
The soffit of the deck in Span 3 exhibits localized areas of spalling with exposed reinforcing steel, delaminations, and cracking. Much of the deterioration of embedded reinforcing steel has been prompted by prolonged exposure to deck drainage combined with shallow cover. The most significant areas of deterioration were typically found adjacent to joints such as between the west face of Pier 2 and Floorbeam 1 in Span 3. Also deterioration was significant inside the pier chambers in the vicinity of deck drain and manhole penetrations

Photo C4-38 (ID C325) – Soffit between west face of Pier 2 and Floorbeam 1 in Span 3, 5' x 5' area of spalling, delamination and exposed rebar, 3/8" diameter remaining on rebar.

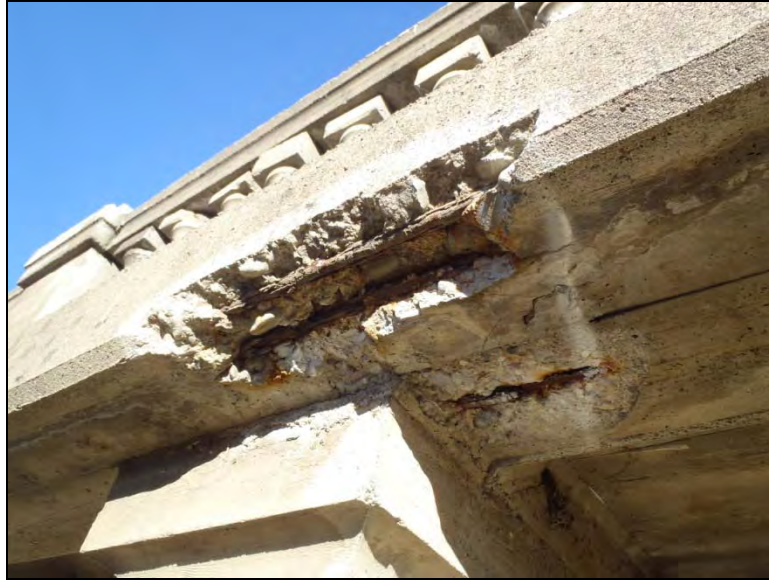
Similar areas of deterioration were noted on the soffit beneath the sidewalk overhang. One of the most pronounced areas of soffit deterioration was noted along the edge of the deck between Floorbeams 18 and 19 on the south edge. It consisted of a deep spall with rebar exhibiting up to 70% section loss and adjacent delaminations.

Photo C2-03 (ID C101) – Deterioration between Floorbeams 18 and 19 along south overhang in Span 3.

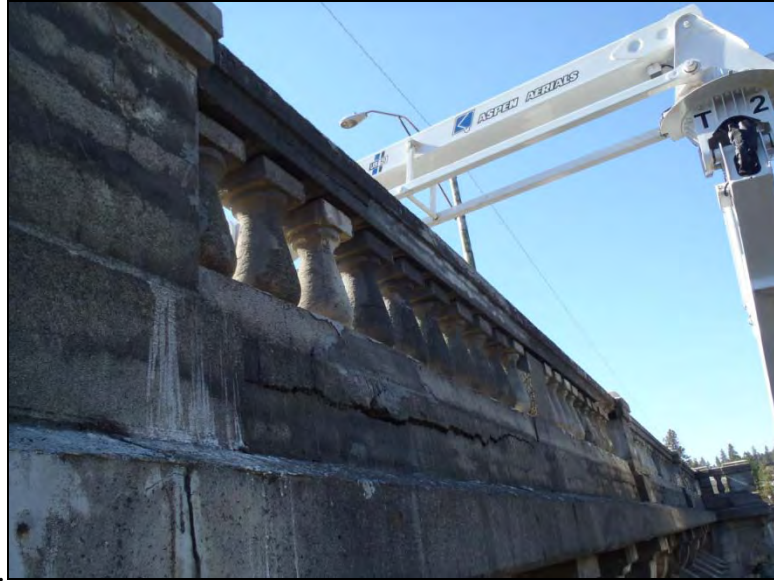
Ornamental bridge rail is located along the exterior edges of the sidewalk. Jersey-type barrier is located between the sidewalk and the roadway. The ornamental rail is in generally poor condition with large patched areas, severe scaling, spalling, delaminations and cracking. Wide horizontal cracks were observed in the exterior face above and below the balusters.

Photo C3-61 (ID C244) - North exterior rail between Floorbeams 16 & 18, Span 3, wide horizontal cracks in rail both above and below balusters.

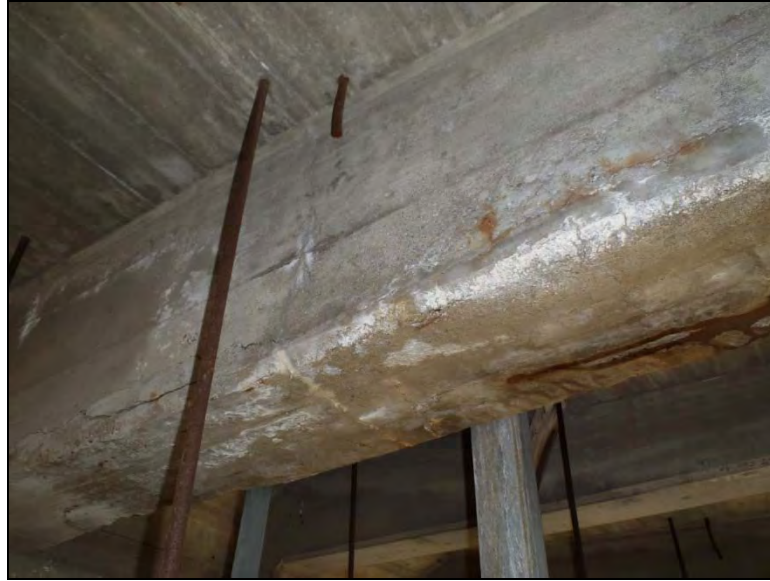
Photo C3-90 (ID C257) - Span 3, Floorbeam 24 between arch rib lines C & D. Entire bottom face is delaminated. Extensive evidence of rust staining and seepage through joint.

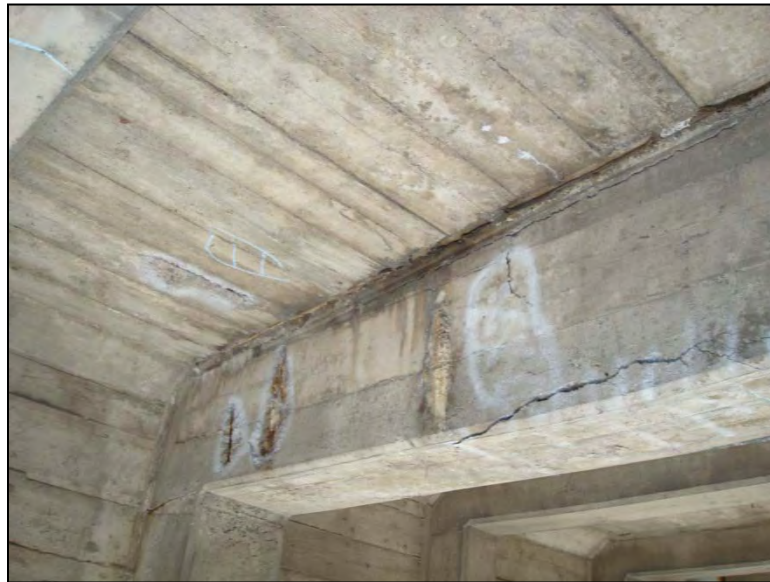
Photo C4-42 (ID C330) – Span 3, Floorbeam 4 at midspan between Spandrel Arches A & B, 4' long x full width x 3" deep delaminated area with spalling. Multiple spalls and delaminations at midspan also noted. Exposed bars in photo have up to 1/8" loss in diameter.

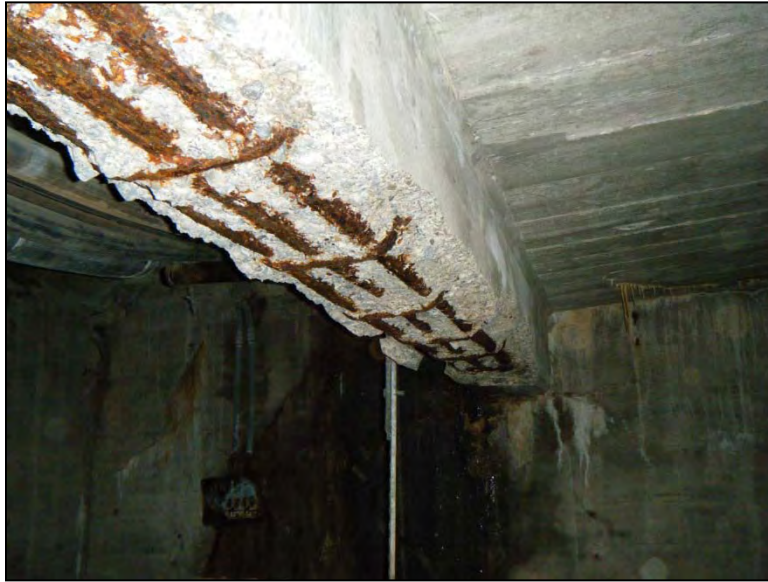
Inside the piers, the transverse floorbeams found in the spans are replaced by longitudinal concrete beams that support the deck slab over the piers. These beams exhibited significant deterioration due to years of exposure to deck drainage. Beams with spalling, delaminations and bars with section loss were commonly found in all the pier chambers. In some cases, not

only bottom bars, but also shear stirrups were affected by this deterioration. Deterioration was most prevalent on the first two interior beams (B1, B2, B9 and B10).

Photo D1-20 (ID E013) – Full length spall on bottom face of Beam 10 in Pier 2. 1/8" section loss to bottom bars and stirrups.

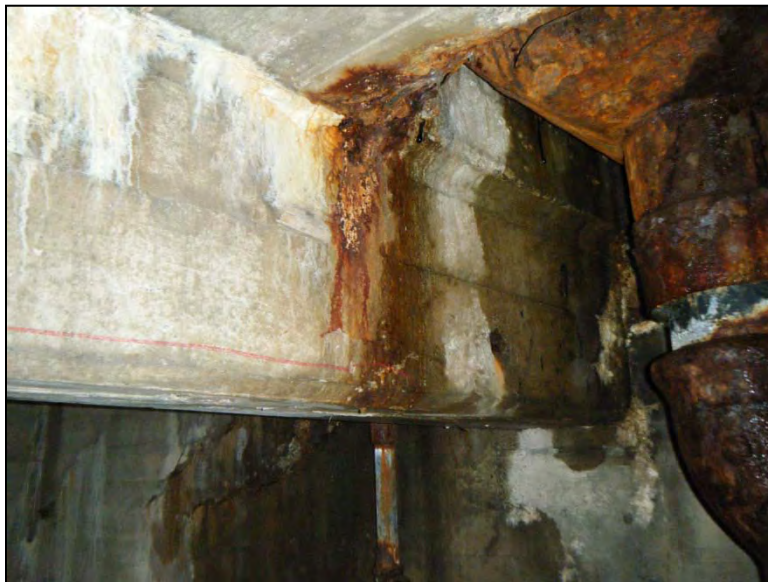
Moisture is readily available to promote deterioration of embedded reinforcing steel as evidenced by leaking drains and joints and extensive efflorescence deposits.

Photo D1-10 (ID E008) – West end of Beam 1 inside Pier 2, note heavy leakage through scupper pan, extensive rust staining, and efflorescence on concrete beam.

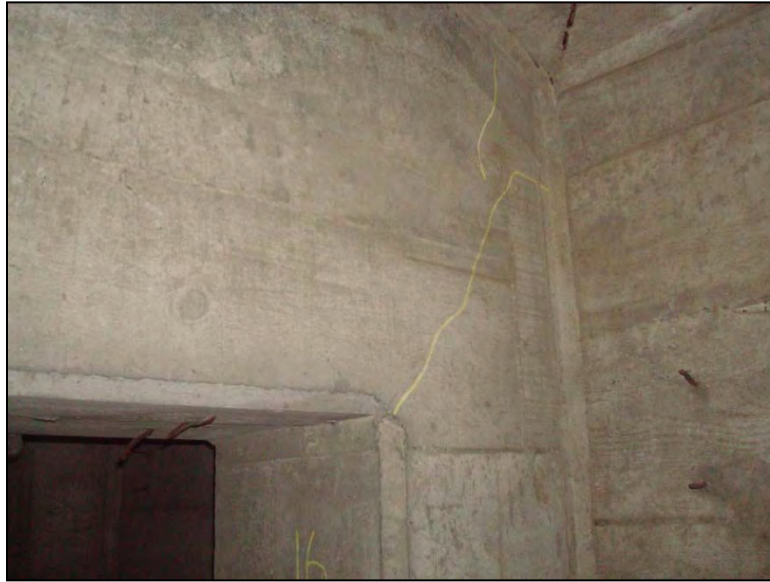
Another condition that was frequently noted was the presence of narrow diagonal cracks in the floorbeam ends above the pilasters at Spandrel Walls B & C. This condition was noted primarily in Floorbeams 8 – 20.

Photo E1-03 (ID E004) – Narrow diagonal cracks at pilaster-floorbeam intersection. Typical both web faces. No exposed bars, leakage or rust staining.

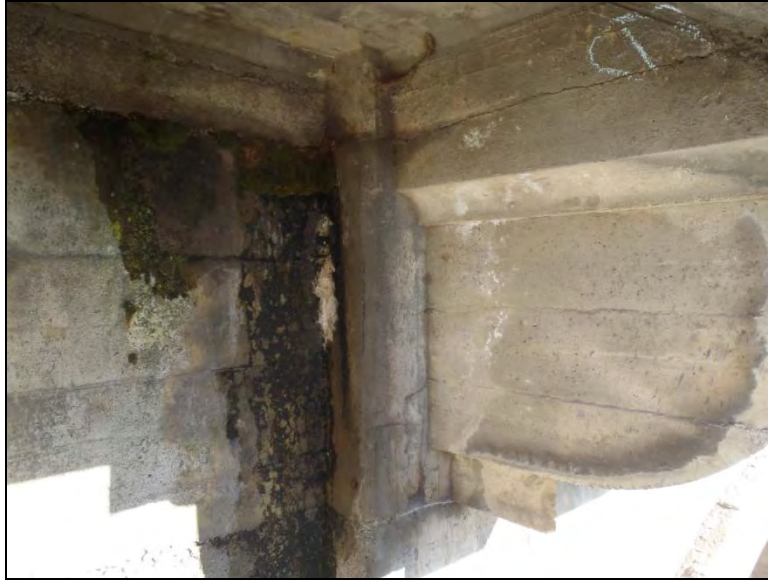
Beneath the sidewalk, floorbeam cantilevers support the deck slab. These members exhibited localized cracking, spalling and delaminations. Deterioration appeared slightly more pronounced along the north elevation of the bridge. Section loss to exposed bars was typically 1/16" or less. Drainage and leakage from the sidewalk above was evident between the floorbeam cantilevers and spandrel walls and spandrel arches in a number of locations. Shallow cover was a contributing factor to many of the observed spalls.

Photo C2-22 (ID C121) – South sidewalk overhang at Floorbeam 8. Evidence of leakage through joint and 6" dia. delaminated area.

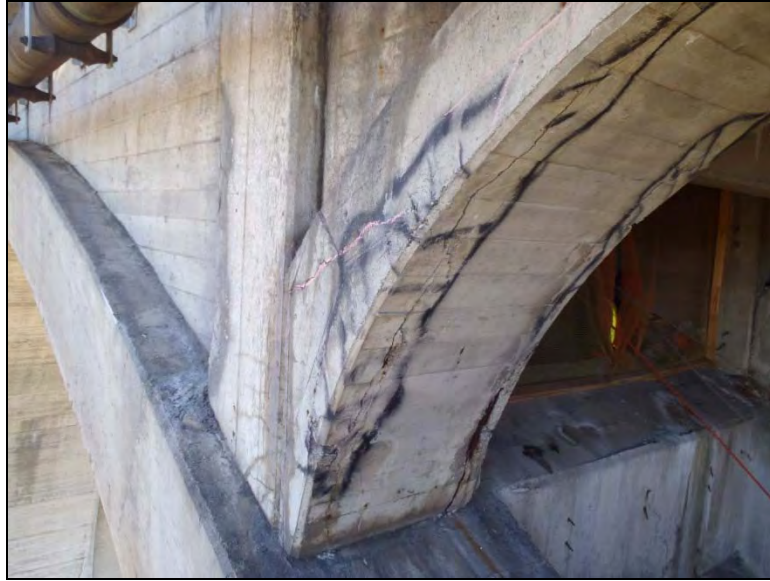
Large areas of deterioration were typically found on the spandrel arch soffits along the corners. Additionally, frequent cracking was also noted in these areas suggesting the occurrence of corrosion of the embedded steel reinforcing.

Photo C3-70 (ID C247) – Span 3, Spandrel Arch D, between Floorbeams 20 & 22. Large delaminated areas with exposed bars and rust staining on both corners. Typical at symmetrical locations.

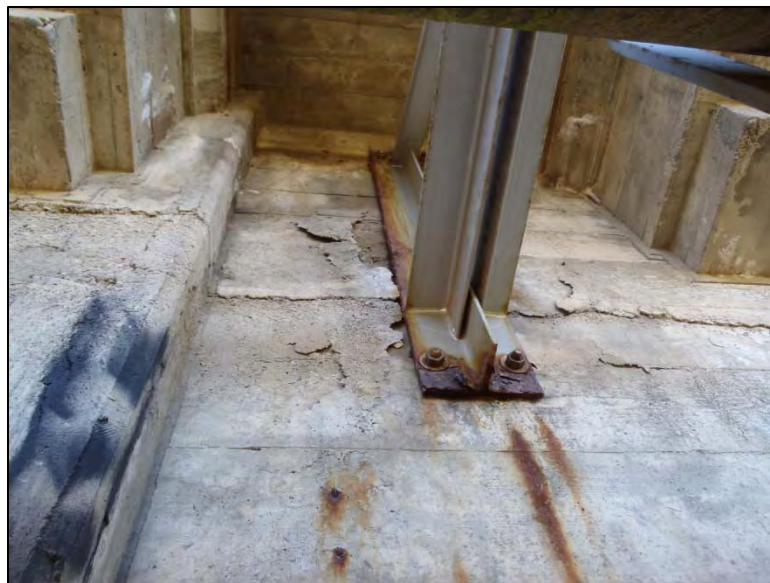
Photo C3-43 (ID C233) – Span 3, Spandrel Wall D between Floorbeams 8 & 9. Multiple localized delaminated areas and spalls, some with exposed reinforcing steel. Bars exhibit up to 1/16" section loss. Also note corrosion on steel utility bracket.

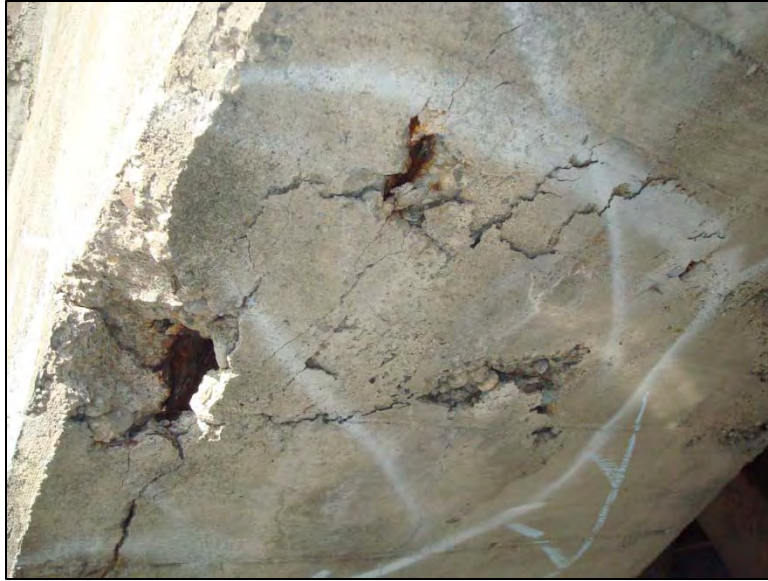
Photo C4-17 (ID C311) – Span 3, Spandrel Arch A soffit, between Floorbeams 2 & 3. 5' H x 4' W x 4" D delaminated area with spalls and exposed reinforcing steel. Bars exhibit approximately 3/16" section loss maximum.

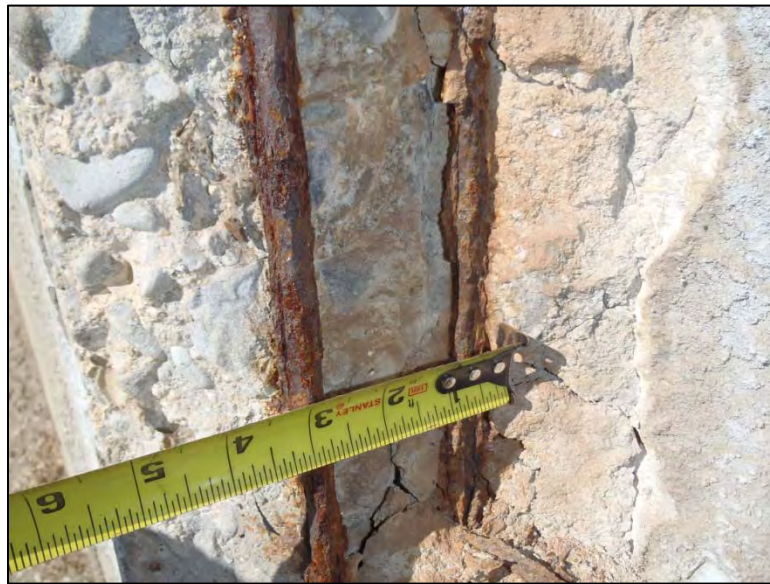
Photo C2-45 (ID C136) – Span 3, Spandrel Arch A, below Floorbeam 8. 5' tall spall along corner, 2 layers of bars exposed. Max loss to bar diameters = 100%.

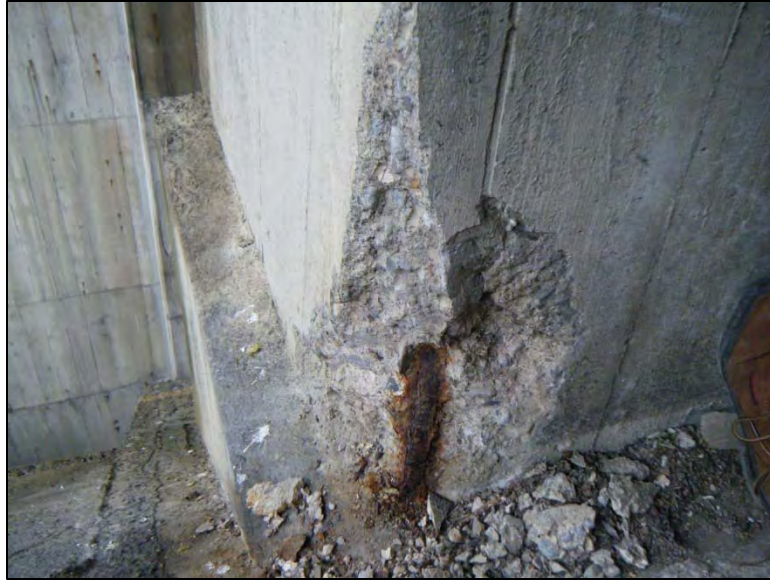
Spandrel columns are located at floorbeams 4 and 24. They typically exhibit delaminations and spalls in the vertical faces with deterioration particularly pronounced on the corners. Section loss was noted to exposed bars on the columns.

Photo D1-06 (ID D007) – Span 3, Spandrel Column B-24, large corner spall with exposed reinforcing steel with 1/16” loss to bar.

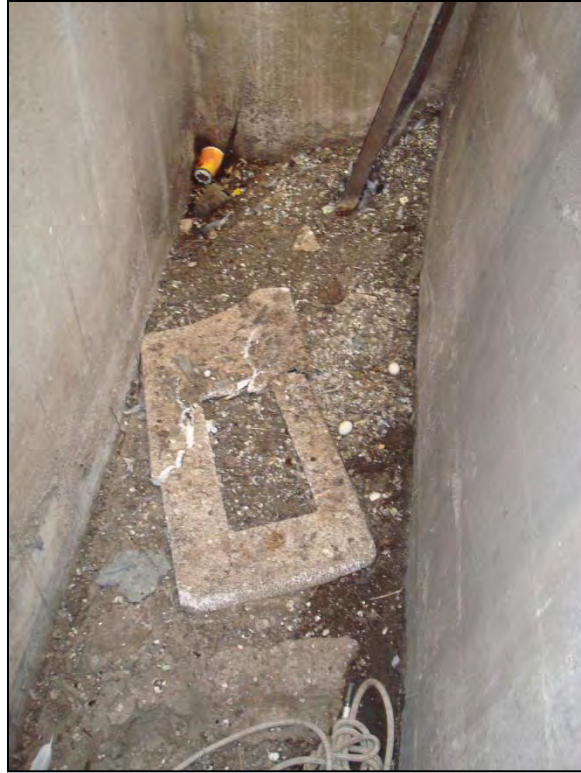
Photo E2-09(ID E111) – Heavy debris (dirt, garbage, bird waste, etc.) at base of arch floor at west face of Pier 2

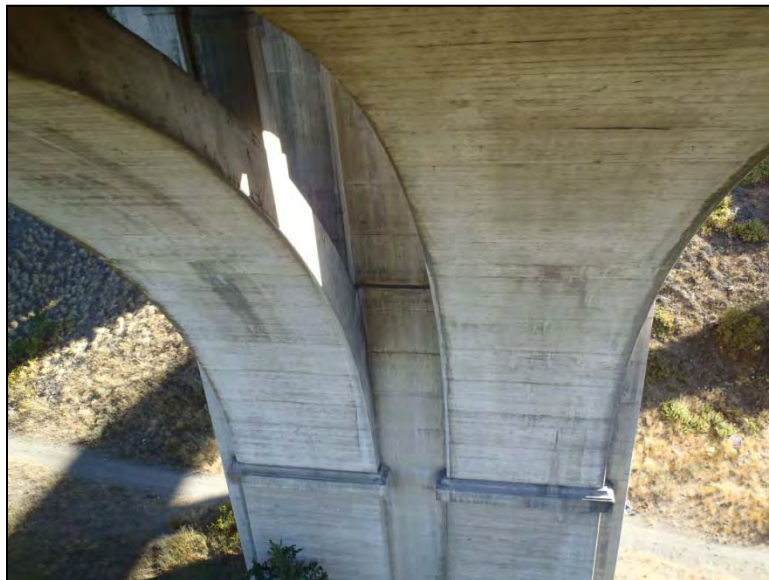
Photo C2-25 – Typical condition of arch soffit in Span 3

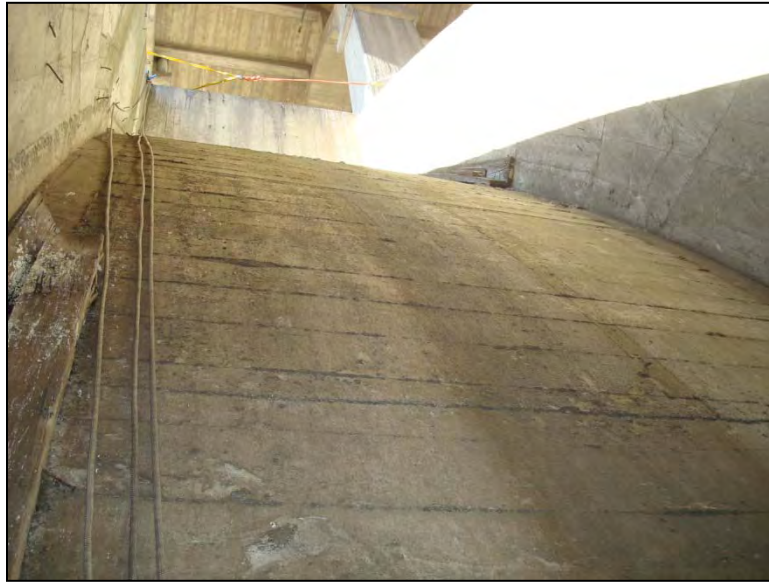
Photo E2-10 –Typical overall view, arch floor between Arch Ribs A & B below Floorbeams 1-4. Note typical rough/poor formwork/finishing and localized honeycombing patches.

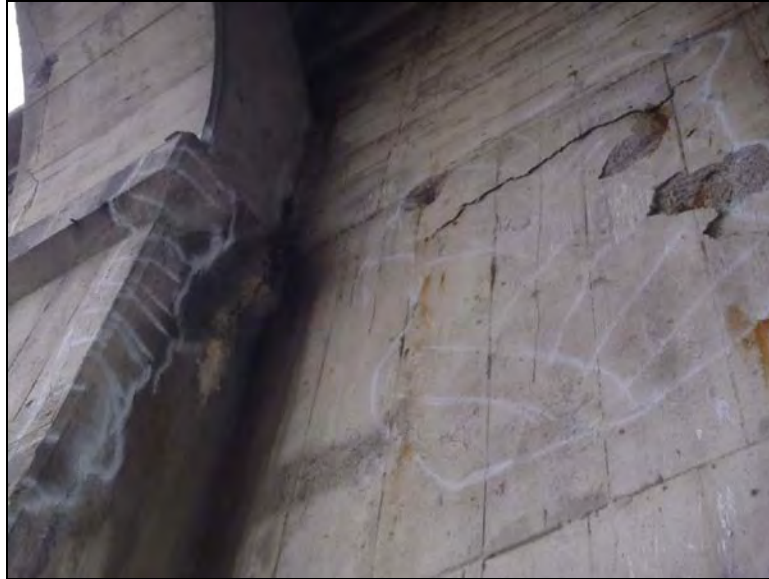
Photo C1-13 (ID C008) – West face of Pier 3 between Arch Ribs A & B. 4' x 6' delaminated area and 6' high corner delamination on pilaster above Arch Rib A. Localized spalls are present in the delaminated areas and have exposed bars with up to 1/8" loss to bar diameter.

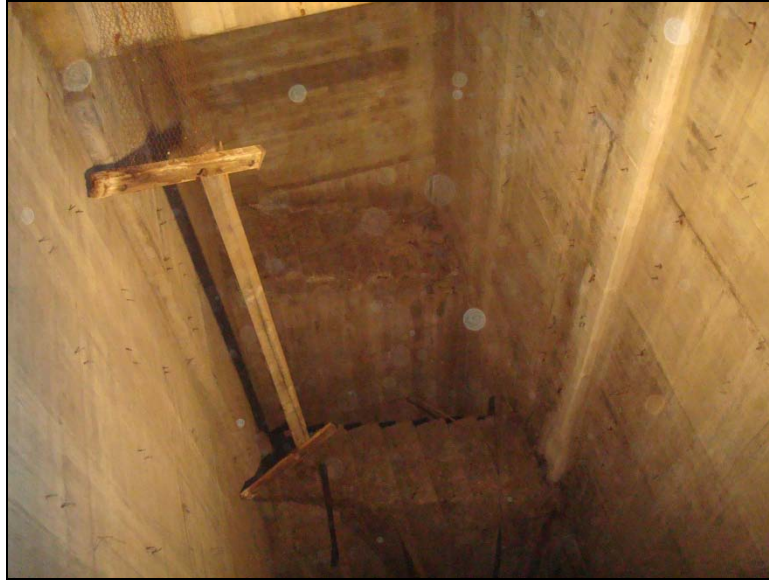
Photo E3-25 (ID E327) – Typical condition, interior of Pier 2. No significant deficiencies noted.

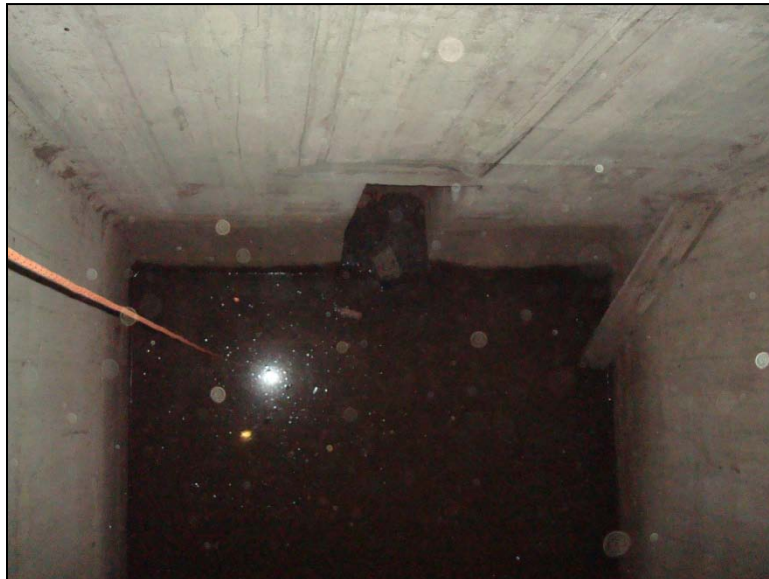
Photo E3-29 (ID E336) – Looking down at lower chamber in Pier 2, access door on east face. Trapped water and debris in base of pier.

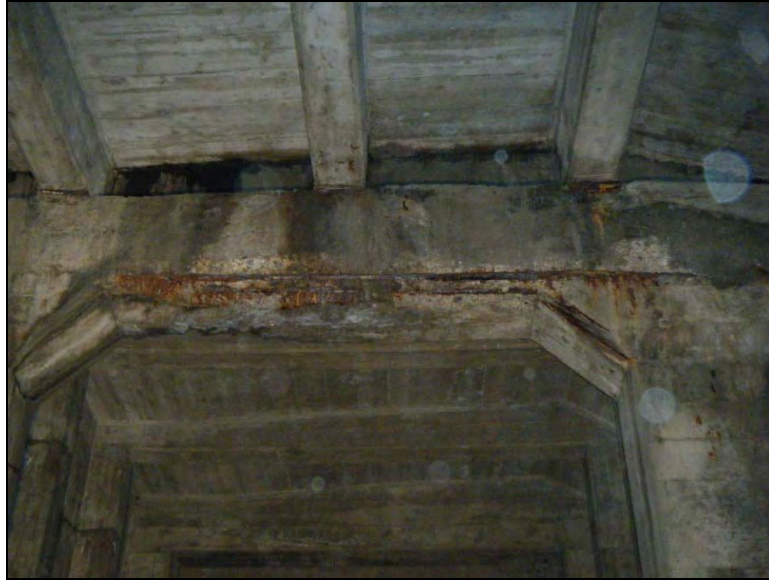
Photo D2-07 (ID M101) – Large spalled area with exposed bottom bars on floorbeam where East Approach meets Arch Span 1. Water leakage through joint above.

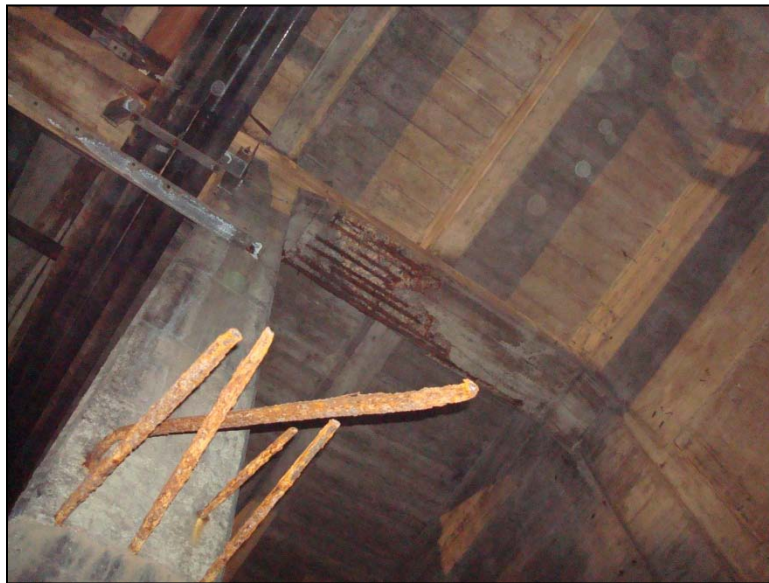
Photo C4-48 (ID M401) – Spalling and bars with section loss (estimated at 1/8" max loss to diameter) on bottom of floorbeam at Column Line 1 in West Approach.

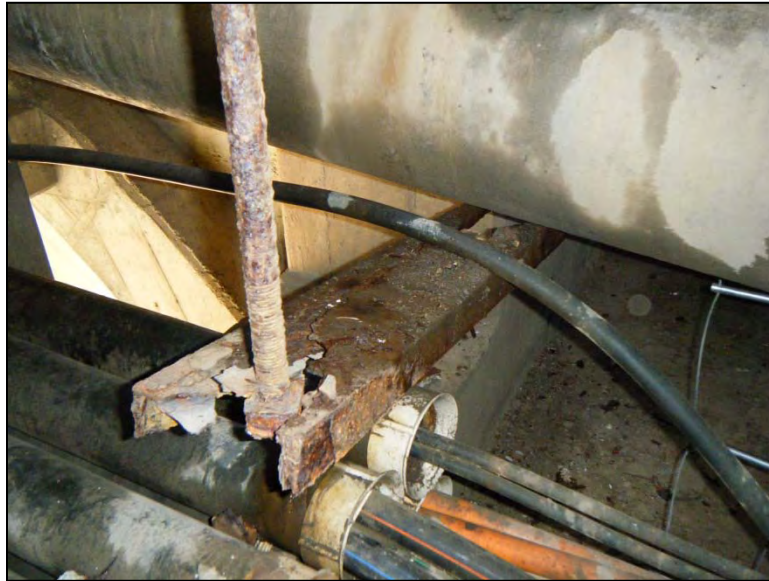
A large bank of utility conduits is located between spandrel wall/arch lines C & D. Additionally, utility lines are mounted on the exterior north face of the bridge, immediately below deck level. Corrosion was noted on the steel elements comprising the support system for these utilities. In some extreme cases that corrosion had progressed to a degree that the integrity of the support is compromised, mainly on the interior utility brackets. Supports on the north exterior elevation were found to be generally sound and intact.

Photo D1-27 (ID E019) – Failed steel utility support bracket near east wall of Pier 2. Bracket supports a 12” dia. pipe.

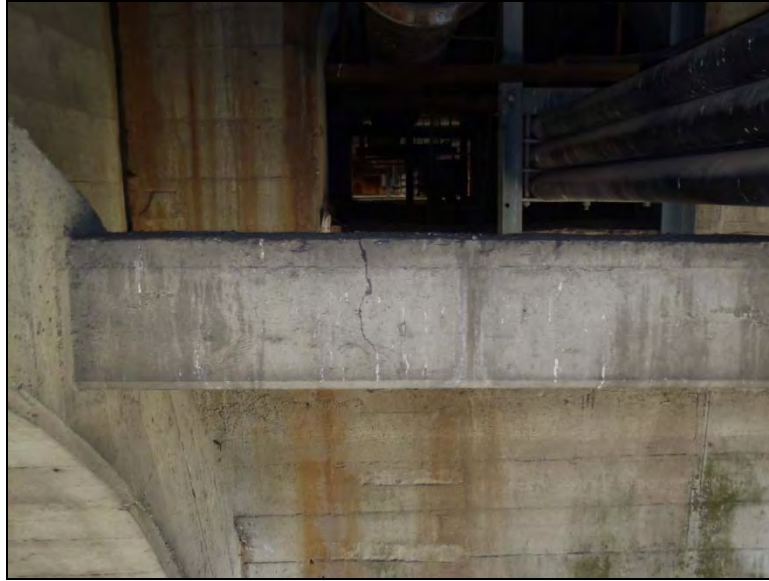
Between Spandrel Arches C and D, transverse beams are present whose purpose was likely to support utilities. They are currently not supporting the utility lines in this area. These beams exhibit medium vertical and diagonal cracks and localized areas of honeycombing.

Photo C3-109 (ID C271) – Transverse beam between Spandrel Arches C & D at Floorbeam 27. Vertical crack 2' from face of Spandrel Arch C. This cracked condition is typical at several locations

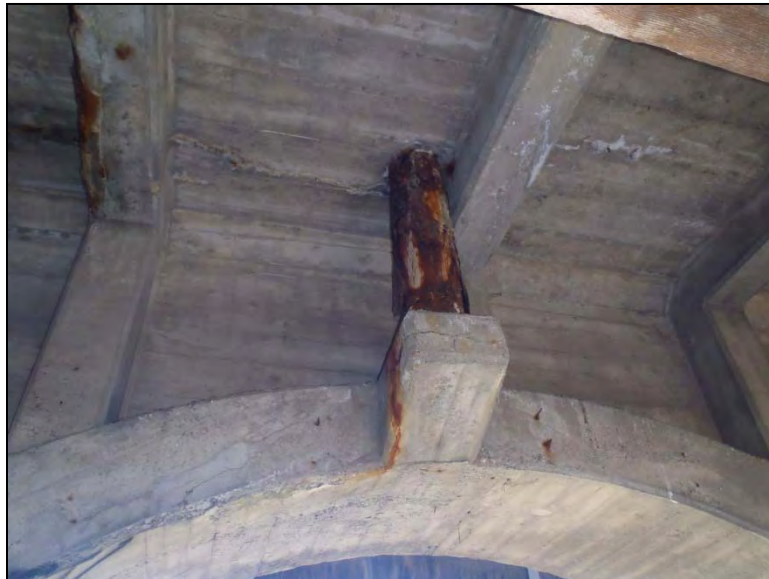
Light poles are located along the north side of the bridge deck. These poles penetrate the deck and are supported by small pilasters on the Spandrel Arch/Wall D. These pilasters exhibit extensive distress related to prolonged exposure to deck drainage and corrosion of the embedded steel. The vertical steel poles also exhibit heavy laminating corrosion and rust staining.

Photo C3-31 (ID C223) – Light pole pilaster at Floorbeam 6. Corrosion related distress to steel pole and concrete pilaster.
