November 3, 2021

Project G201062

PROJECT: Marshall Creek Estates, Spokane, Washington
SUBJECT: Geohazard Evaluation

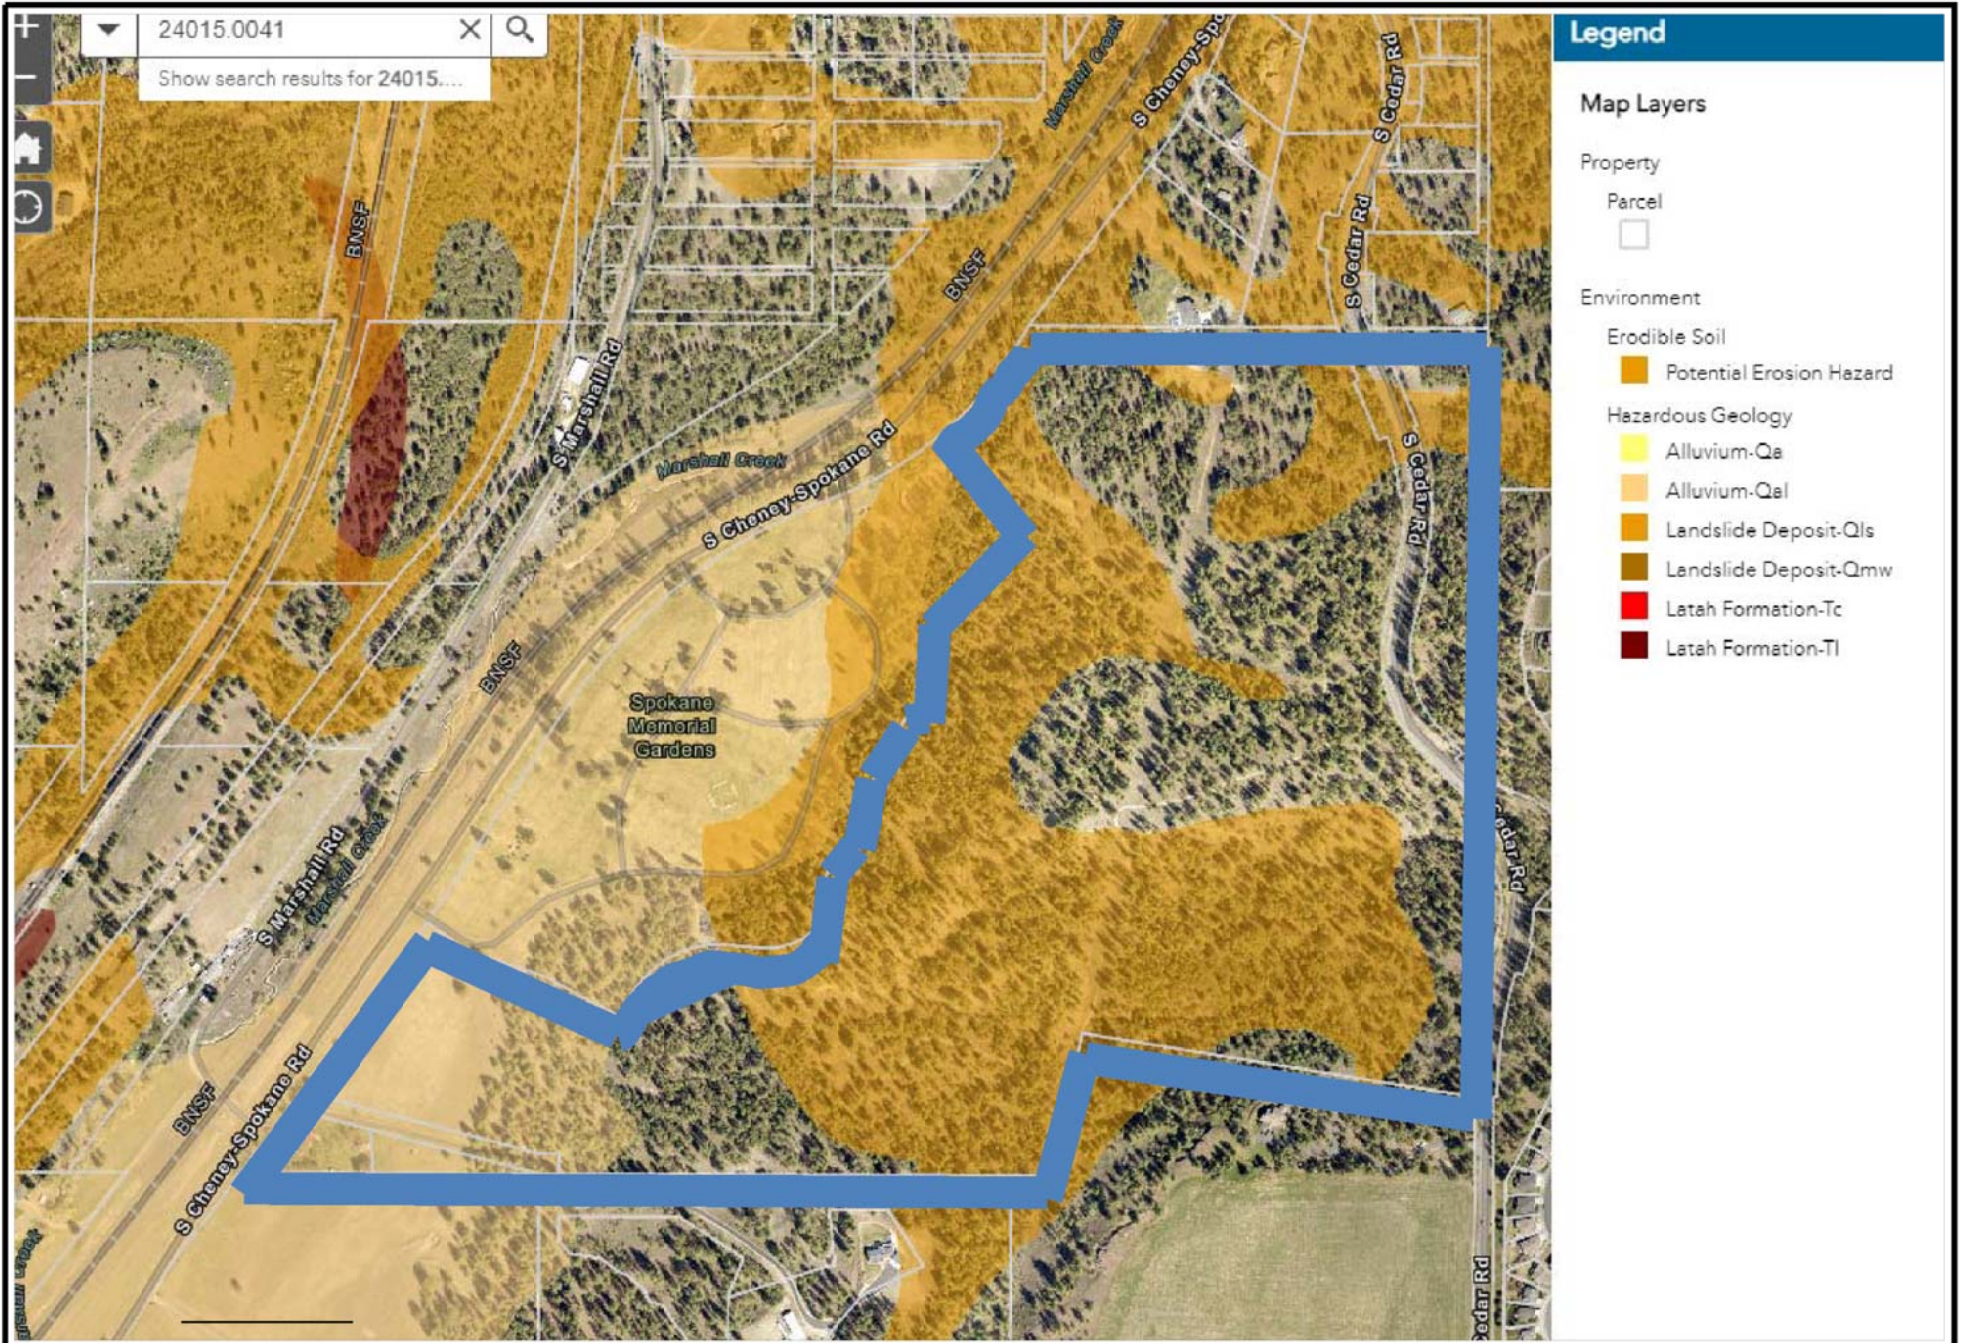
FIGURE 3

Hazardous geology is typically associated with having a high susceptibility for landslides. Alluvium is mapped in the southwest corner of the site. Alluvial soils (Qal) are located at the southwest corner of the site. These soils may be subject to slope instability due to high water stream erosion or rapidly water drawdown along slopes steeper than 30 percent.

The area mapped as *Hazardous Geology* is in an area of potential flooding which could lead to instability of the alluvial soils. Slopes in this area range from relatively level to 13 percent.

Erodible soil hazards are mapped at the site as shown on the attached *Figure*. The NRCS classifies the erodible soils as Marble loamy sand, 15 to 30 percent slopes (Unit 3122).

A K factor for the Unit 3122 soil is not listed. The estimated erosion hazard for this soil unit is severe due to the slope inclinations and the silt and fine sand elements of the soil.

The hazard associated with the alluvium soil will typically be erosion. This hazard should be mitigated as described in the *Soil Erosion* section of this report and the GER.

Soil erosion potential is considered severe through much of the site but should be manageable with typical BMPs and not disturbing slopes when possible. These soils are also susceptible to tracking off site by vehicle traffic in wet conditions. Typical BMPs such as rock armoring of egress points and silt fencing, will address this hazard. These BMPs should be included in the grading and erosion plan for the site.
