# Geohazard Conditions Report

Volkman Housing project  
Spokane County, WA

1/24/2025

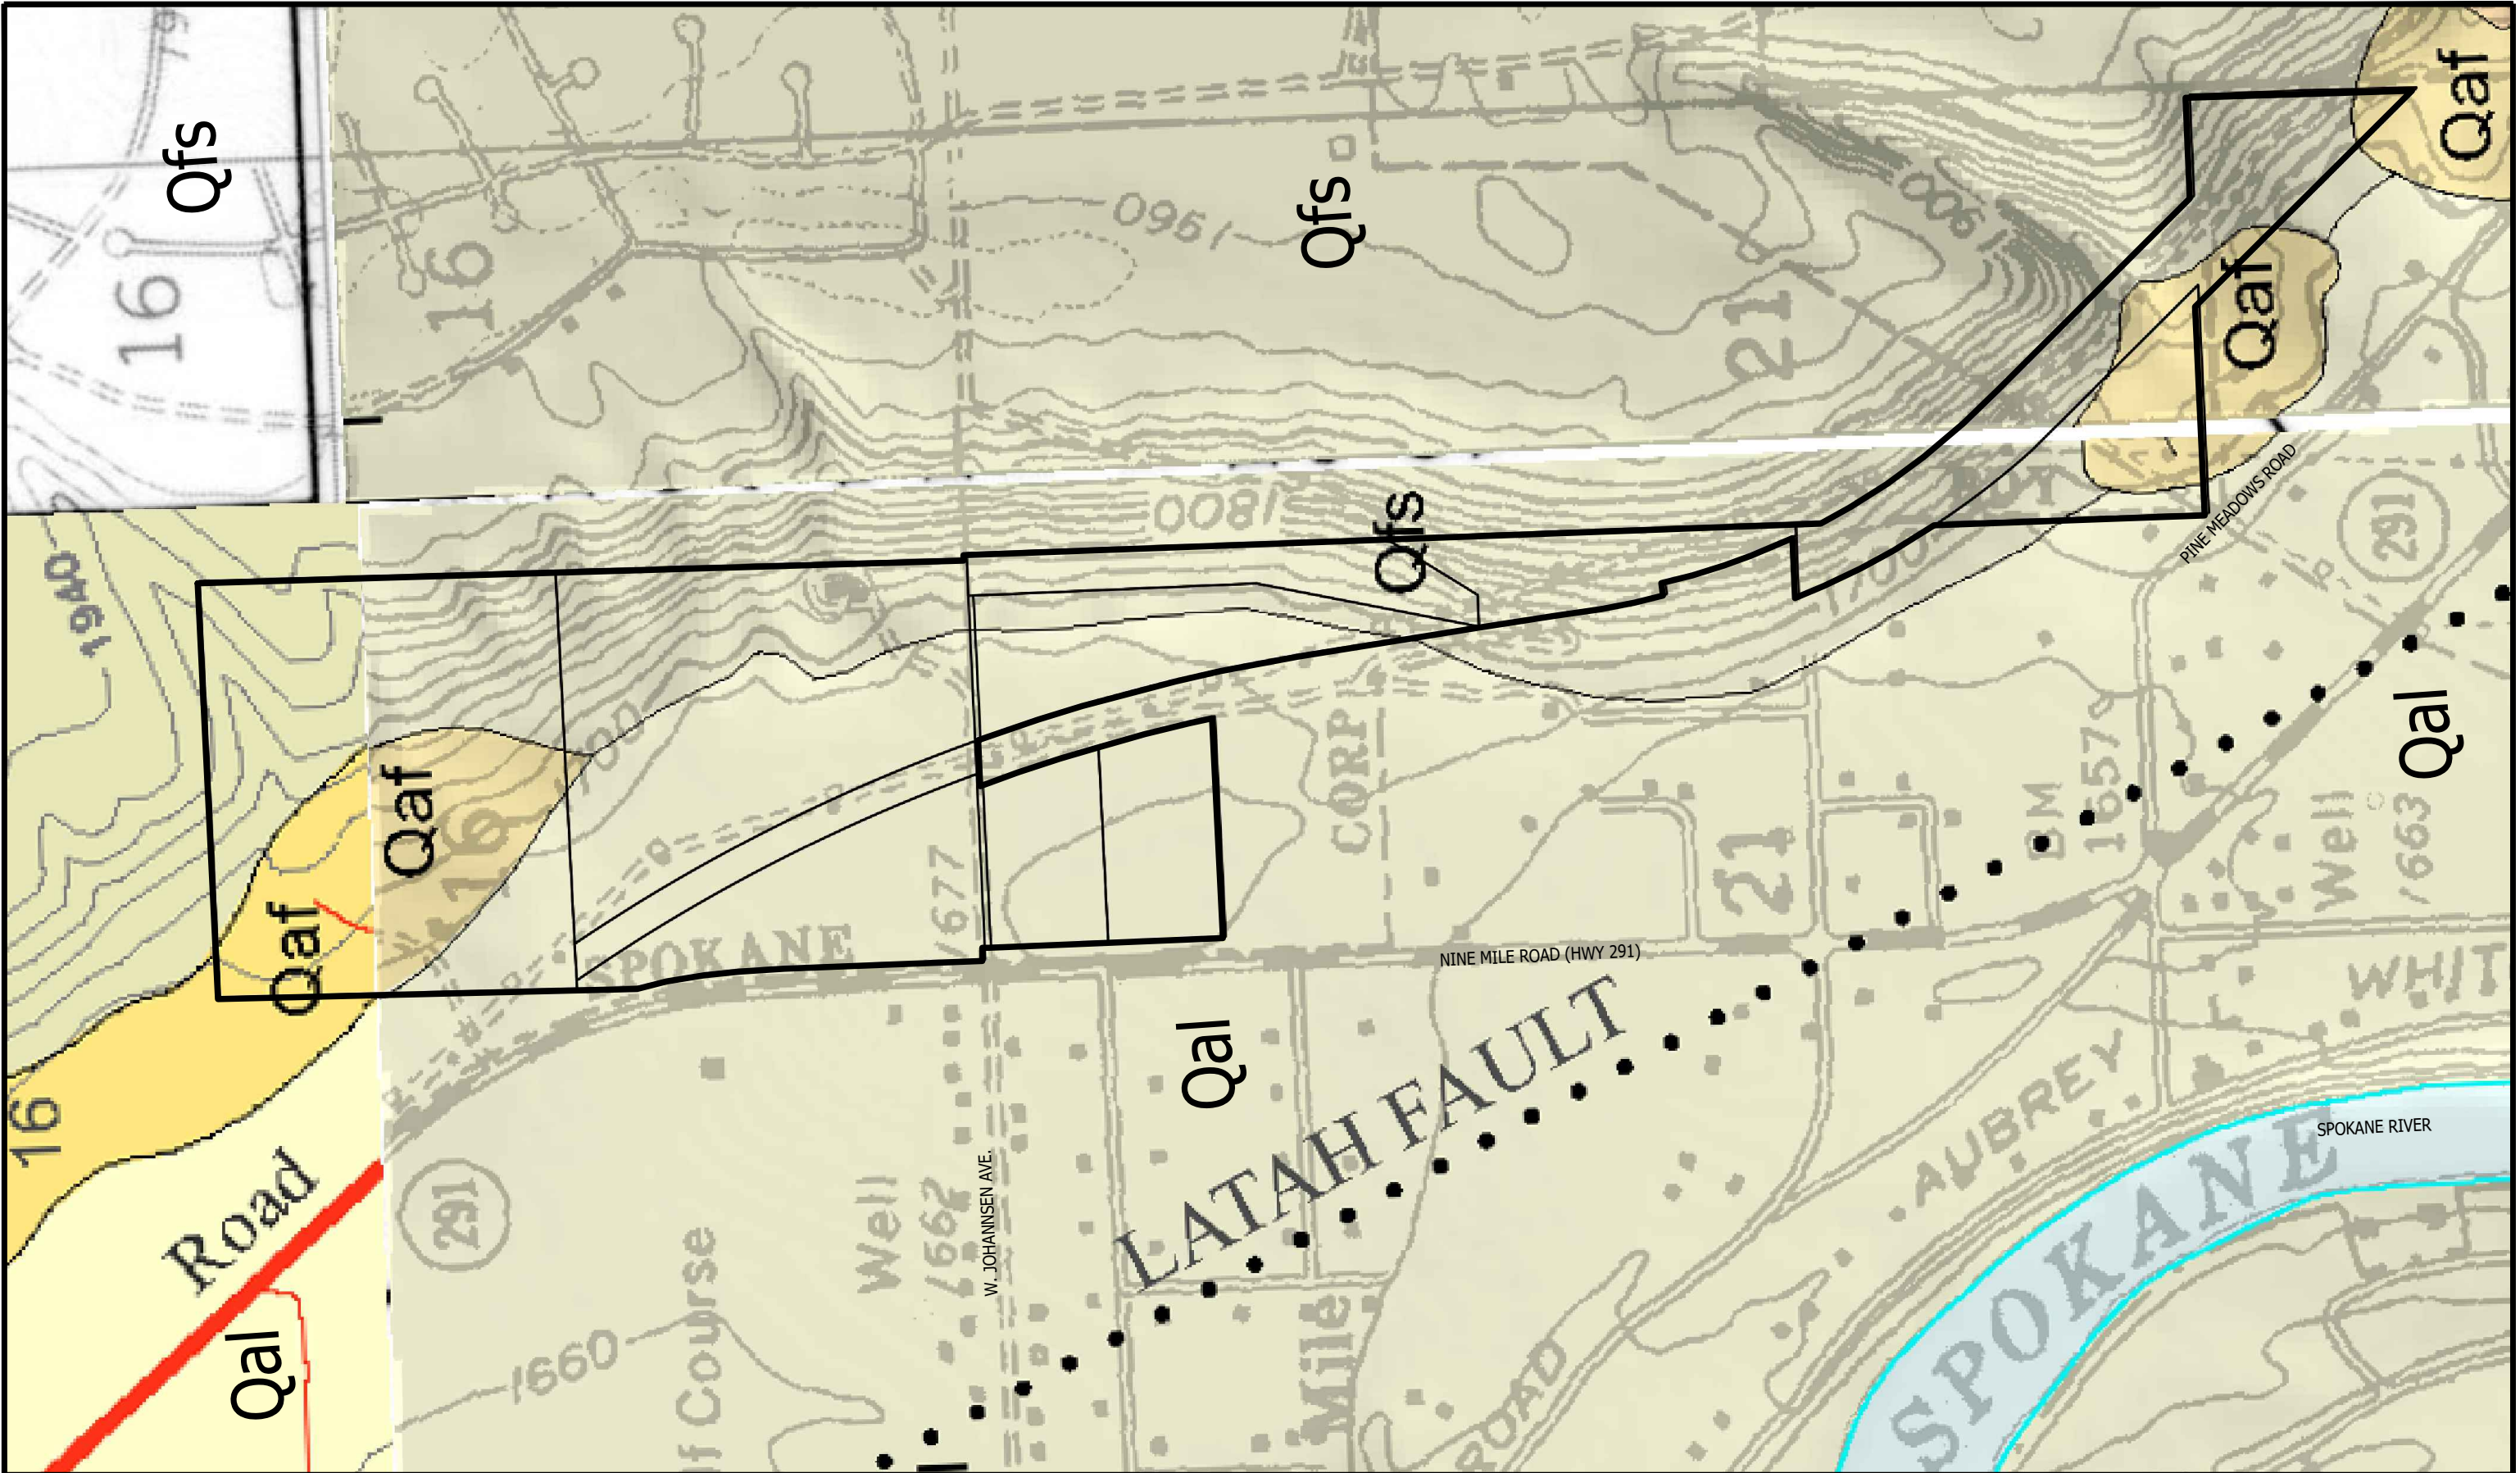
FIGURE 2-2

Quaternary alluvium (*Qal*) was mapped by the WSDNR on parts of the site, as illustrated in *Figure 2-2*. The encountered soils were coarse-grained, well consolidated, and formed relatively gentle slopes. In the areas mapped as alluvium, we did not observe evidence of erosion or landslide hazards during our surface reconnaissance and subsurface explorations.

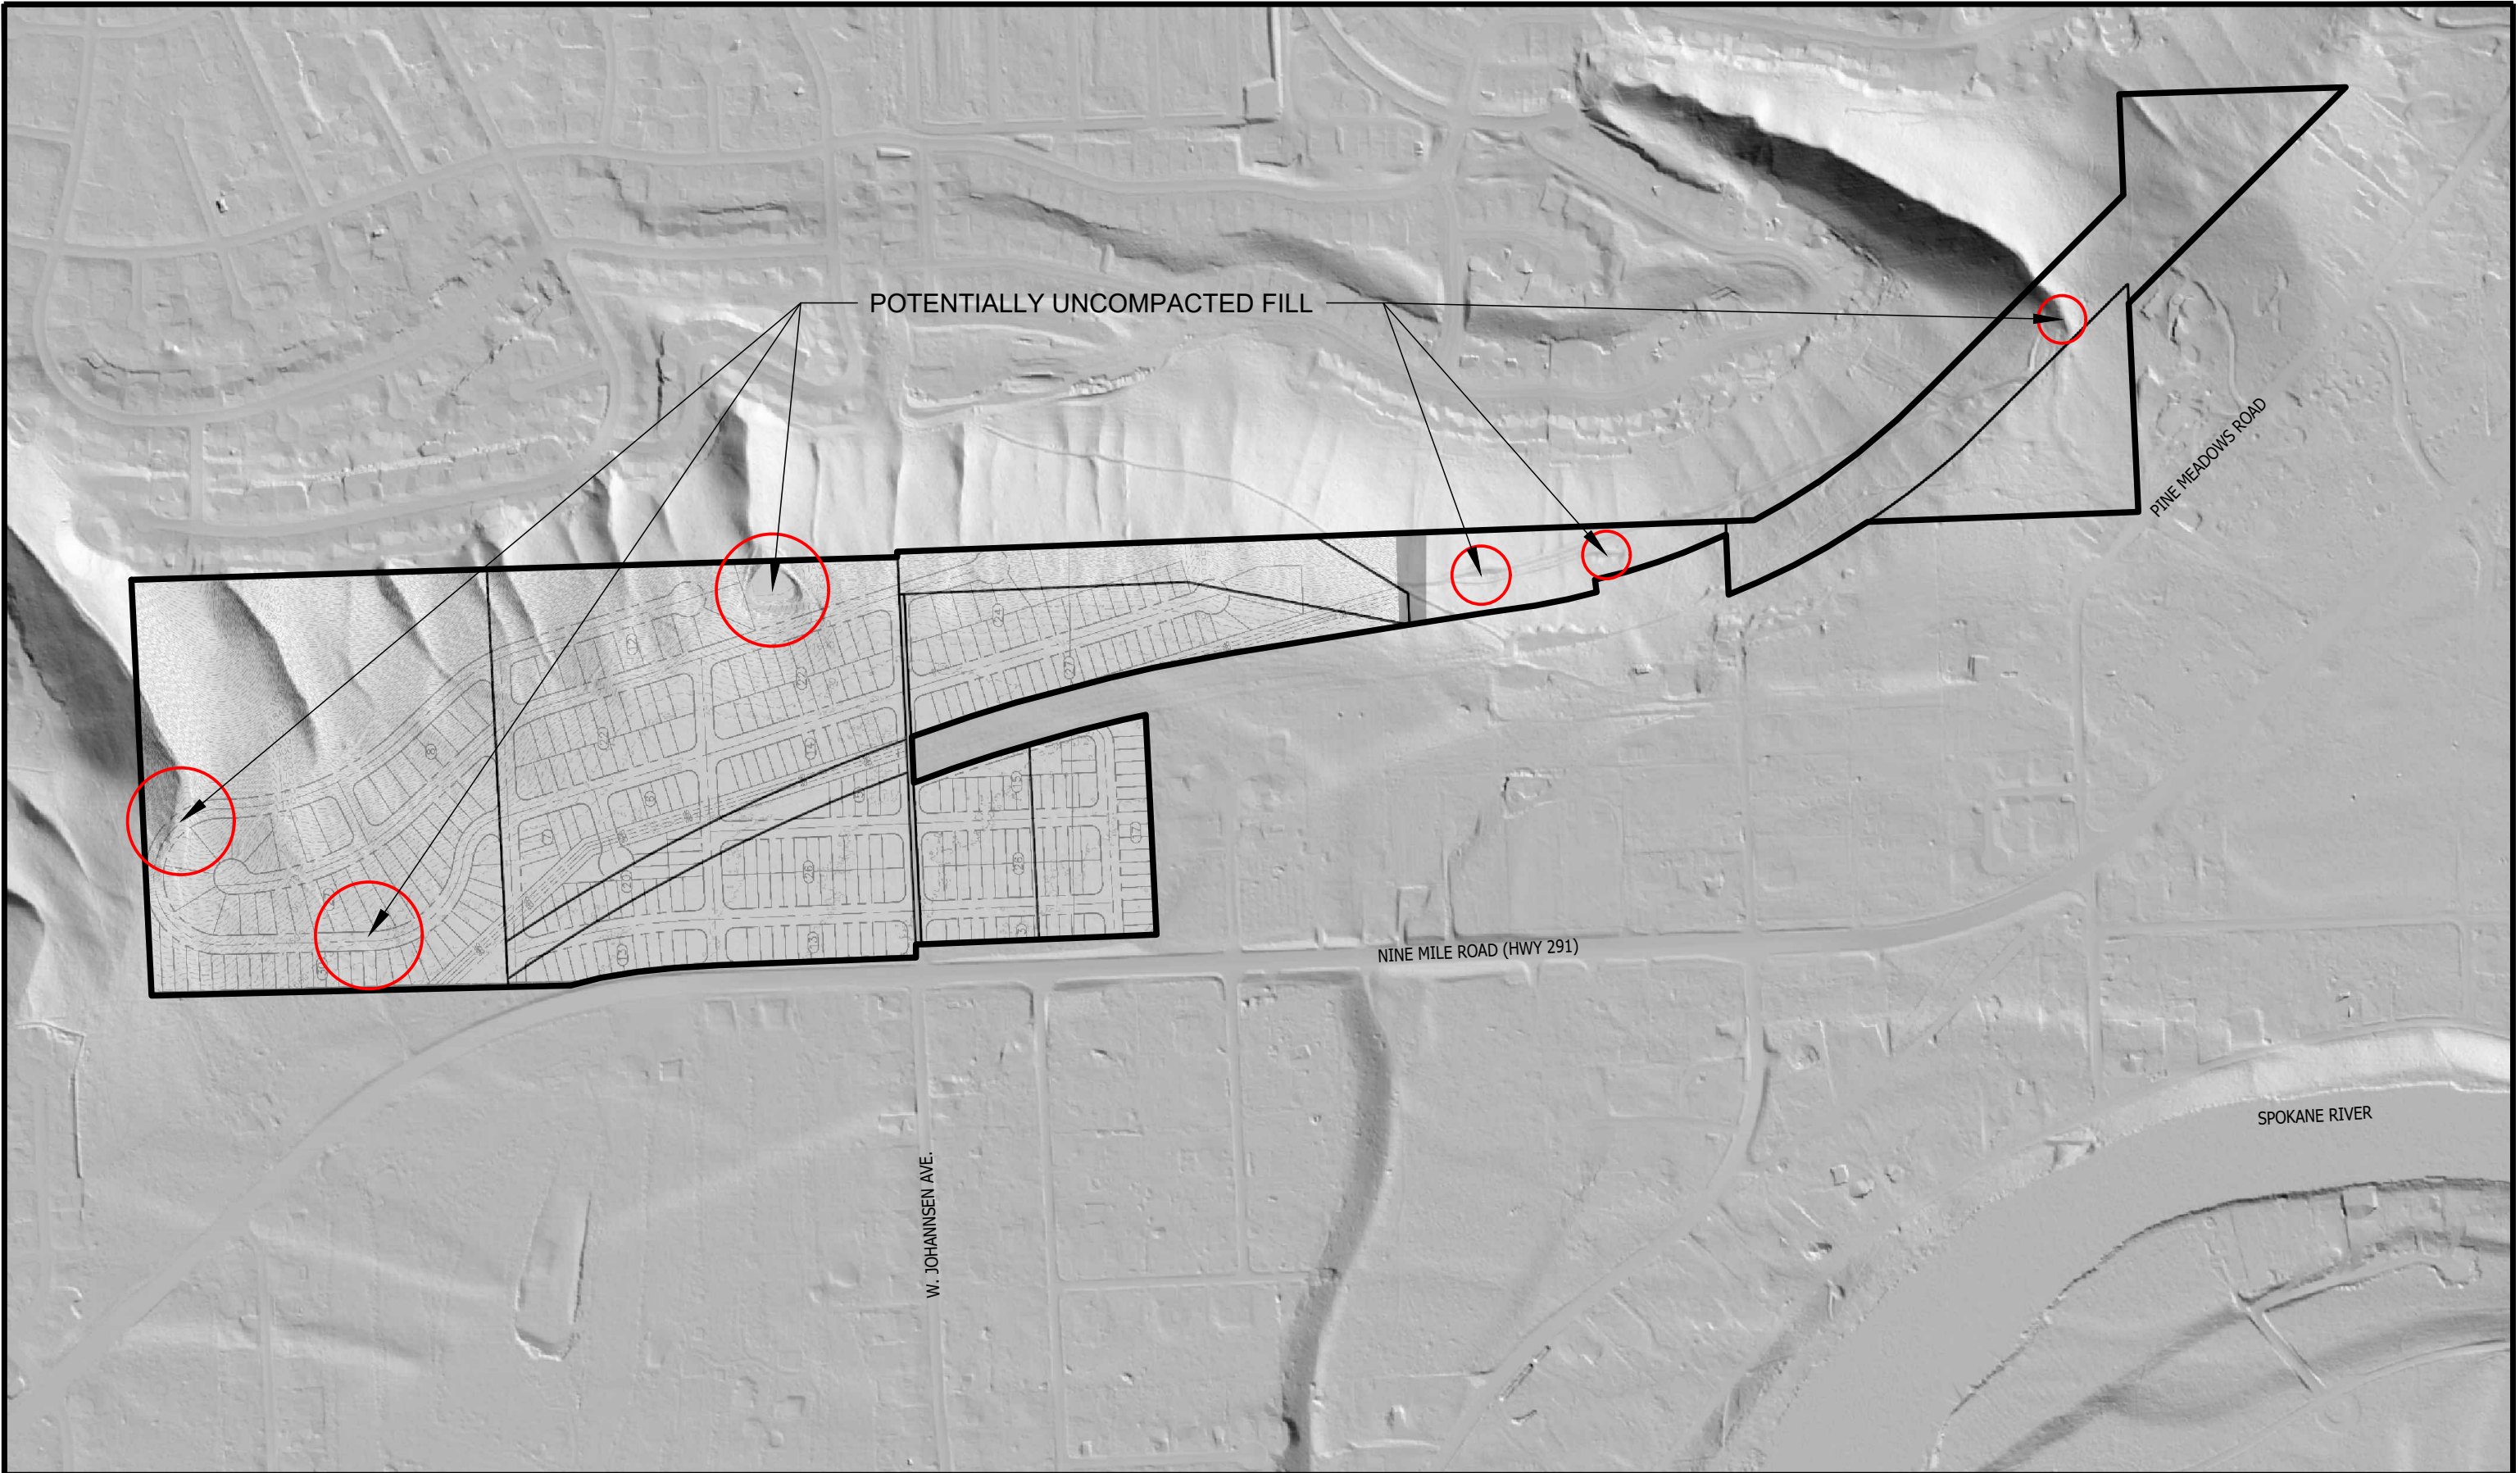
FIGURE 2-3

constructed by cut and fill methods. At the center of the northern boundary of the site, fill was observed in an area possibly used as a borrow pit. High-voltage powerlines were observed on an easement from the northwest corner to the southwest corner. On the southern half, a road was cut into the slope beneath the power lines. Near the top of the road, an erratic, approximately 8-foot diameter boulder was observed. Several indications of buried gas and communication lines were observed perpendicular to Pine Meadows Road.

○ AREAS IDENTIFIED AS POTENTIALLY UNCOMPACTED FILL

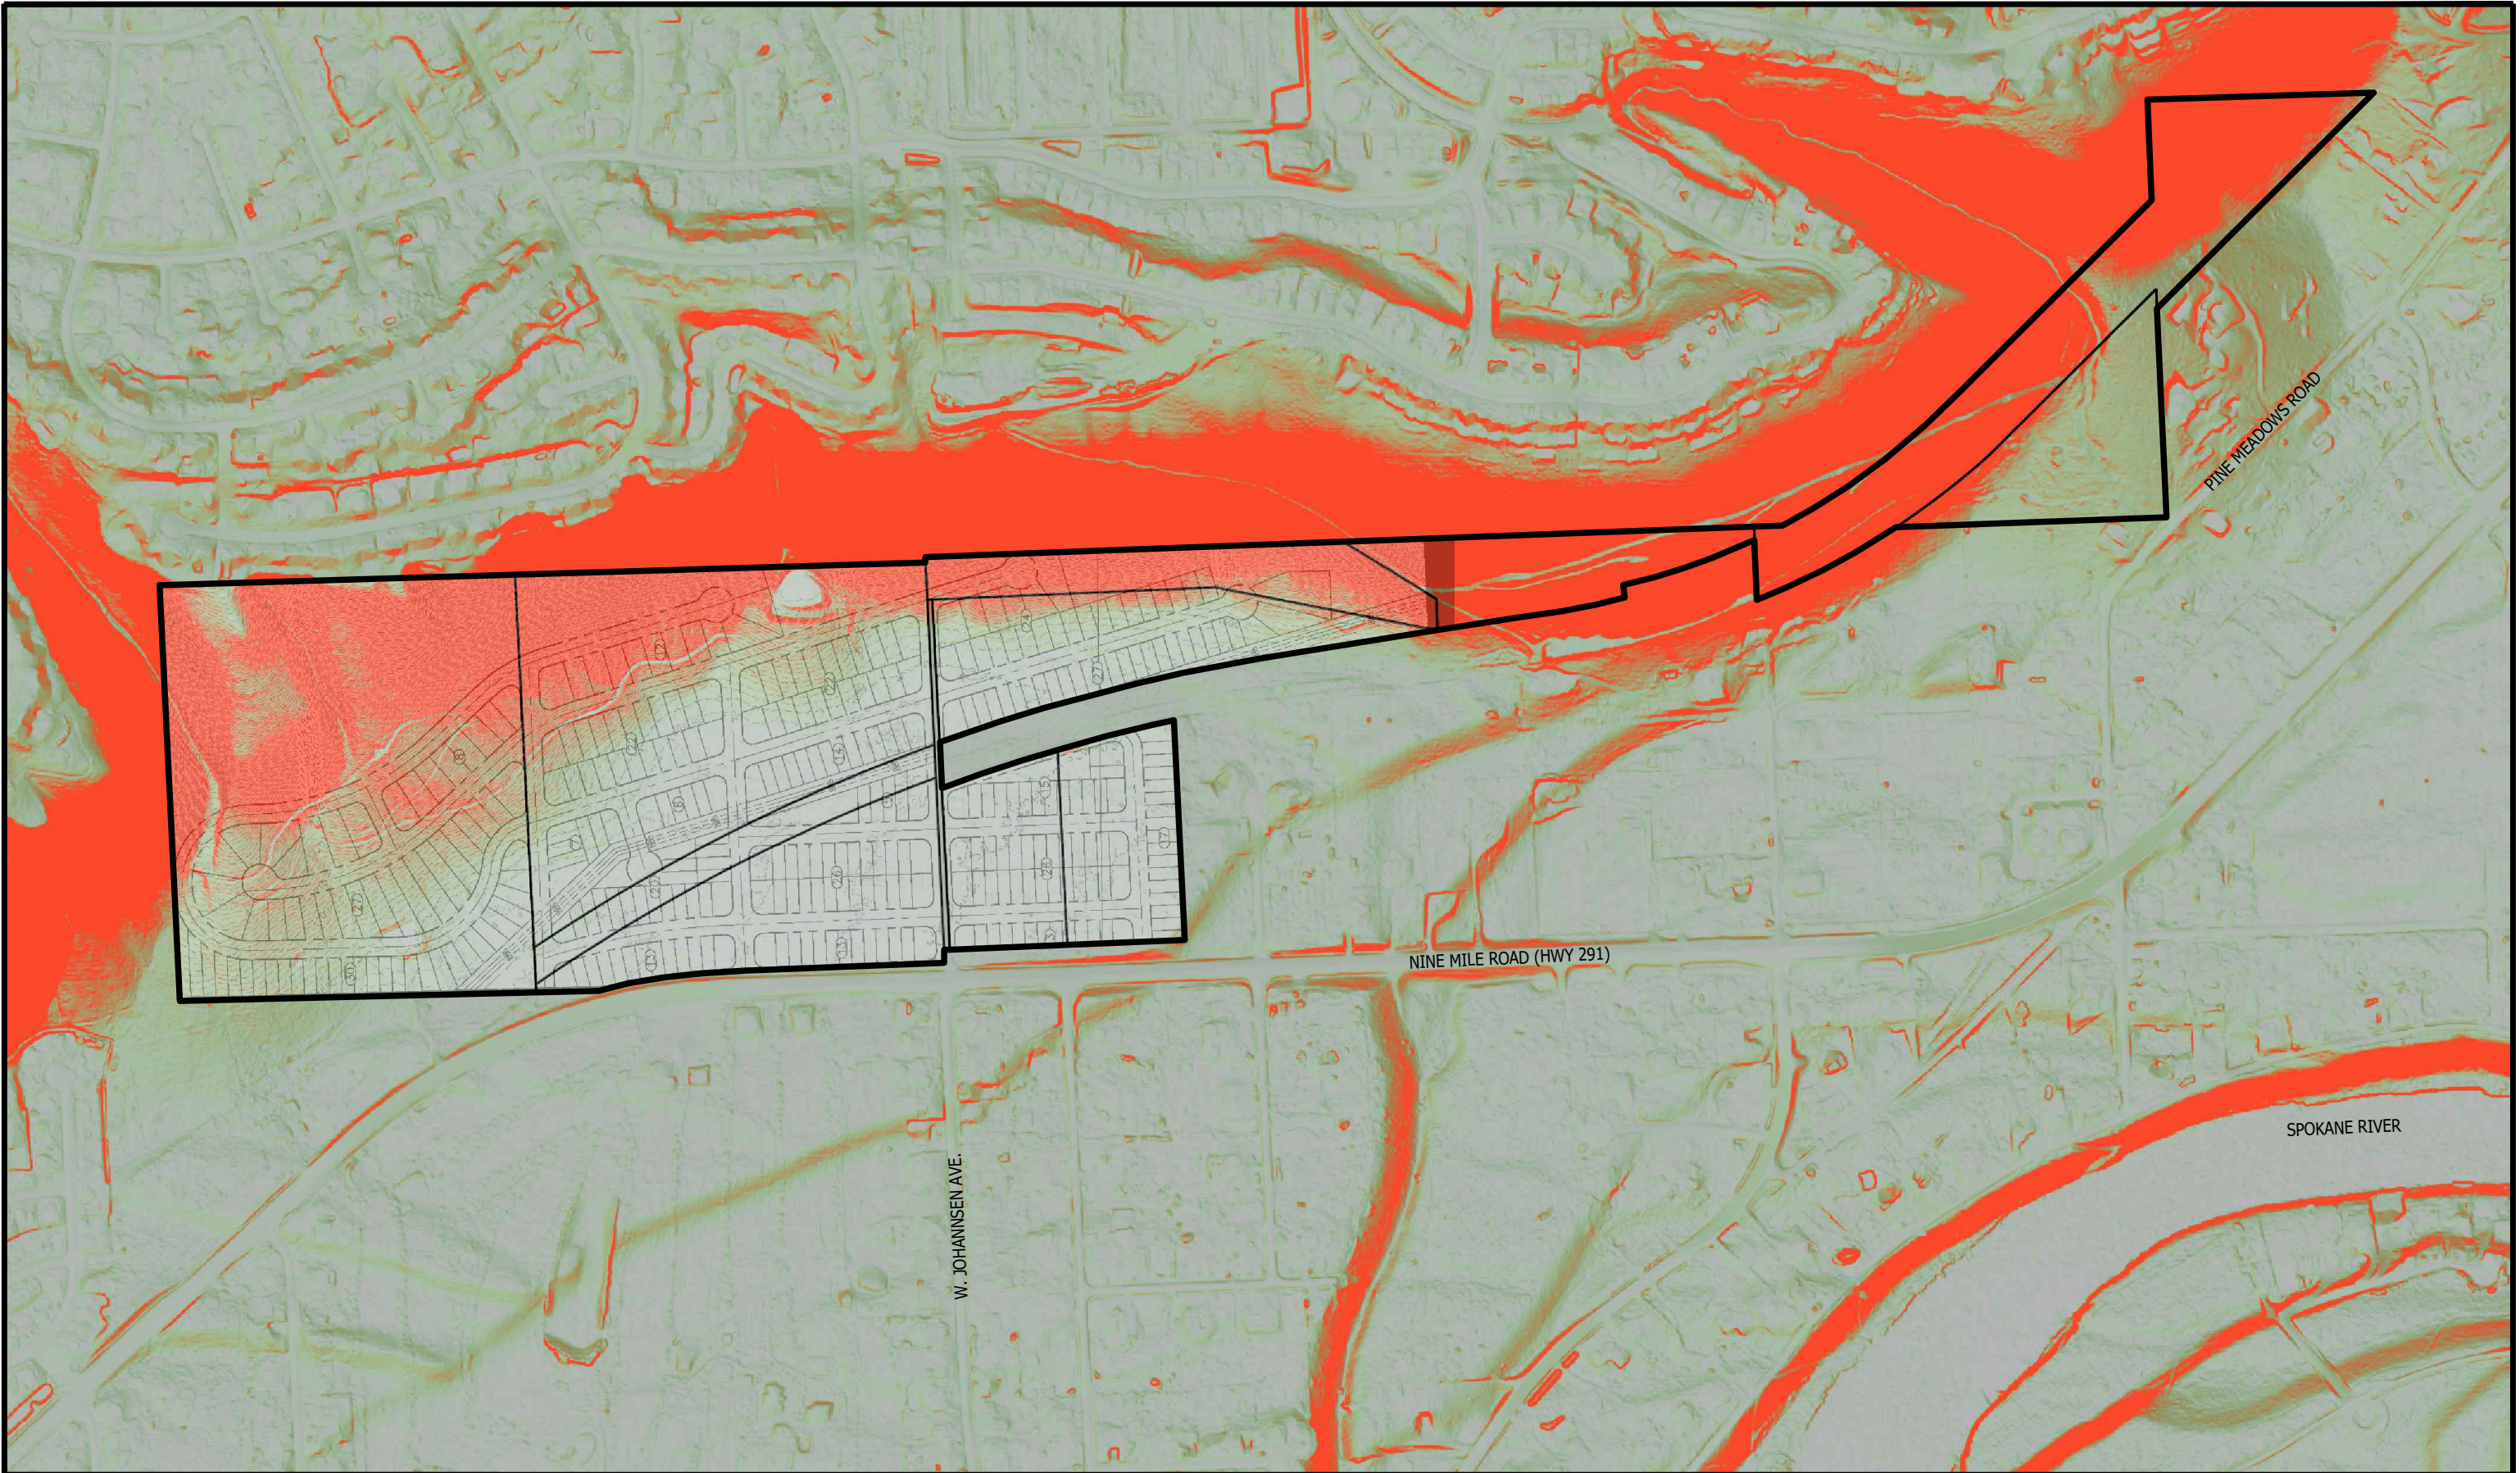
FIGURE 2-4

**Geologic Hazards.** Geologic hazards identified on the site, as defined by the CAO are slopes greater than 30 percent, soils identified by the NRCS as posing a severe potential for erosion, areas mapped as alluvium, and areas of uncompacted fill. The extent of these hazards were delineated in *Figures 2-2, to 2-5* utilizing GIS data obtained from the Washington State Department of Natural Resources and Spokane County.

Although geologic hazards are present, we conclude these hazards can be mitigated by use of typical construction best management practices, preservation of natural drainages, and following the recommendations outlined in this report.

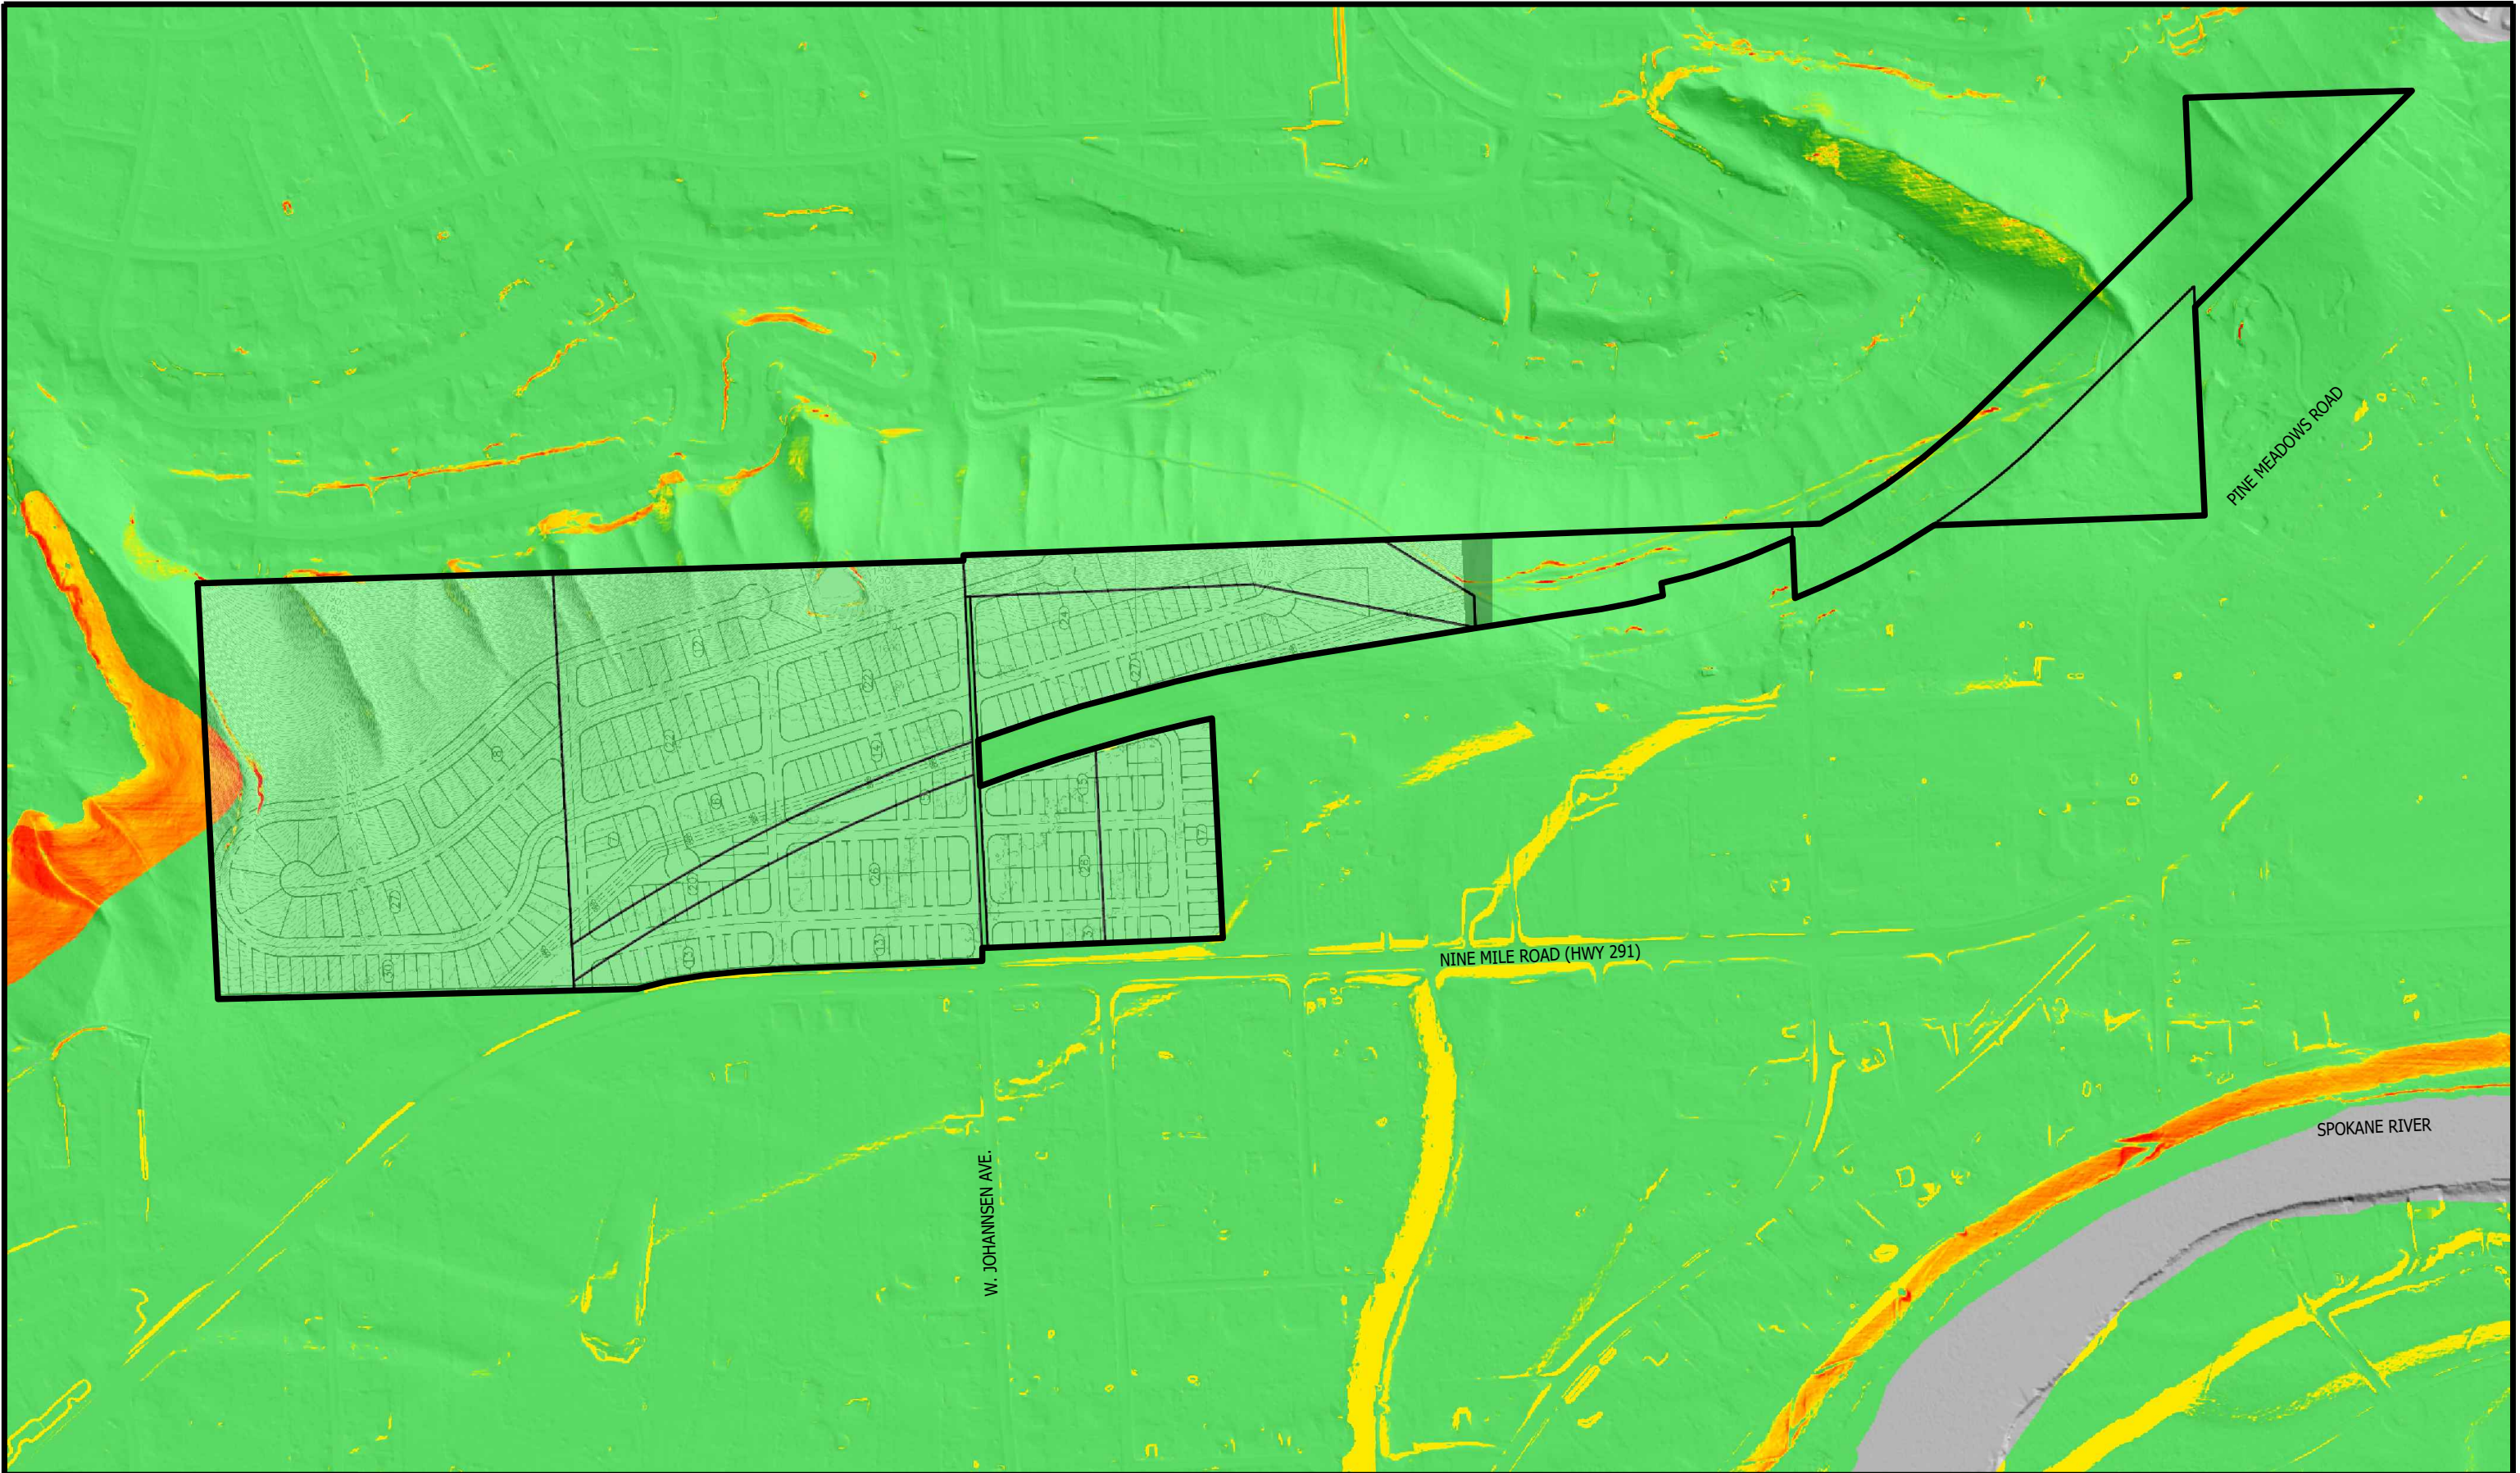
FIGURE 2-5  
PROJECT NUMBER G22525  
DATE: 8/2022

We used the modified version of the Universal Soil Loss Equation (USLE) outlined in Section 11.20.090 L Appendix L in the CAO to determine whether soils pose a severe potential for erosion. *“The index is a product of K times the average slope of the map unit (K\*ave slope). Slight has an index of less than or equal to 3.0 (less than 5 tons/acre/yr.), moderate has an index of 3.0 to 4.0 (5 to 8 tons/acre/yr.), and severe has an index greater than 4.0 (greater than 8 tons/acre/yr.)”* Table 2 lists slopes that pose severe potential for erosion based on the equation outlined above. The potential for erosion, based on the parameters in *table 2*, is illustrated in *Figure 2-5, Soil Erosion Hazard Map*. Soils identified as posing a severe potential for erosion are located on and north of the northern edge of the site, outside the proposed development.

We recommend retaining qualified professionals to complete erosion and sediment control plans, civil engineering and stormwater design, and geotechnical exploration and analysis.
