Project: Carnation Garage Building on Cataldo Avenue between Washington and Howard Streets
Spokane, WA

Subject: Limited Visual Review of Structural Condition

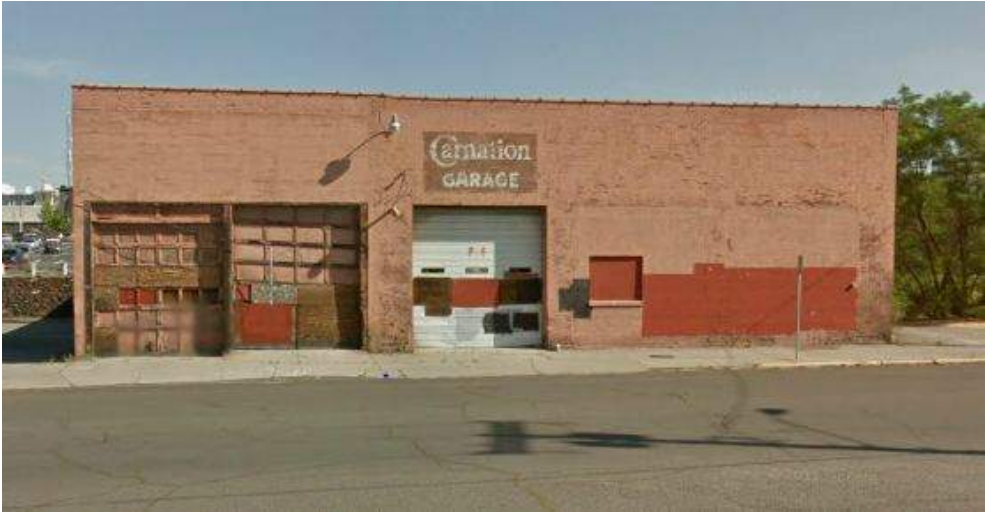
Many areas where the exterior walls were brick masonry were in need of attention. Large areas would require clean up and restoration of mortar and replacement of bricks. Areas of particular attention would be at the corners and parapets.

Photo 1: South Exterior Wall Facing Cataldo Avenue

3. Exterior walls would require fairly extensive restoration, which would include the demolition and/or bracing of parapets, re-pointing mortar joints, and brick replacement in several areas.

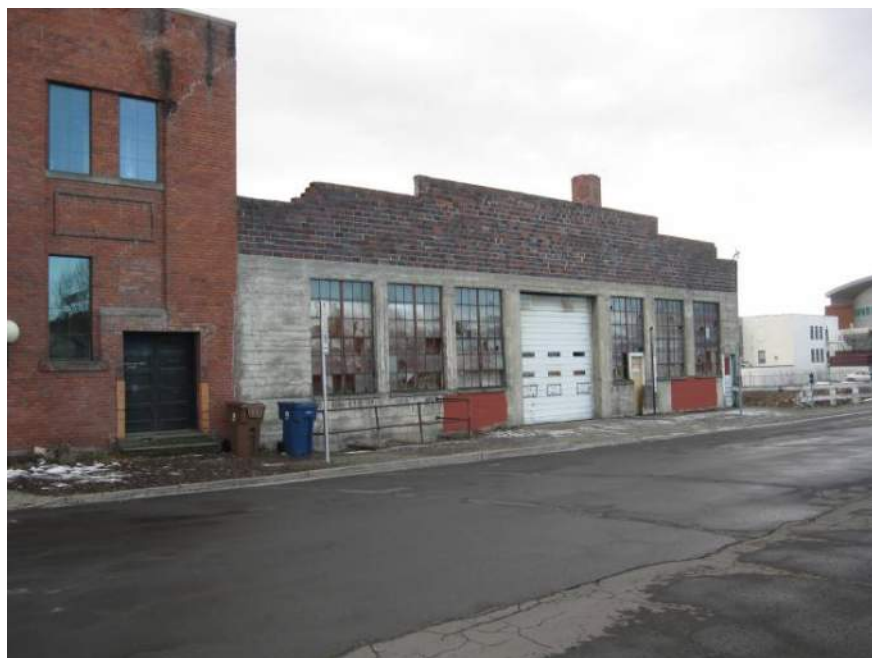
Exterior walls appear to be mainly unreinforced brick masonry with the possible exception of the north and west walls. The north and west walls appear to be concrete or concrete masonry. The walls on the north half of the building appear to have concrete column elements supporting the primary, clear-span trusses with masonry infill between columns. The north end wall has an unreinforced masonry parapet extending up from the building wall.

Photo 3: North End Exterior Wall

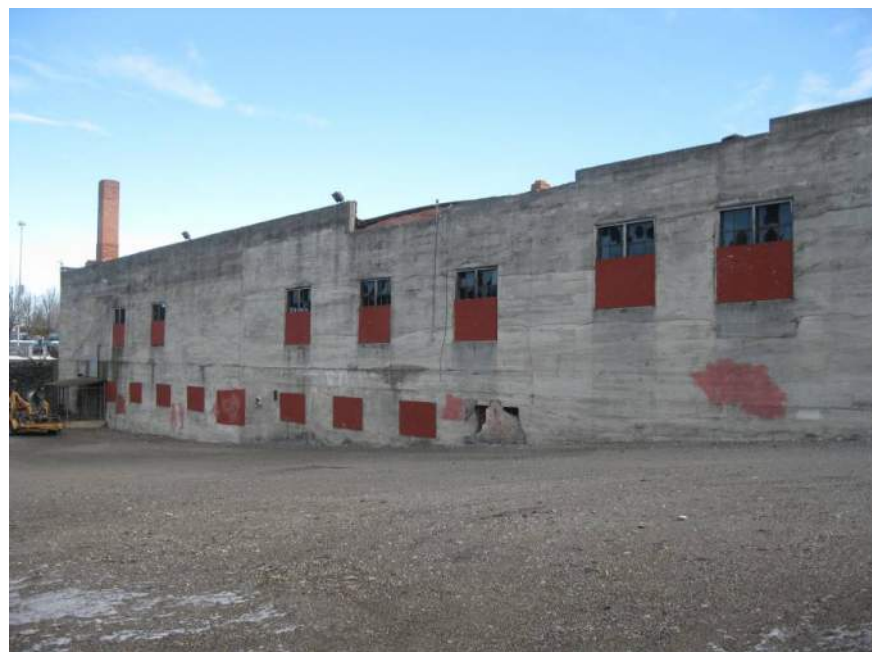
Photo 4: West Side Exterior Wall

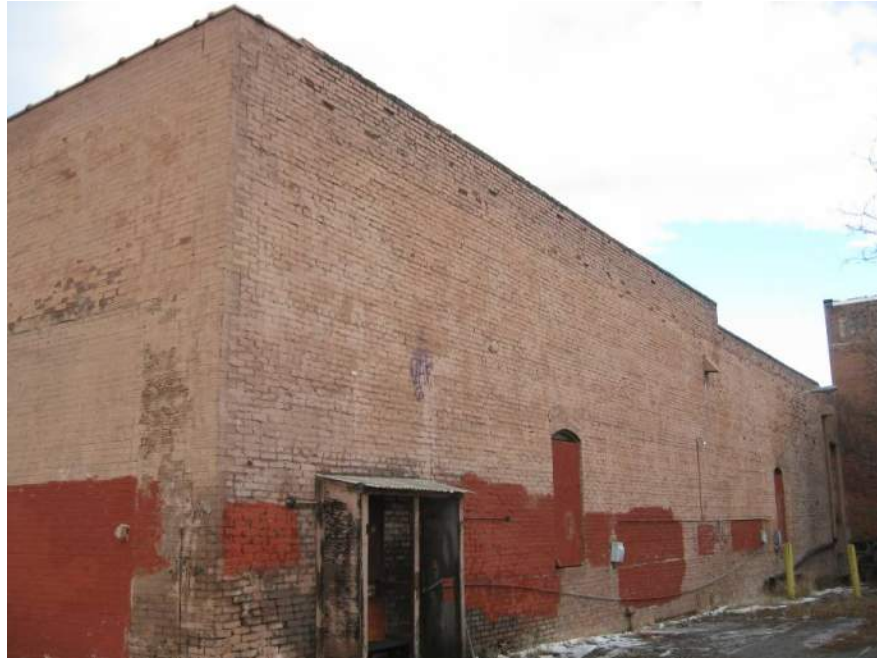
In one area of basalt foundation wall, in the southeast portion of the building, the wall had failed and was shored with some plywood supported by braces. Along the east side, it also appeared that what might have originally been constructed as window wells to the basement level had been infilled. The failed basement wall could be one of these locations and would require repair to restore the exterior wall.

Photo 5: Southeast Corner Exterior Wall

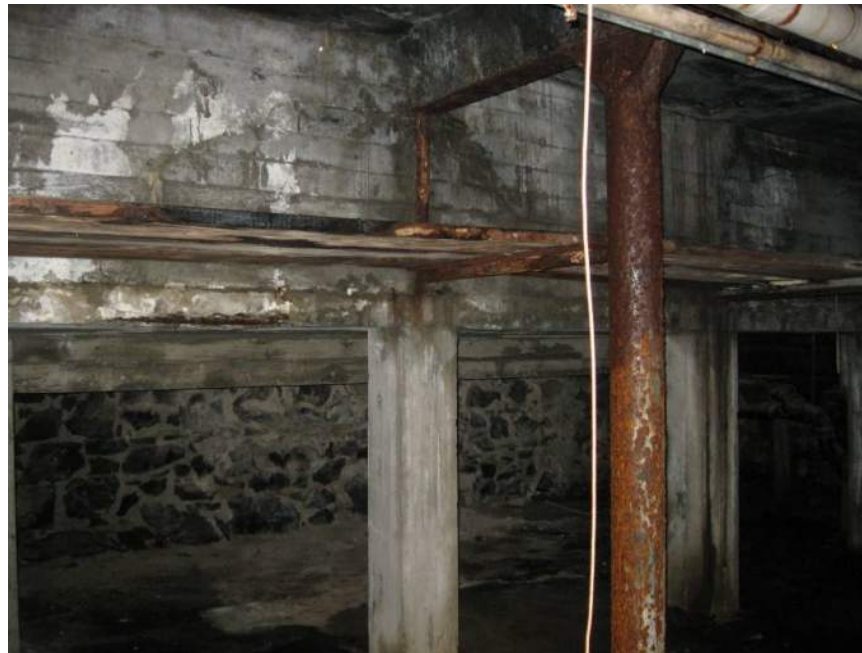
The main floor in the southern portion of the building was not in as good of shape. Contributing factors may be the traffic in this area or the substantial roof leaks. Significant corrosion was seen in exposed steel elements as well as areas of corroded reinforcing steel in slabs.

Photo 6: Main Floor Framing at South End (from lower level)

5. The main level floor would require some fairly extensive remedial work to repair or replace areas damage by exposure to moisture or other damage. This is largely isolated in the southern half of the building. Floor capacity, especially at the northern half of the building, is likely adequate for a variety of possible uses.

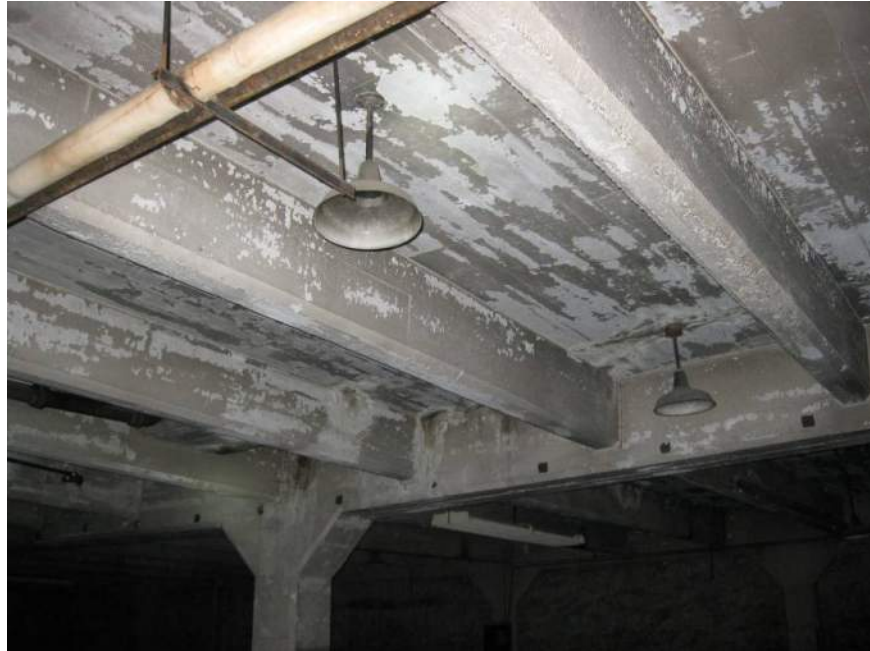
The main floor in the northern half of the building generally appeared to be in very good condition. Roof leaks do not appear to be significant enough to have caused deterioration of the floor level. From below the structural elements appear to be of a size that suggests design for traffic loads. This is consistent with our estimation of the originally-intended use.

Photo 7: Main Floor Framing at North End (from lower level)

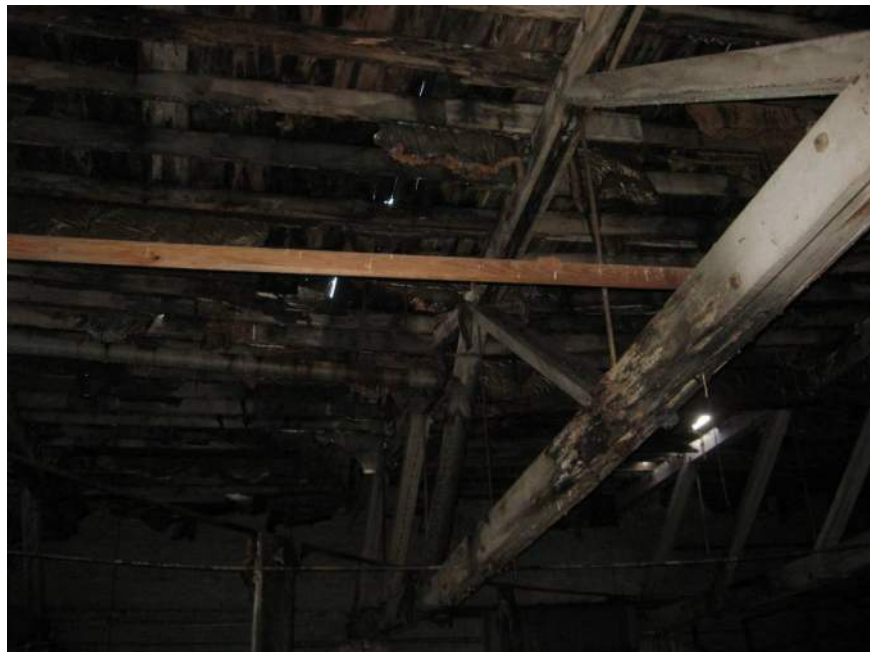
This is the area of greatest concern and we recommend the City consider blocking off all access at the main floor level until remediation efforts can be completed. The large wood trusses that span this area have decayed significantly. The decay and failure is likely due to long-term exposure to water through leaks at the roof. One primary truss in this area has nearly completely failed both at the top and bottom

chord levels and is in danger of collapsing. Large holes in the roof are visible and multiple leaking areas were evident.

Photo 8: Failed Roof Structure in Southeast Area

1. As noted above, the southeast area roof is likely in need of complete replacement. This should be addressed in the short term by blocking access to this space and then followed by consideration of long-term solutions.
2. The north area roof is in much better shape. However, even in this area there is evidence of extensive water damage that would likely require the replacement of significant portions of the roof deck and joists. In addition, the design criteria used when the building was originally constructed are likely not compliant with current code-required snow load capacity or lateral

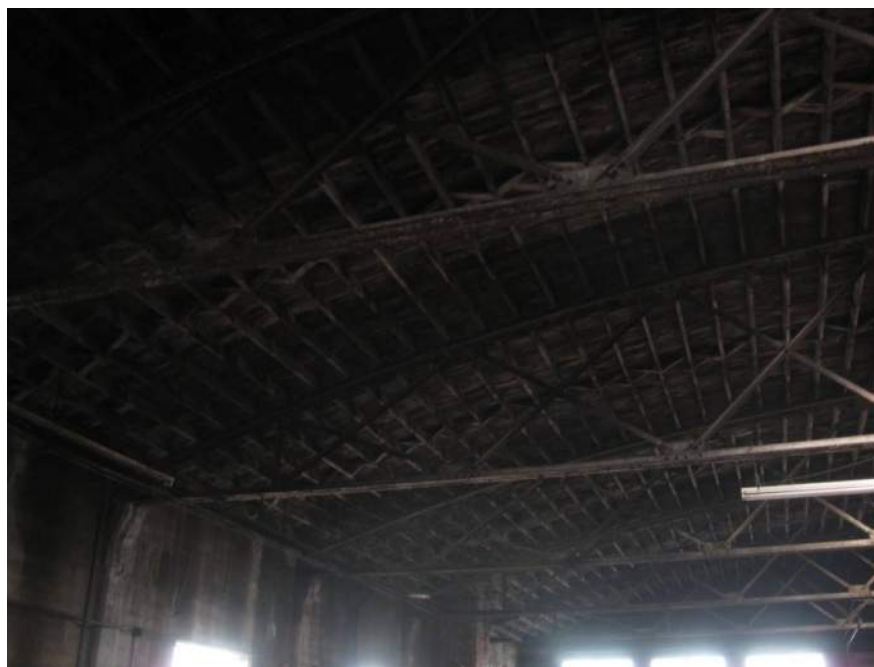
The roof is supported on clear-span steel trusses that are built up with steel angle shapes, and appears to be in generally good condition. However, the wood decking and joists shows signs of decay due to moisture penetration, likely resulting in dry rot and compromise of the structural integrity. Water staining and damp areas were visible throughout much of this area.

Photo 9: General Roof Framing at North End

forces. Examples include consideration of unbalanced snow loading on a curved roof, snow drift loading, and roof diaphragm attachments. A use change and renovation would trigger required upgrades to new standards. The likely outcome would be the necessity of structural strengthening of the steel trusses, replacement or addition of roof joists, the possible addition of plywood sheathing to create a better roof diaphragm, and the addition of ties between the roof deck and the exterior walls.

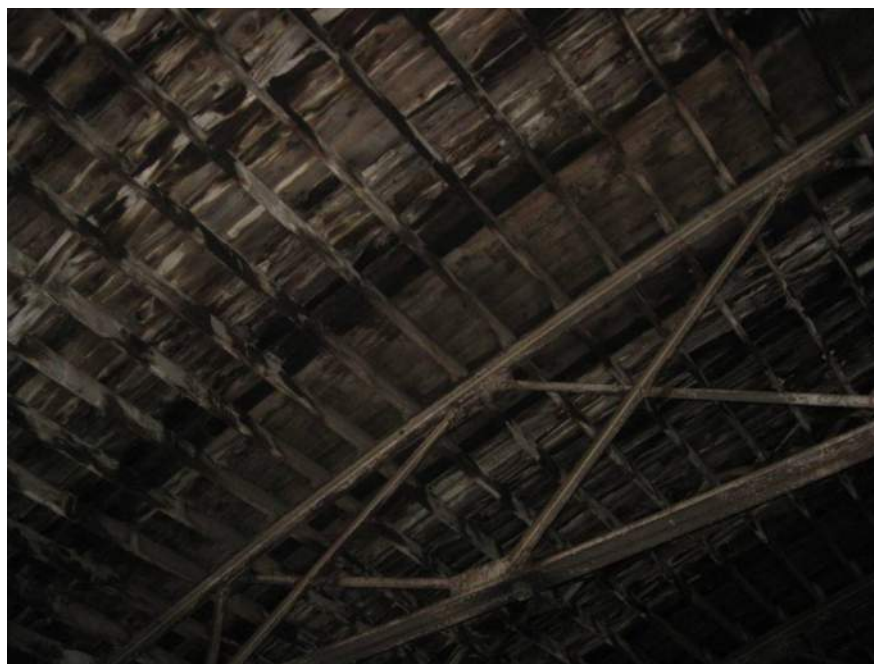
Photo 10: Typical North Area Roof Moisture Damage
