Underwater Inspection Report King Cole Bridge Spokane, WA

Inspection Date: July 29, 2014
12-2454B

**RE: Underwater Inspection of King Cole Bridge
Spokane, Washington**

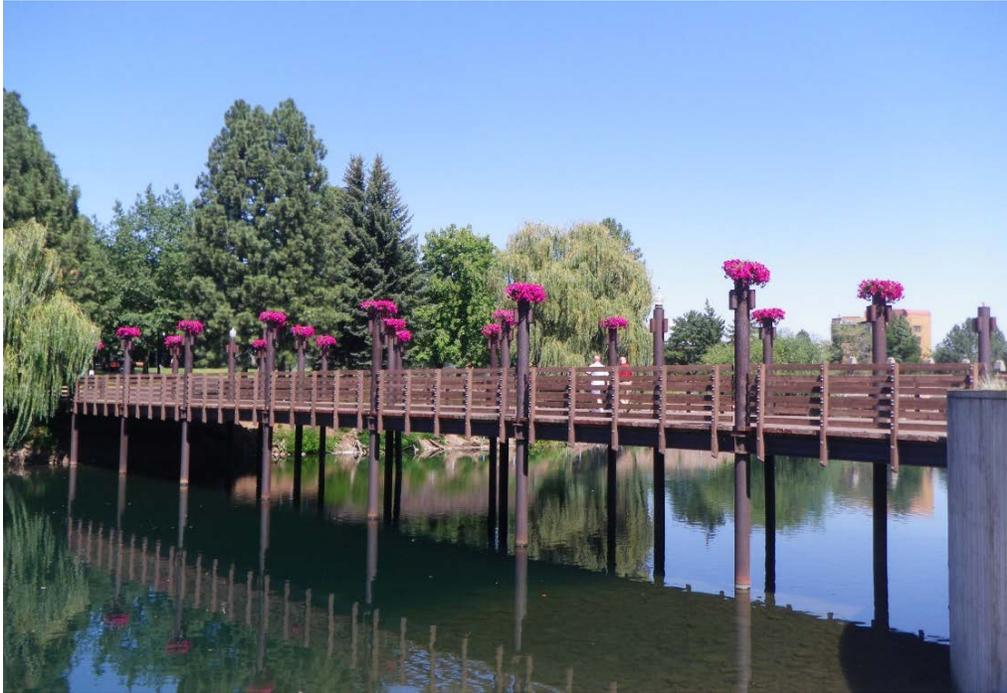
PHOTO No. 1: King Cole Bridge, Looking North - Note the steel girder and beam construction of the superstructure. This bridge is supported on steel pipe piling which extend up above the deck and provide lighting and decorative functions.

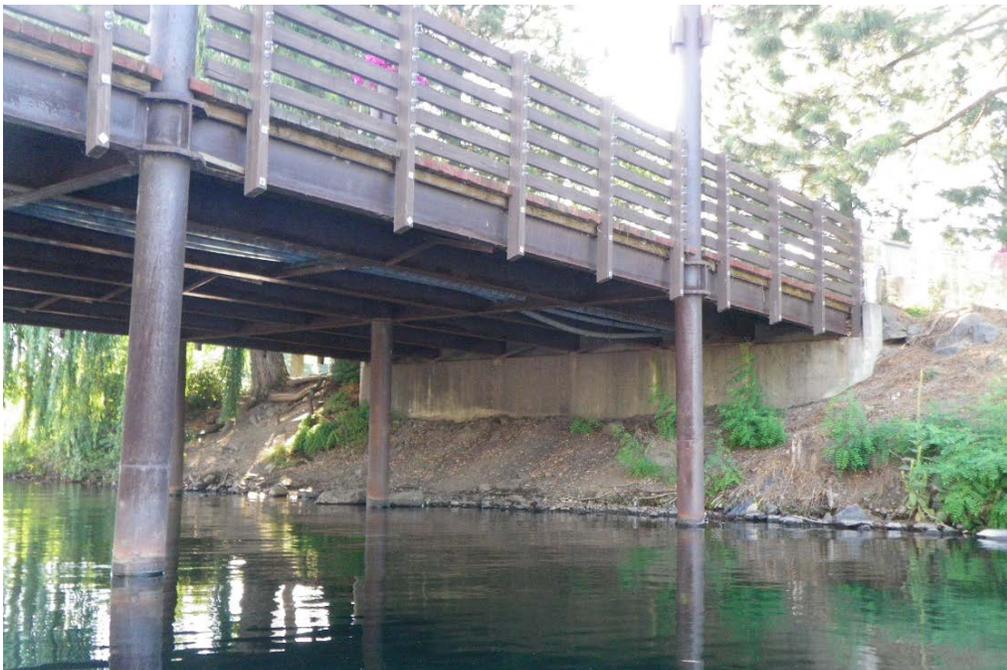
Cursory inspection of Abutment No. 1 noted it to be in generally good condition with no evidence of any cracking, spalling or other significant damage. Underwater inspection of Abutment No. 9 found the concrete to be sound with no evidence of any cracking, spalling or exposed reinforcing steel. Refer to Photo's No. 2 aqnd10.

PHOTO No. 2: Abutment No. 1, Looking Northwest - Note the good condition of the concrete which was found to be sound. Also note the general good condition of the steel with minor surface corrosion and the apparent stable condition of the bank.

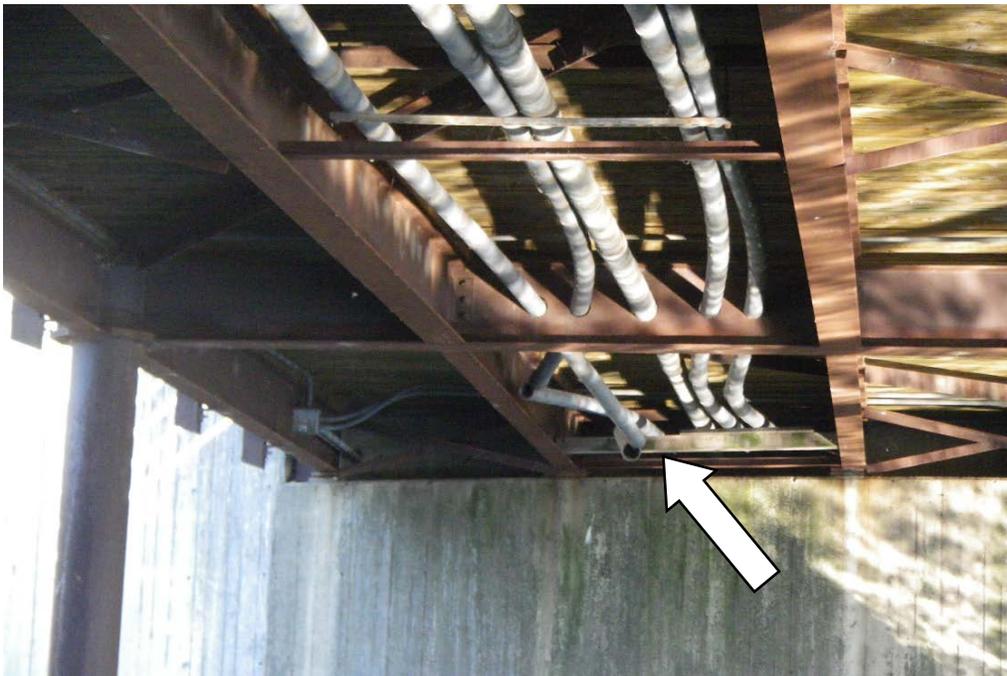
<input checked="" type="checkbox"/> Scour (12)		- Inspection in the vicinity of Abutment 9 noted damage to the utility conduits
Scour Mitigat. (13)		between Row A-B. (Refer to Photo No. 3)
<input checked="" type="checkbox"/> Channel (14)	12	- No general scour patterns were noted. The channel elevation is gradual
Streambed(15)		and consistent across the channel with no evidence of any significant
Drift(16)		aggradation or degradation. No previous data was available for comparison.
Flow (17)		- Localized scour was noted downstream of the submerged logs between Bent
		4 – 6, but appears minor at this time.
14		- The channel bank is formed concrete along the southern end at Abutment No. 9. The bank at Abutment No. 1 was noted to be a steep dirt bank with minimal vegetation immediately adjacent to the bridge.
15		- The channel bottom in the vicinity of the pier was found to consist primarily of gravel, rock (2-10" dia.) and areas of soft-silty sand. Probing of the bottom with a #3 rebar noted 6-18 inches of penetration.

PHOTO No. 3: Typical Bridge Superstructure - The bridge is of steel girder and beam design with utilities supported beneath the deck. Note the arrow showing separated conduit in the bay adjacent to Abutment No. 9. The bridge is supported by two concrete abutments and seven, three pile bents.

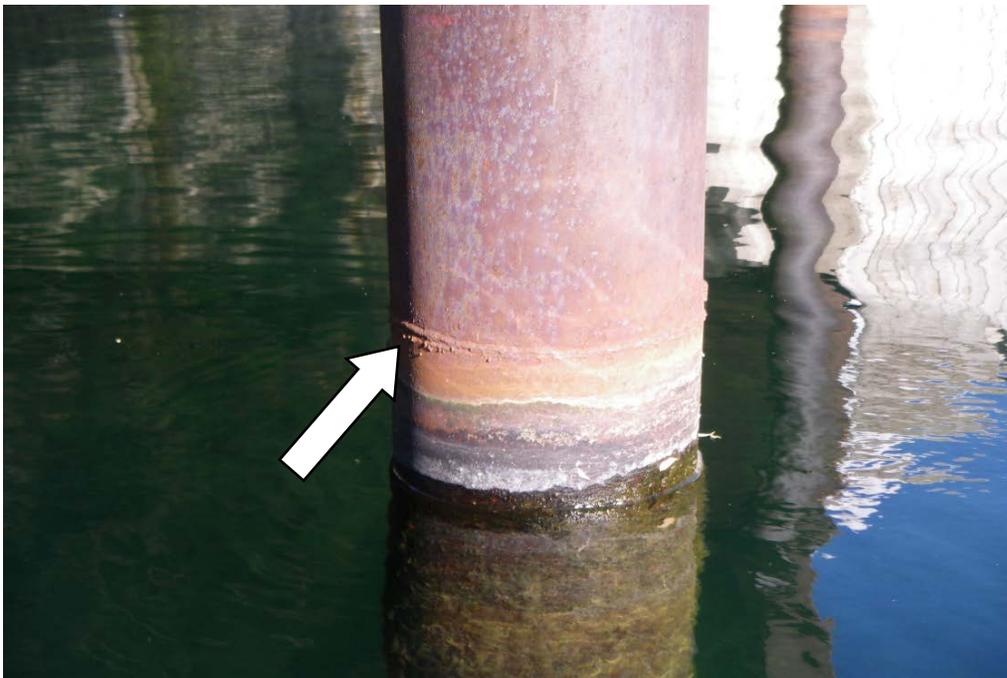
PHOTO No. 4: Bent 7, Row C Pile - Note the good condition of the steel and the general surface corrosion that is typical of COR-TEN steel. Also note the good condition of the weld located approximately 1 foot above the water.

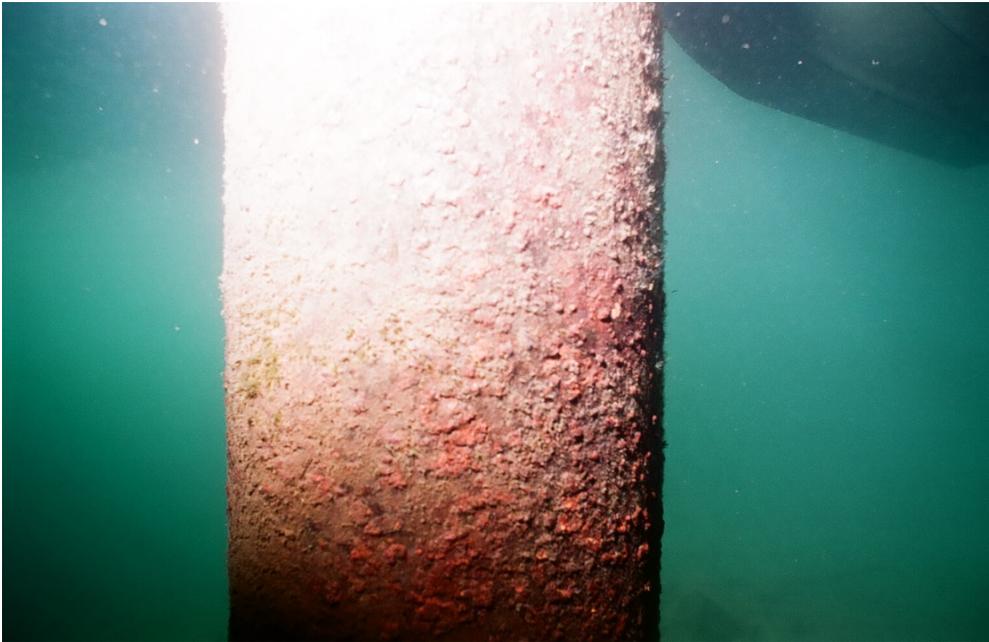
PHOTO No. 5: Bent 4, Row A Pile - Note the general surface corrosion and rust nodules evident on this pile in the submerged zone. This condition was found to be typical of the submerged surfaces of the inspected piling.

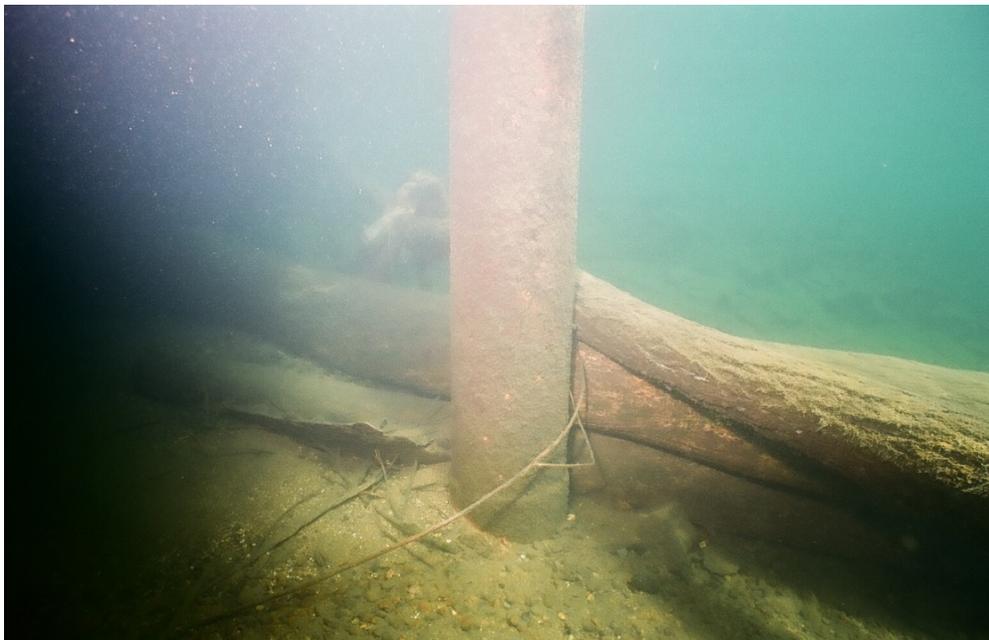
PHOTO No. 6: Bent 4, Row A Pile - Inspection also found general surface corrosion and algae growth evident on this pile at the mudline. This condition was found to be typical of the inspected piling near the channel bottom. Also note the logs that have collected on the upstream side of the bent.

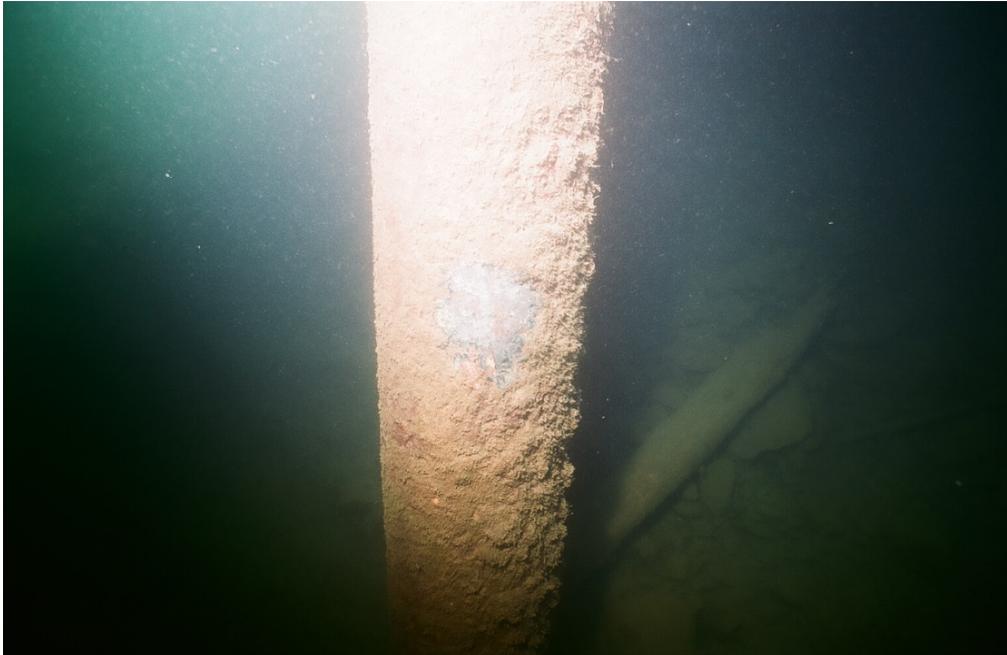
PHOTO No. 7: Bent 7, Row B Pile - Note the generally smooth condition of the steel in the cleaned area. Level II cleaning and Level III ultrasonic thickness readings were taken at this location approximately 6 feet below water. The average steel thickness readings obtained at this location is 0.327 inches.

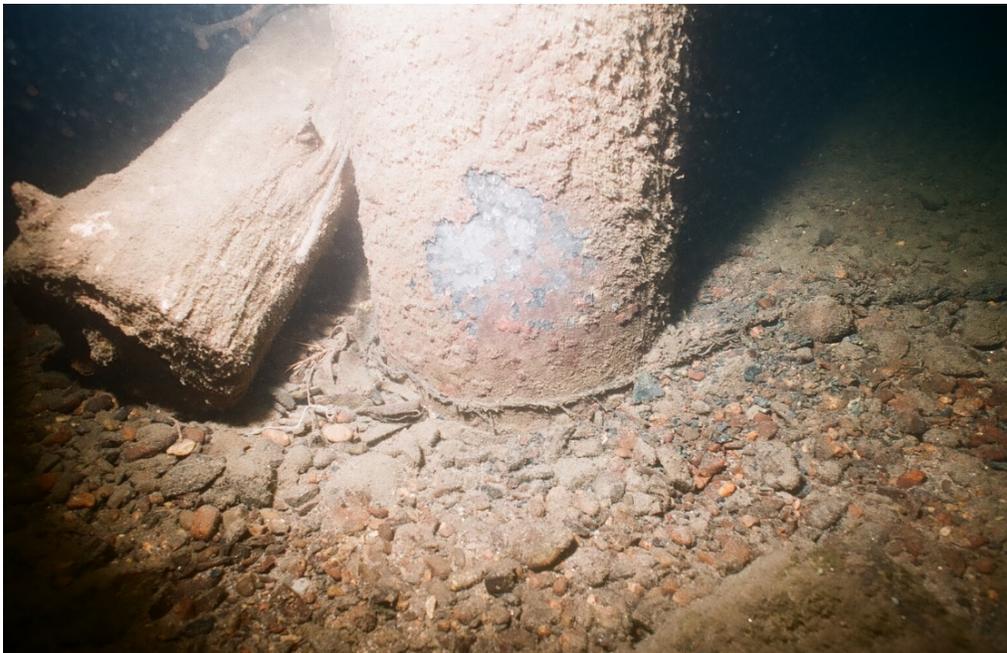
PHOTO No. 8: Bent 7, Row B Pile - This pile was also subjected to Level II cleaning and Level III thickness readings at the mudline. The average steel thickness obtained at this location was 0.345 inches at the mudline. Note the gravel / rock and timber debris evident on the channel bottom.

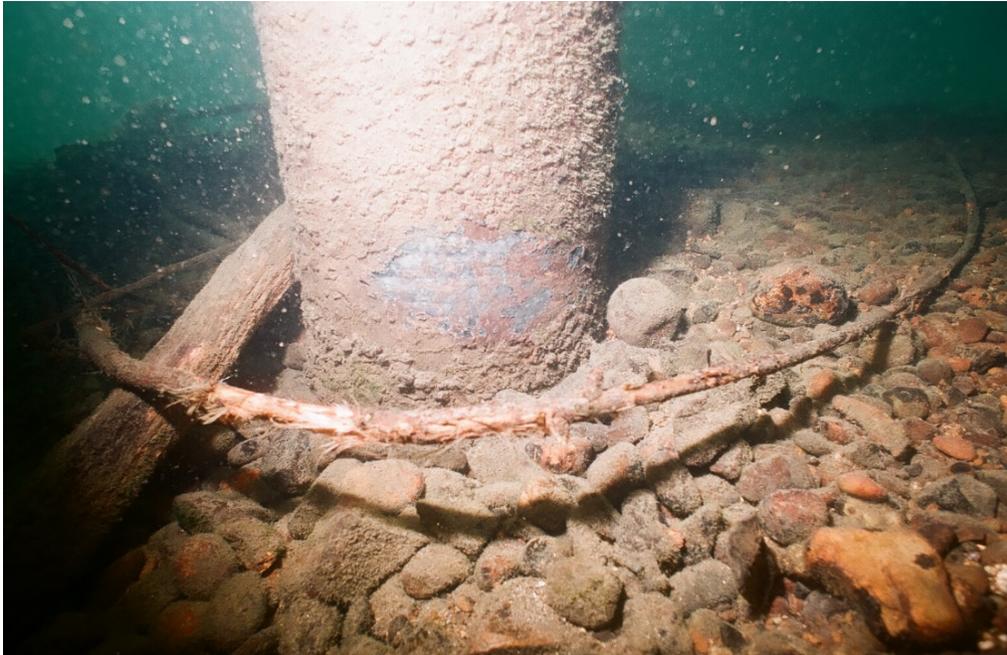
PHOTO No. 9: Bent 4, Row C Pile - This pile was also subjected to Level II cleaning and Level III thickness readings at the mudline. The average steel thickness obtained at this location was 0.392 inches at the mudline. Note the gravel / rock and timber debris evident on the channel bottom.

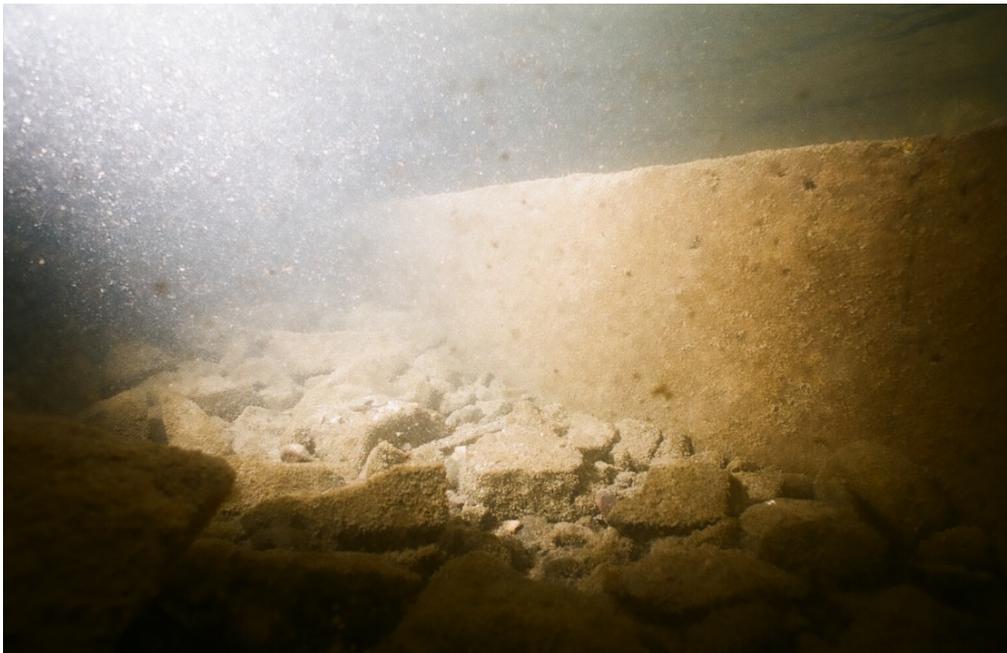
PHOTO No. 10: Abutment No. 9 - Note the good condition of the concrete footing on this abutment. Although no evidence of any undermining was found, the footing was exposed for a height of 4-6 inches along its full length.
