RIVERFRONT PARK BRIDGES

INSPECTION AND ANALYSIS

HOWARD STREET SOUTH CHANNEL BRIDGE

NOVEMBER 14, 2014 | Final Report

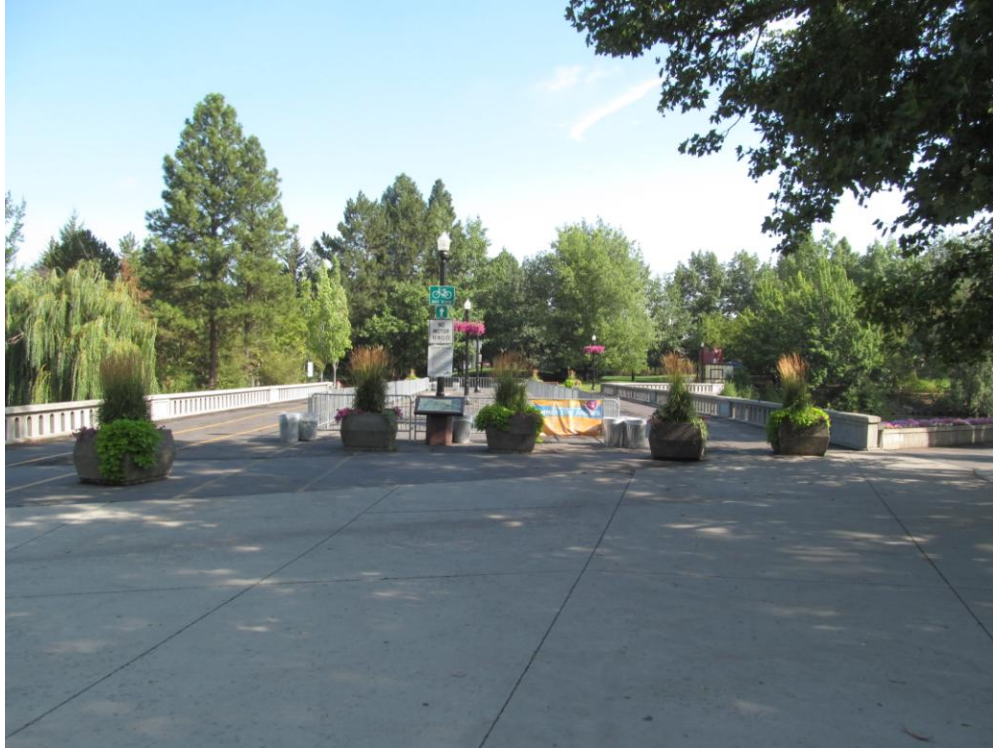
Photo 1 –Howard Street South Bridge Deck (Looking North)

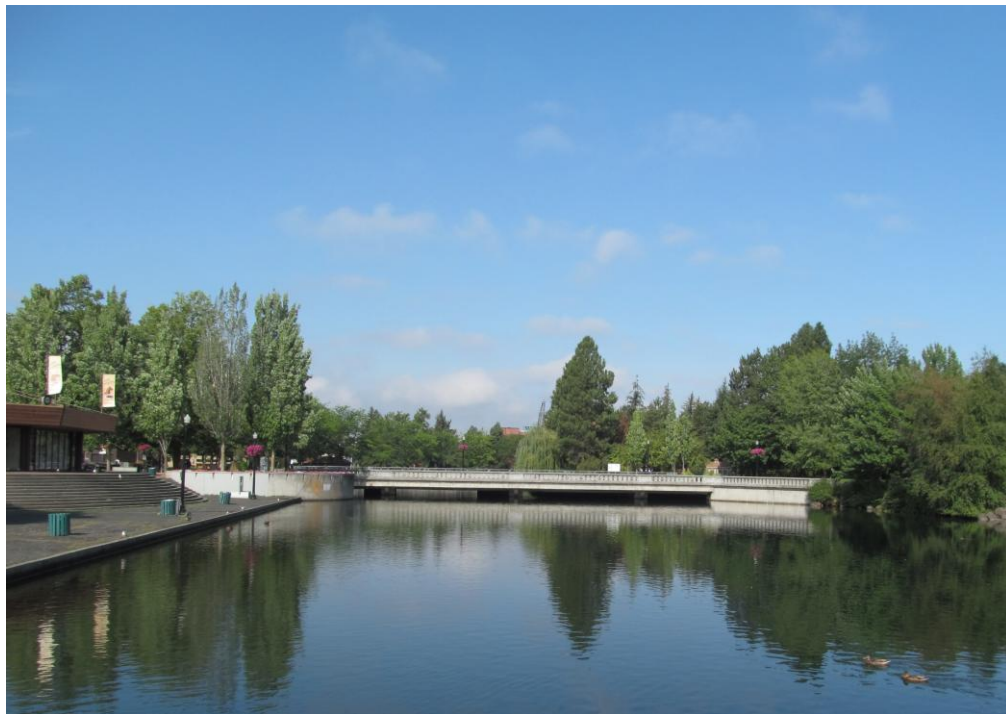
Photo 2 – Howard Street South Bridge Elevation (Looking West)

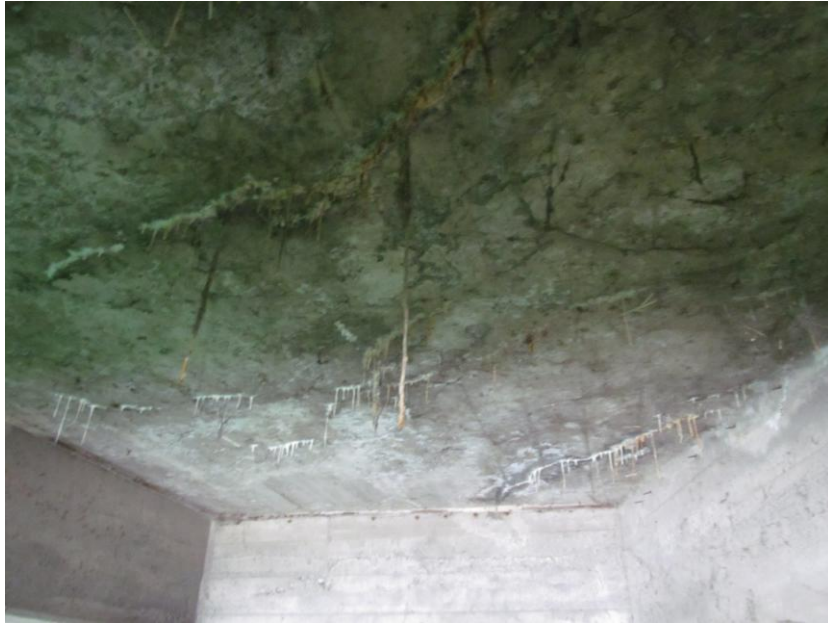
The bridge is in poor condition structurally. Most of the primary load carrying components as seen from the underside of the bridge exhibit severe concrete deterioration such as cracks, spalls, and exposed corroded reinforcement with measurable section loss. The exterior girders (A, B, E, and F) are in worse condition than the interior girders. The cap beams, which the longitudinal girders frame into, and the deck underside, which the longitudinal girders support, also exhibit evidence of advance deterioration to both the concrete and reinforcing steel.

Photo 3 – Typical Soffit Condition - Map Cracking with Efflorescence/Stalactites

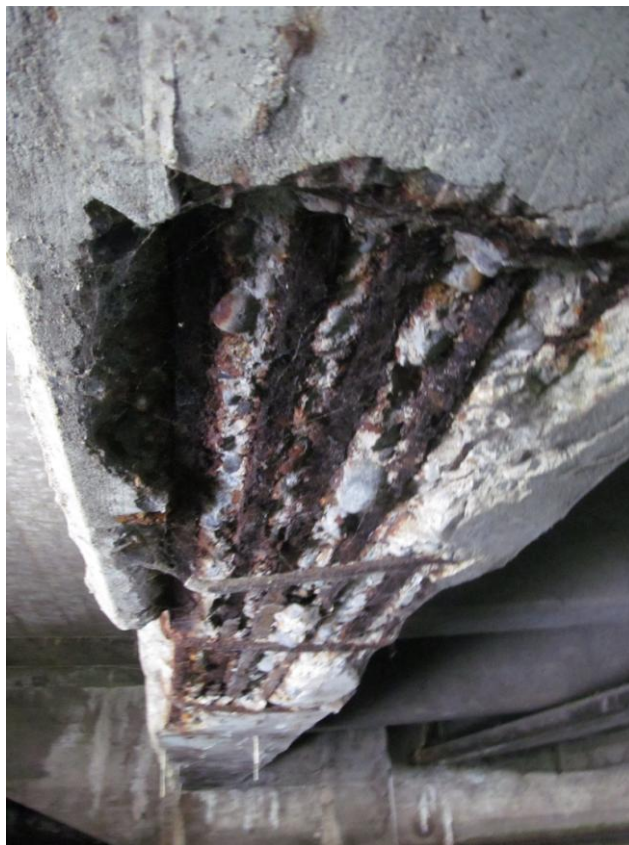
Photo 4 – Typical Condition of Exterior Girders – Exposed/Corroded Reinforcement

girders. Accordingly we recommend that consideration be given to restricting access to the outside area of the bridge and the interior area re-opened to pedestrian traffic.

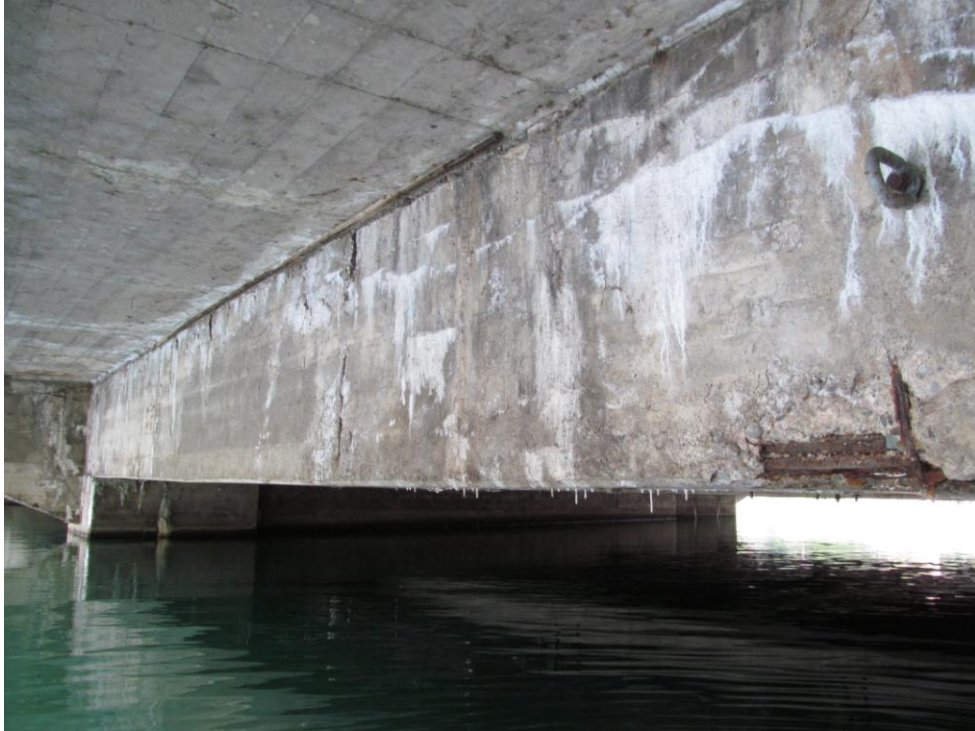
Photo 5 – Typical Condition of Girders – Horizontal Leaching Cracks

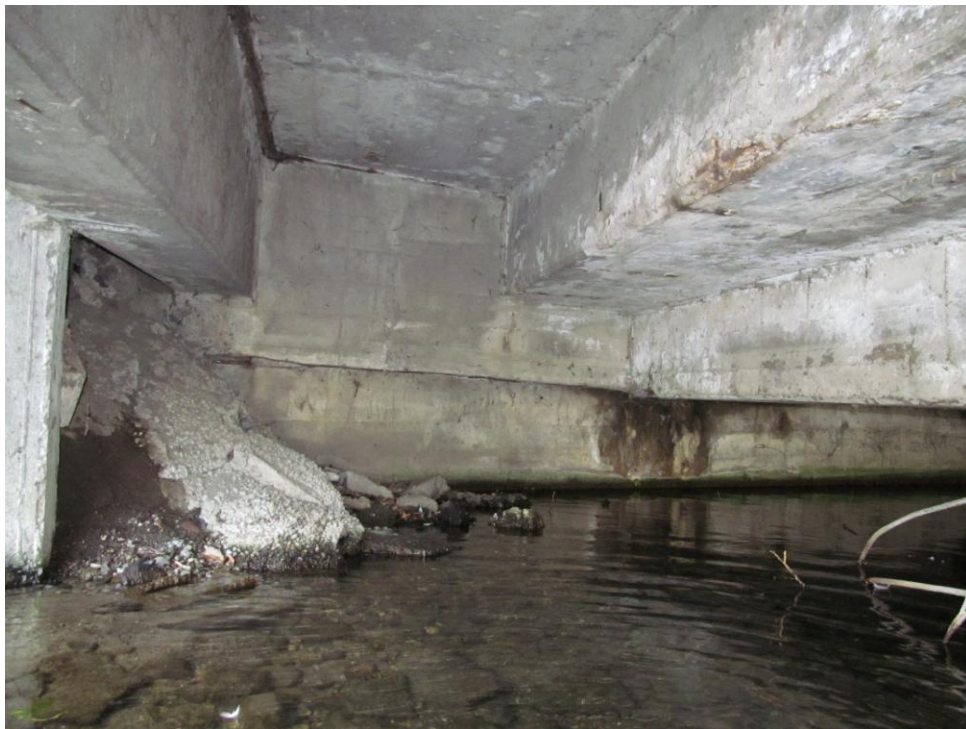
At the east corner of the south abutment (Pier 1), material has spilled out from under the retaining wall but does not appear to be impacting the abutment. At the north abutment (Pier 5), the embankment has sloughed and material has accumulated next to Span 4 Girder B.

Photo 6 – Material Spilling Through at South Abutment
