# RIVERFRONT PARK BRIDGES

## INSPECTION AND ANALYSIS

### NORTH SUSPENSION BRIDGE

NOVEMBER 14, 2014 | Final Report

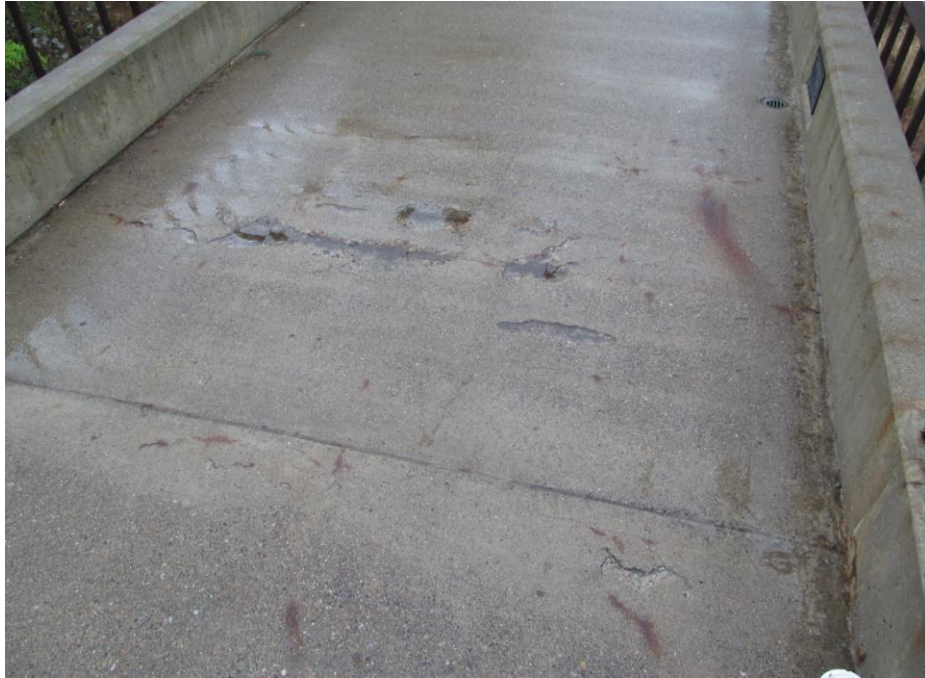
Photo 3 – Exposed Rebar in Deck

Due to the heavy corrosion of the SIP forms and the numerous areas of delaminations in the concrete, the deck and curb should be replaced. The new deck should have an improved drainage system to prevent future corrosion of the superstructure. A drainage channel could be added along the curb. The deck should receive a waterproofing sealant.

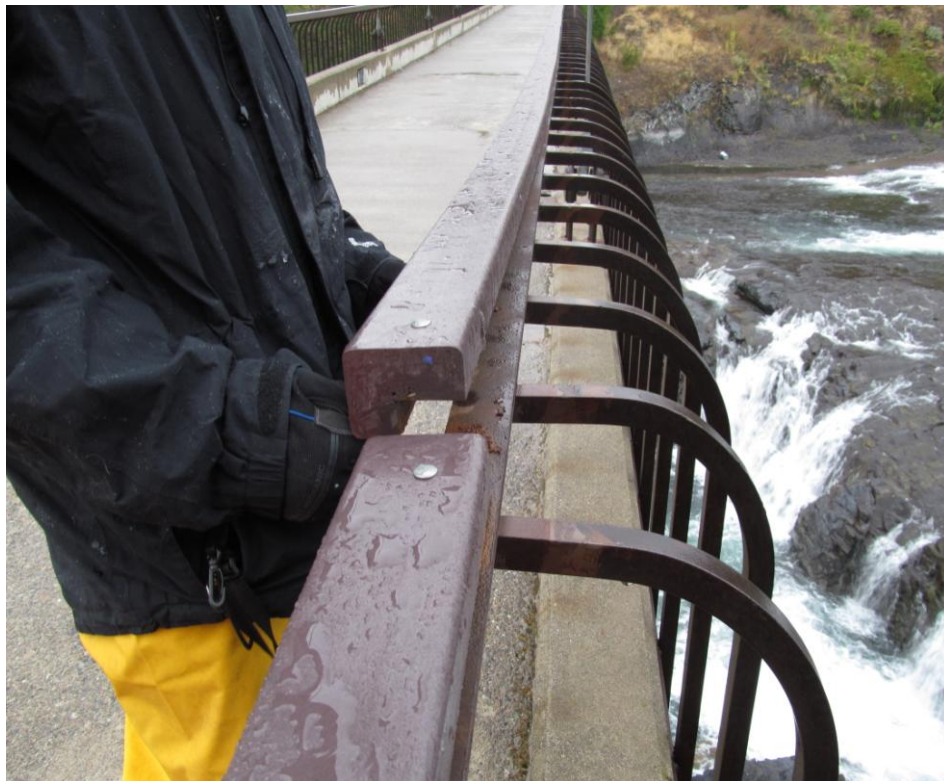
Photo 4 – Loose Cover Plate on Handrail

The hand rail screws that have been stripped between hangers H1-H2 RT and H6-H7 RT should be replaced.

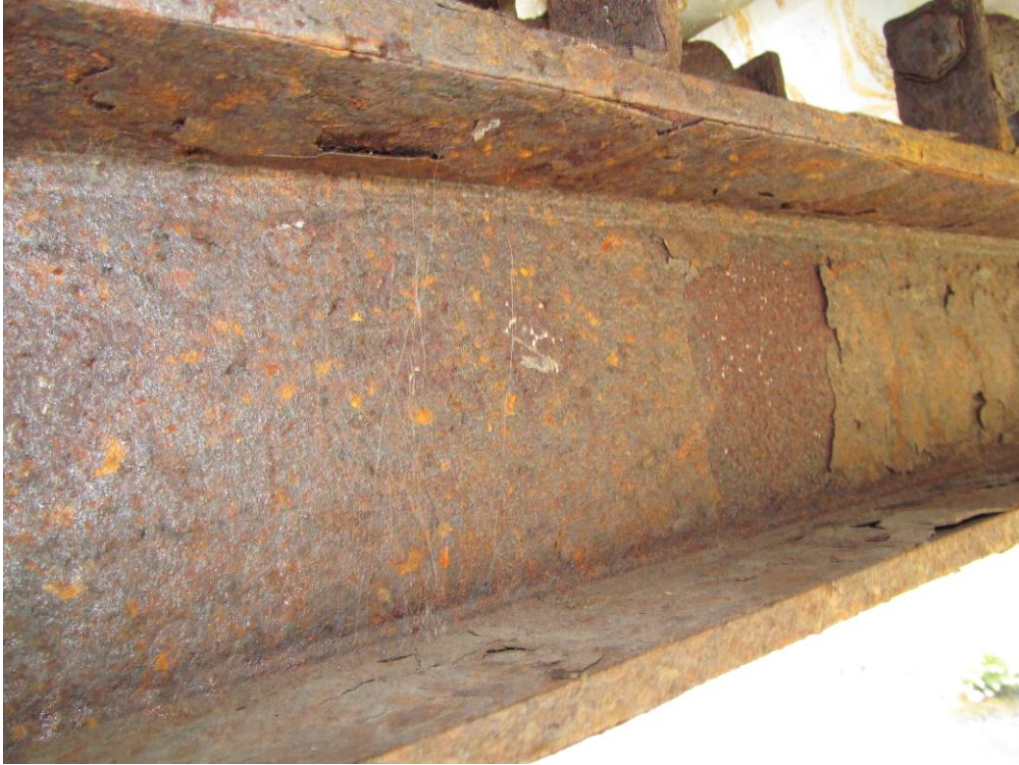
Photo 5 – Moderate Corrosion/Flaking of Floorbeam 1-13

The steel framing should be cleaned of debris and flaking steel. After the deck is removed and the steel is cleaned, another inspection should be performed to determine if there are areas of section loss that need to be reinforced. Floorbeams that are moderately to heavily corroded should be replaced. Floorbeams with minor corrosion should be cleaned and painted.

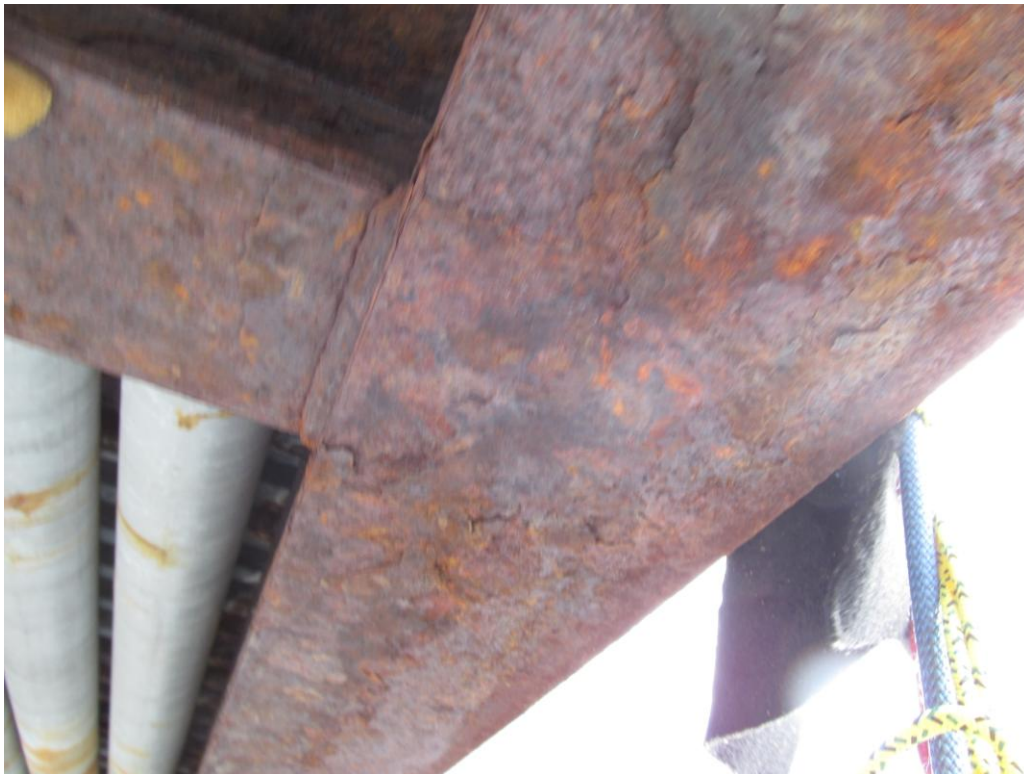
Photo 6 –Moderate Corrosion Bottom Flange of Left Girder at H5

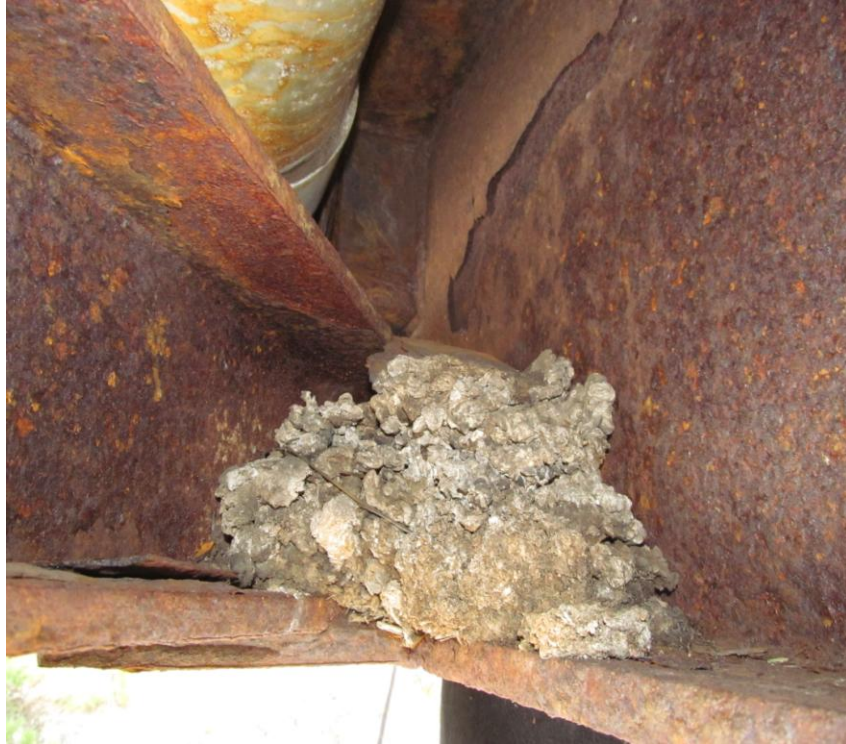
Photo 7 – Debris at Panel Point (Typical)

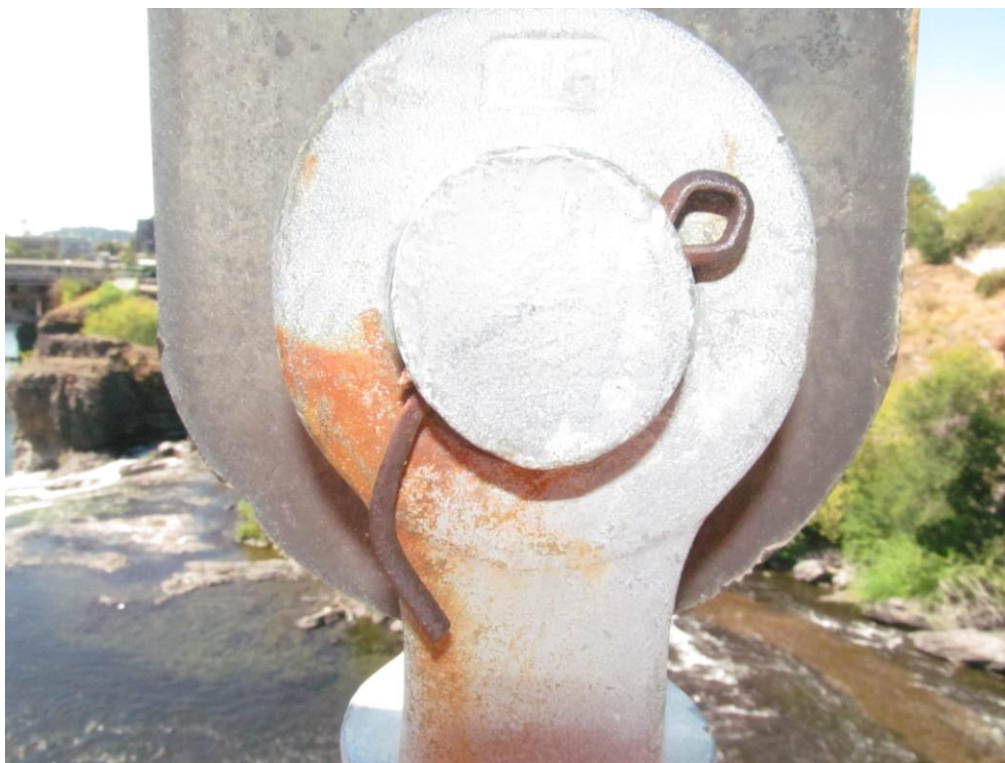
Photo 9 – Hanger H10 LT, Broken Cotter Pin

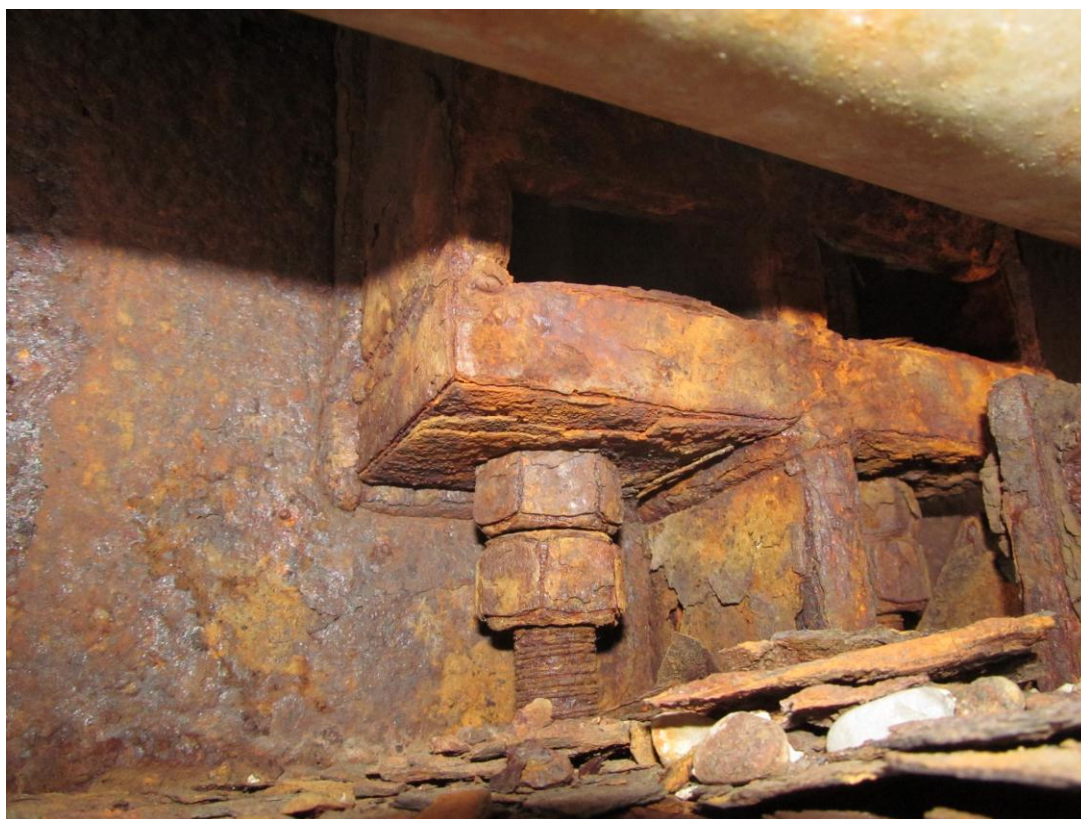
Photo 10 – Moderate to Heavy Corrosion at Interior Suspender Cable Connection (H5 RT)

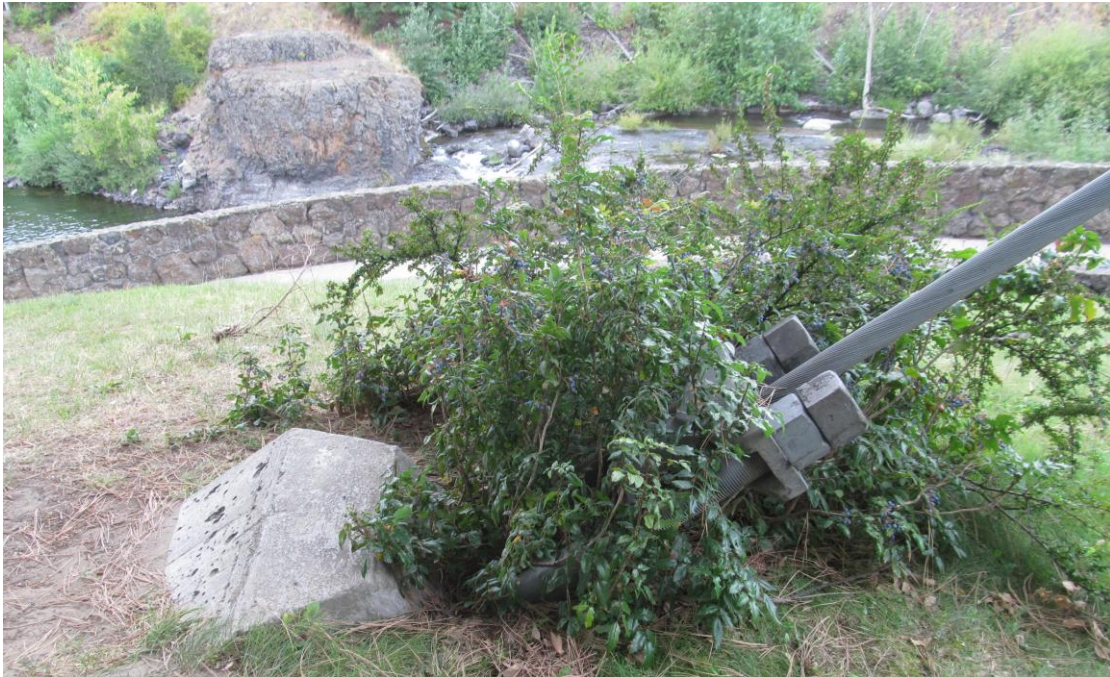
Photo 11 – Shrubs around Cable/Threaded Rod, Partially Buried Concrete Block

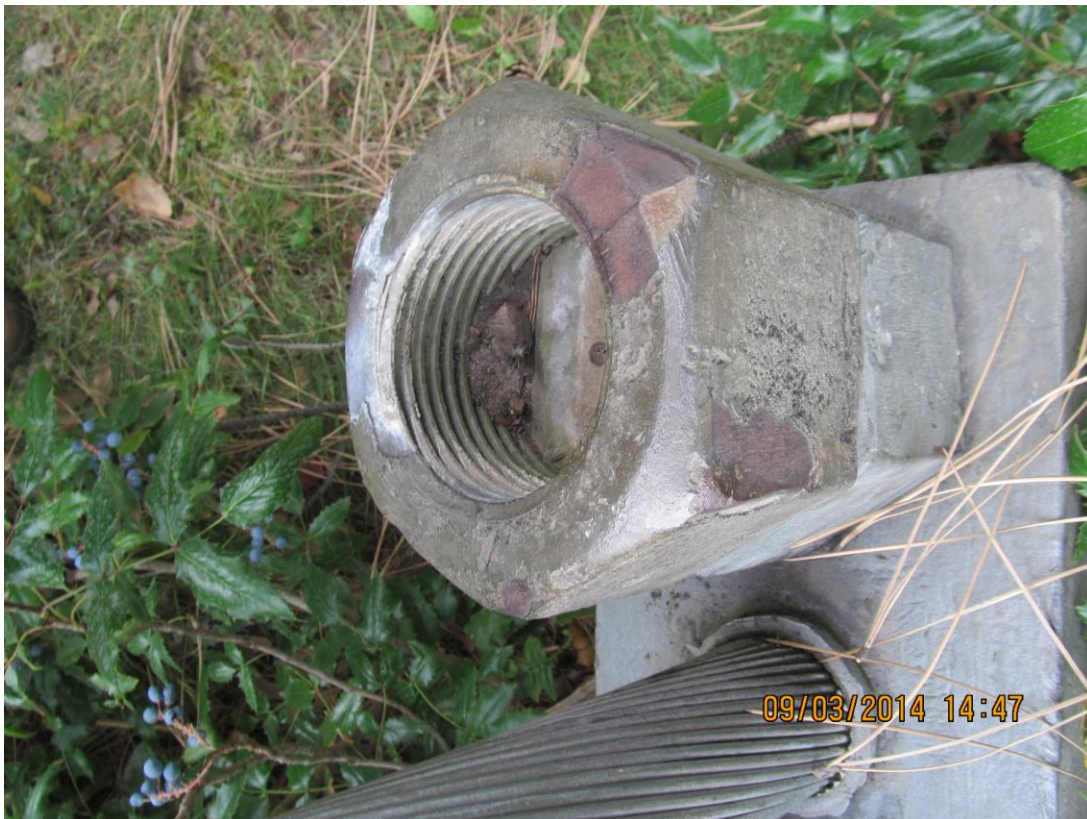
Photo 12 – Lock Nut at Southwest Anchorage is only 30% Engaged

The load rating analysis determined that the original anchor bolts had much more capacity than required based on the design loads. Therefore, if the anchor bolts only have a small to moderate amount of corrosion (less than 25% section loss), they will still have well above sufficient capacity to support dead and live loads. These anchor bolts should be cleaned of all rust and painted. Anchor bolts with severe corrosion (more than 25% section loss) should be replaced.

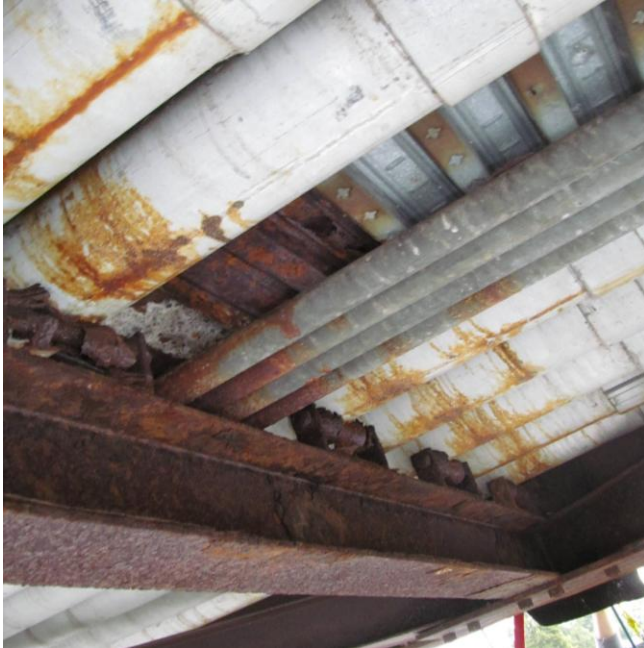
Photo 13 – Corroded/Missing Stay-in-Place Formwork above Floorbeam (Typical)

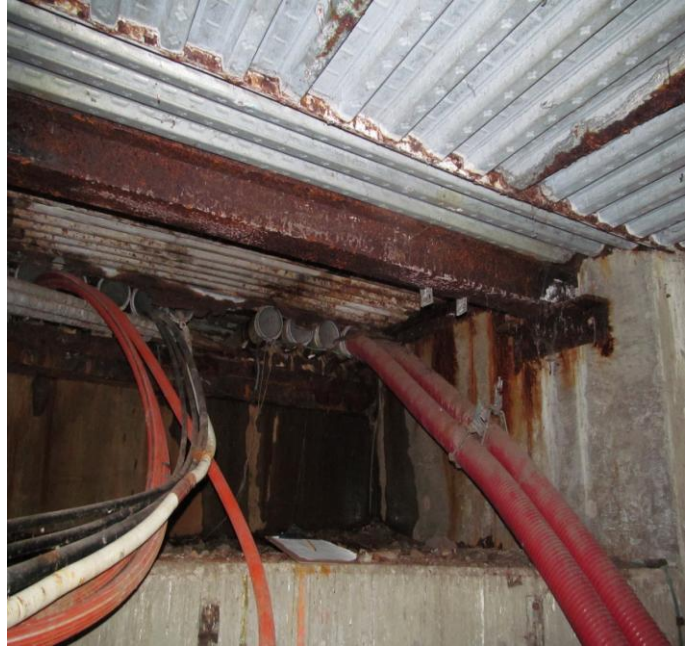
Photo 14 – Corroded/Missing Stay-in-Place Formwork and Corroded Beam/Angle in Vault No. 3 near Abutment

The deck and the steel framing in the vaults should be replaced and additional framing around the manhole opening should be provided. The conduits should be removed during construction, and the new deck should be constructed with removable formwork. The sidewalk around the vaults should also be replaced. A compression seal should be installed at the expansion joints to prevent the large intrusion of water at the joint.

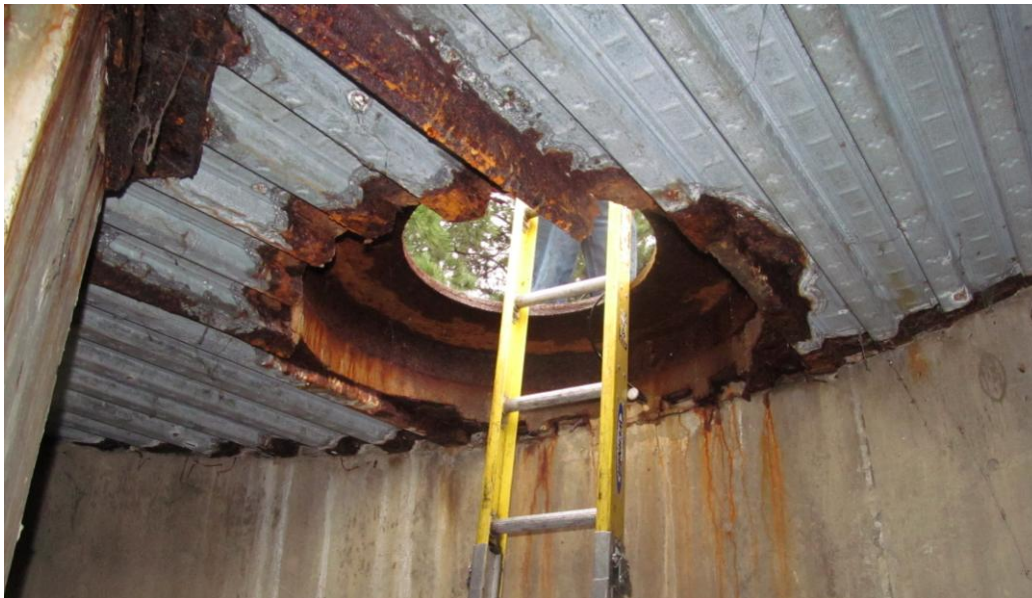
Photo 15 – Corroded Stay-in-Place Formwork around Manhole
