RIVERFRONT PARK BRIDGES

INSPECTION AND ANALYSIS

THEME STREAM BRIDGES

NOVEMBER 14, 2014 | Final Report

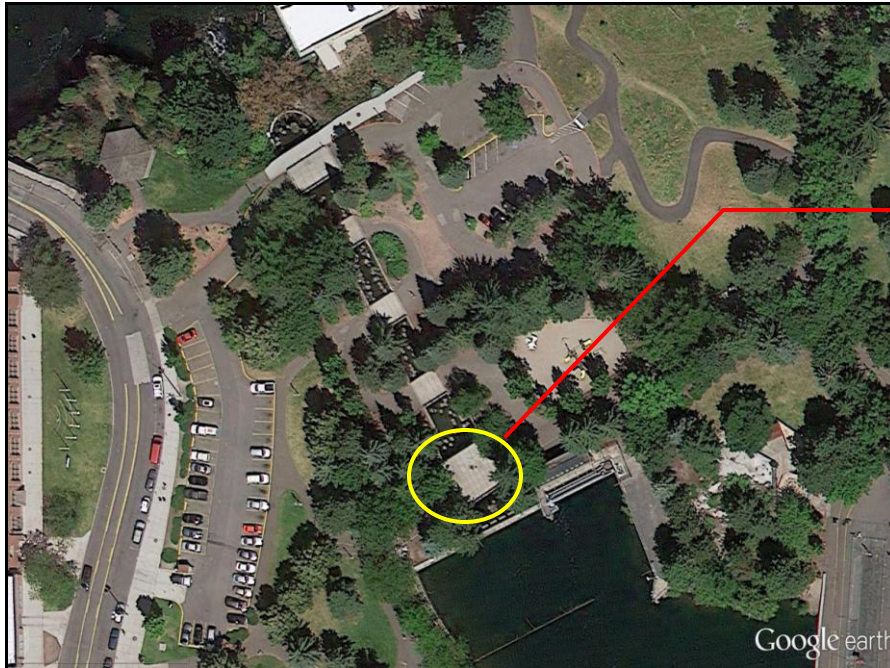
Figure 1: Aerial view of the Theme Stream Bridges

Theme Stream
Bridge to be
replaced

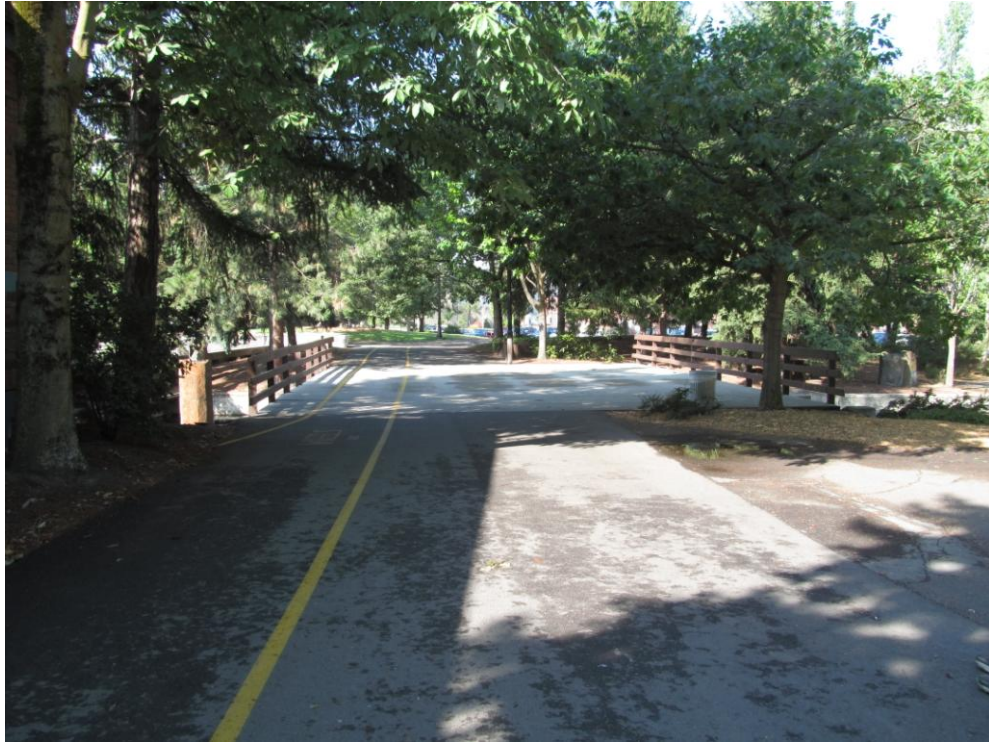
Photo 1 – Theme Stream Bridge – Furthest South

Based on the span length and geometry, the southern Theme Stream Bridge can easily be replaced with a single-span pre-stressed voided slab on new concrete abutments. Because the new bridge will be carrying vehicular traffic it will need a stronger railing system than the existing timber railing. A weathering steel railing that matches the railing on the Avista Theme Stream Bridge is recommended. A plan, elevation, typical section, and cost estimate are included in Appendix B. The total cost for the south bridge replacement and railing replacement for the other bridges is approximately \$1.0 million.

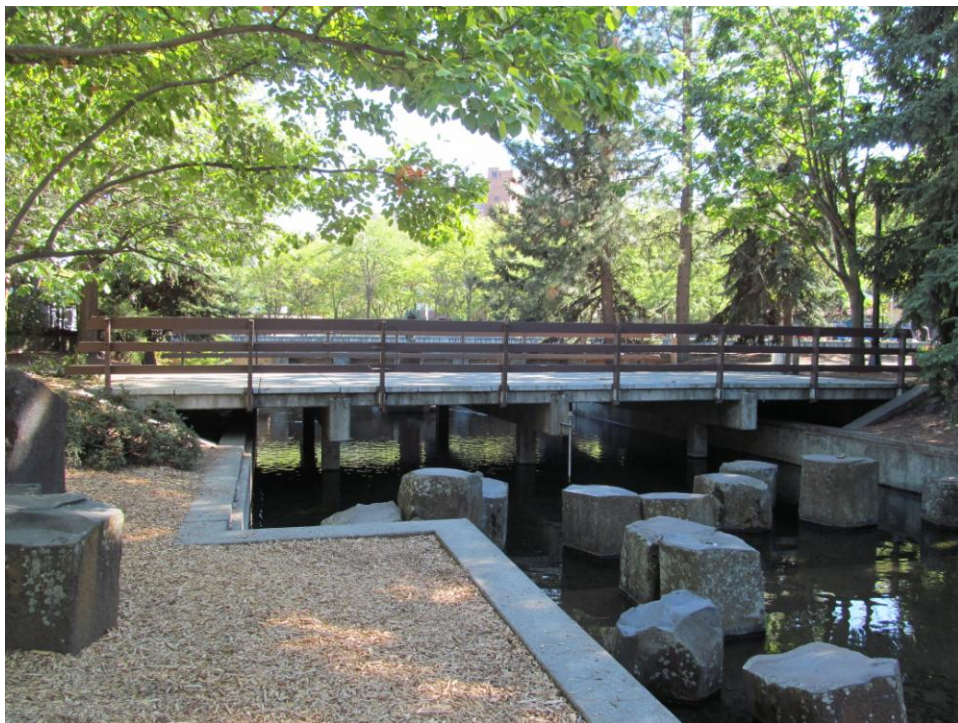
Photo 2 – Theme Stream Bridge South – Furthest South

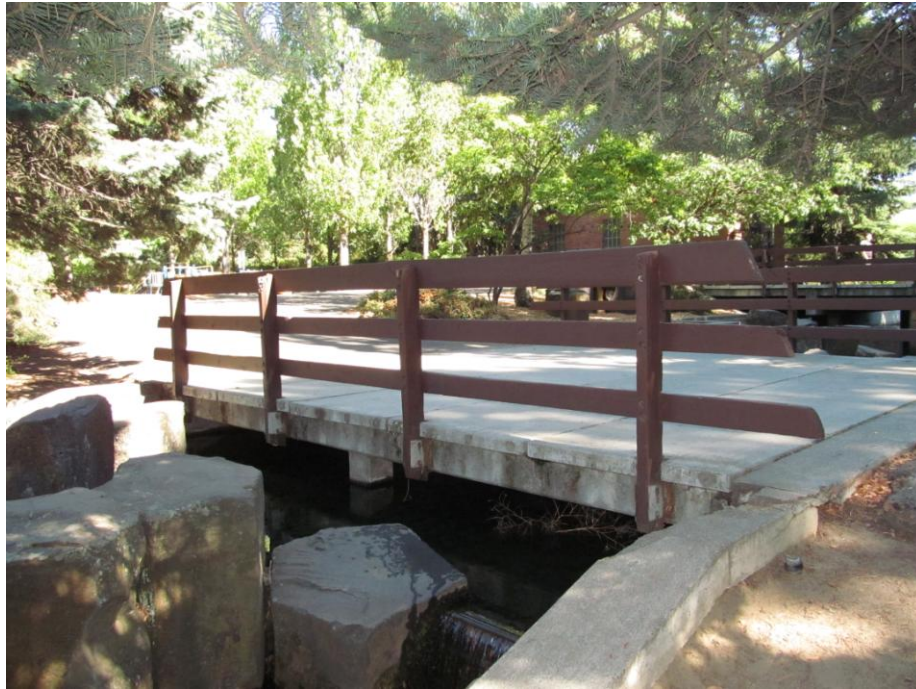
Photo 3 – Theme Stream Bridge – 2nd from the South

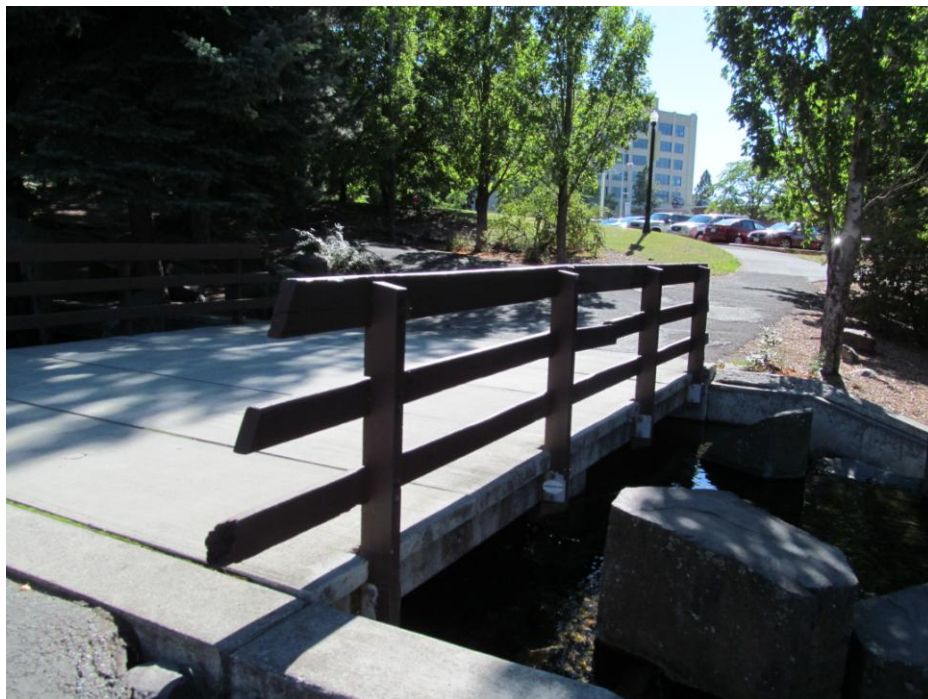
Photo 4 – Theme Stream Bridge – 3rd from the South

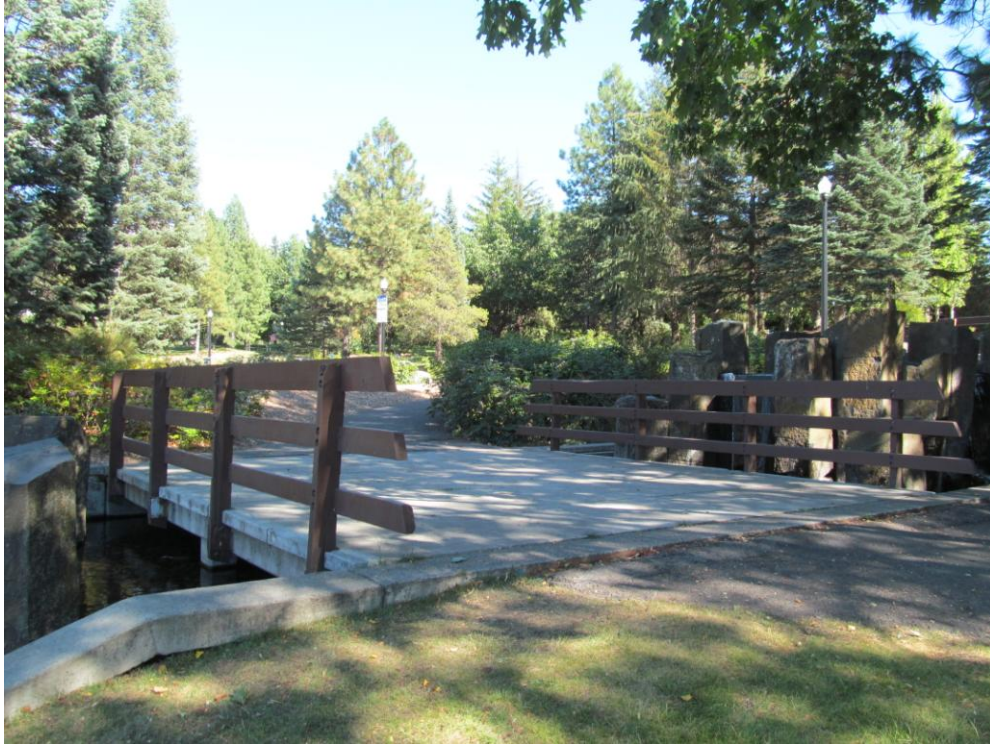
Photo 5 – Theme Stream Bridge – 4th from the South

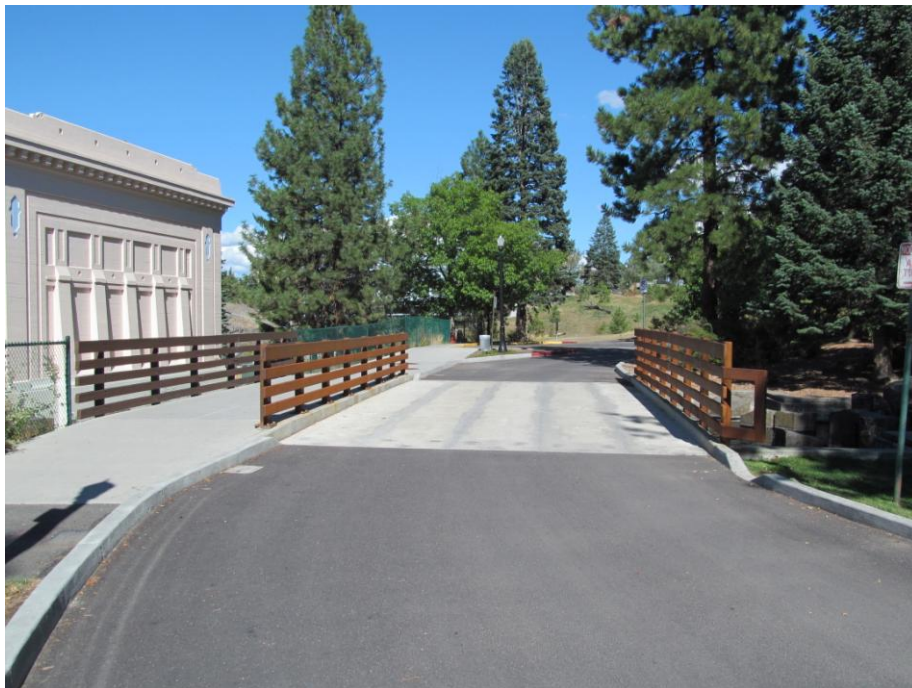
Photo 6 – Theme Stream Bridge – Most Northerly (Avista Bridge)

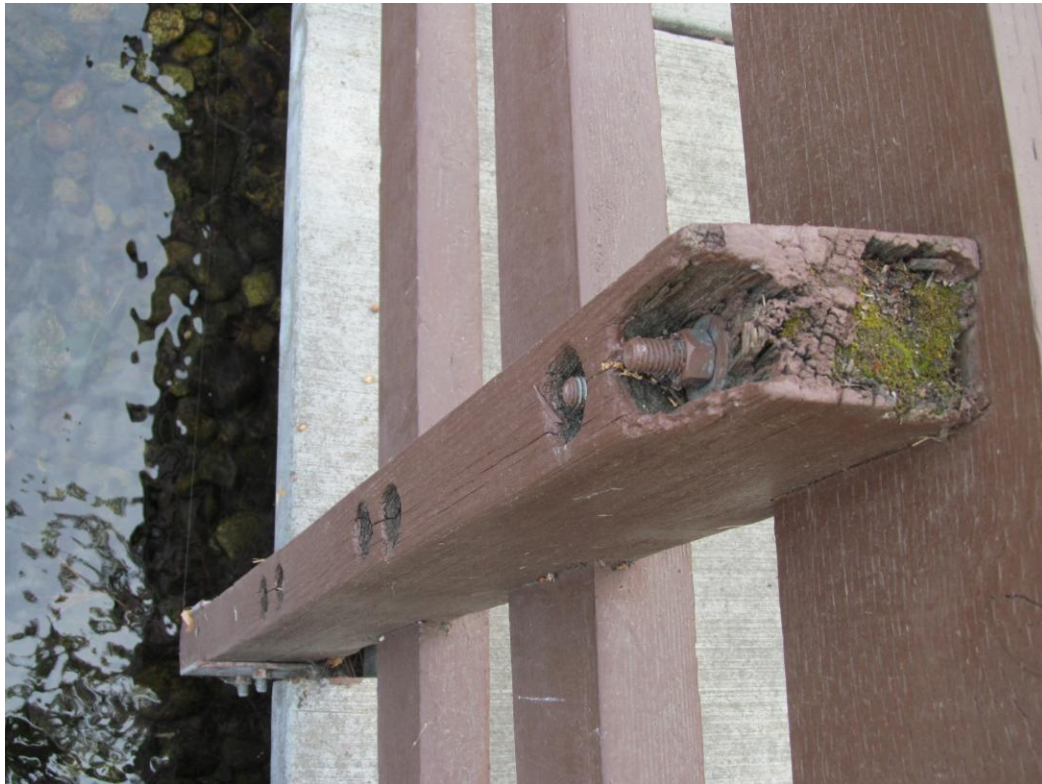
Overall, the structural components of the Theme Stream Bridges are in good condition. Some of the timber railing post connections are loose and some are rotted. The second and third bridges from the south have spalls in the wingwall.

Portions of the timber railing on the other Theme Stream Bridges are in fair to poor condition. The replacement bridge will have a weathering steel railing to match the railing on the Avista Theme Stream Bridge. Replacing all of the timber railing with weathering steel railing will provide a unified look to the bridges and will reduce routine maintenance currently required of the existing timber railing.

Photo 7 – Rotted Timber Railing Post

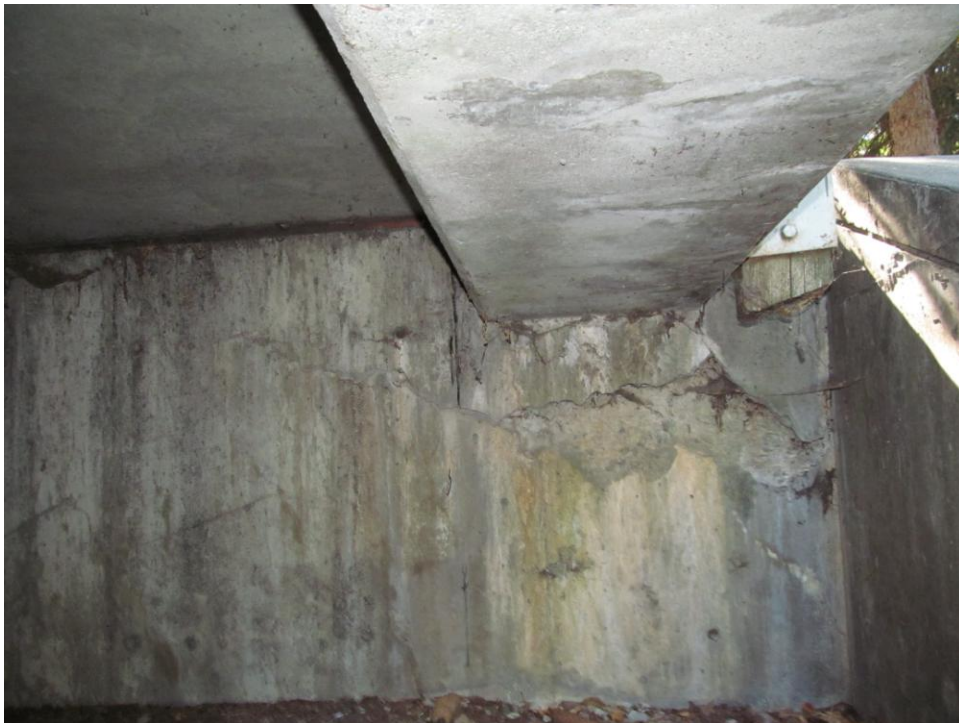
Photo 8 – Spall in Abutment Backwall

The spalls in the wing-walls should be patched.
