RIVERFRONT PARK BRIDGES

INSPECTION AND ANALYSIS

WASHINGTON STREET NORTH BRIDGE

NOVEMBER 14, 2014 | Final Report

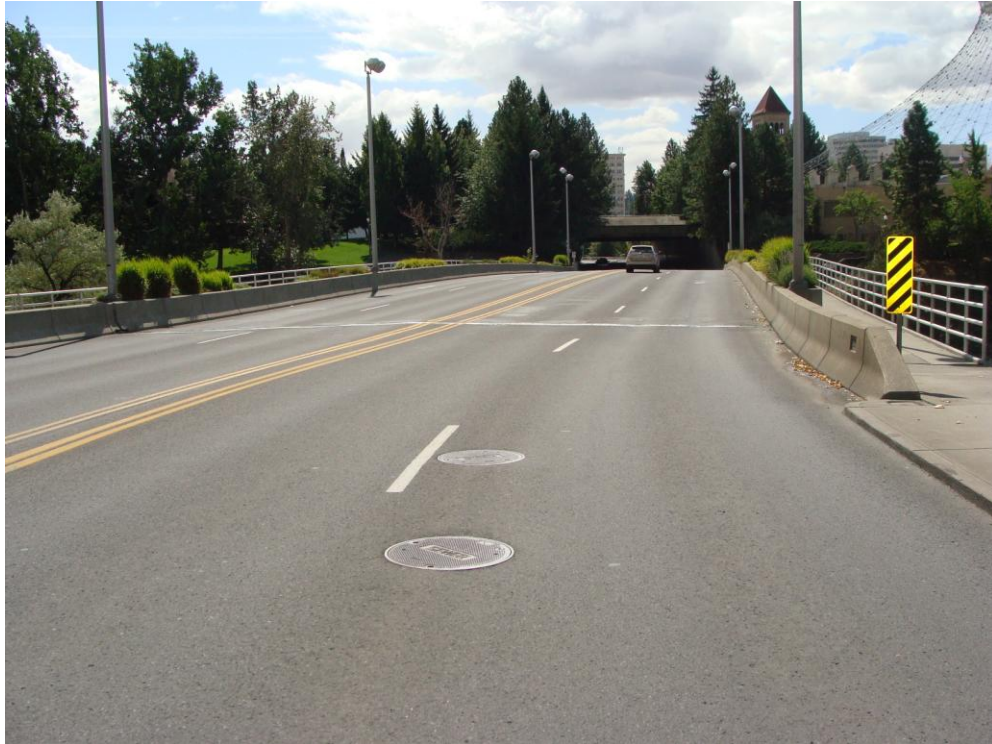
Photo 1 – Washington Street North Bridge Deck (Looking South)

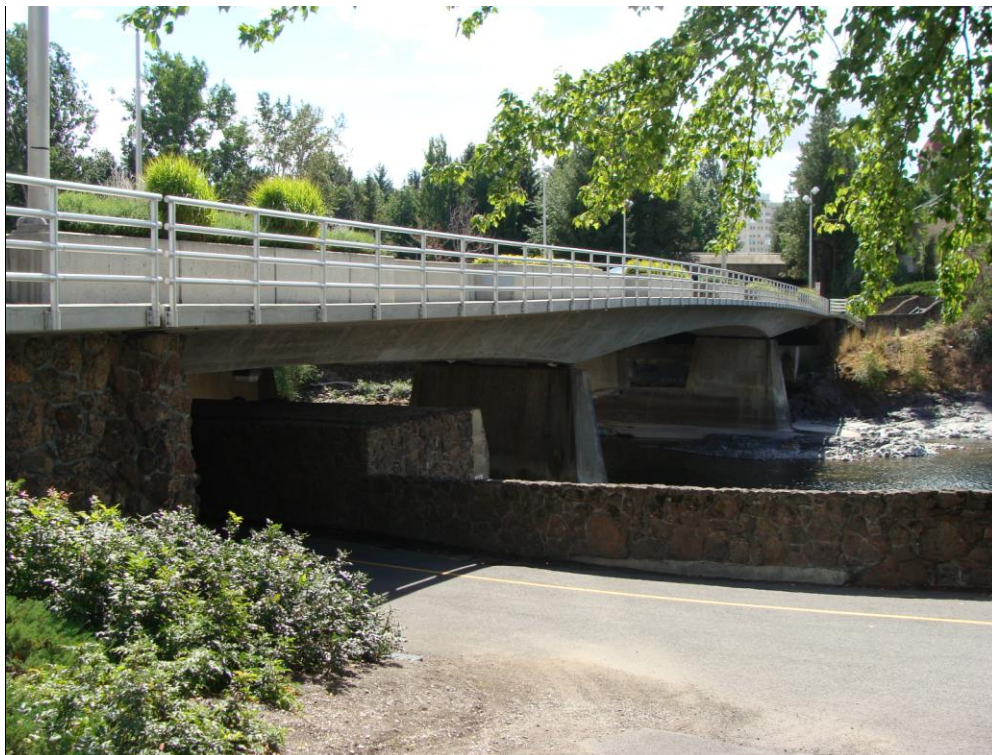
Photo 2 – Washington Street North Bridge Elevation (Looking Southeast)

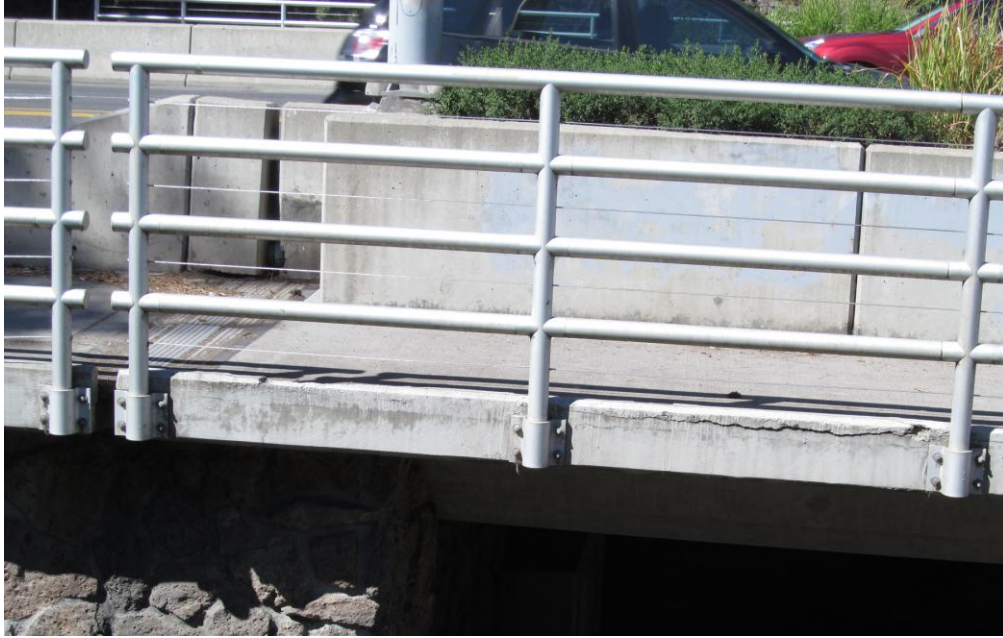
Photo 3 – Existing Sidewalk to be Widened

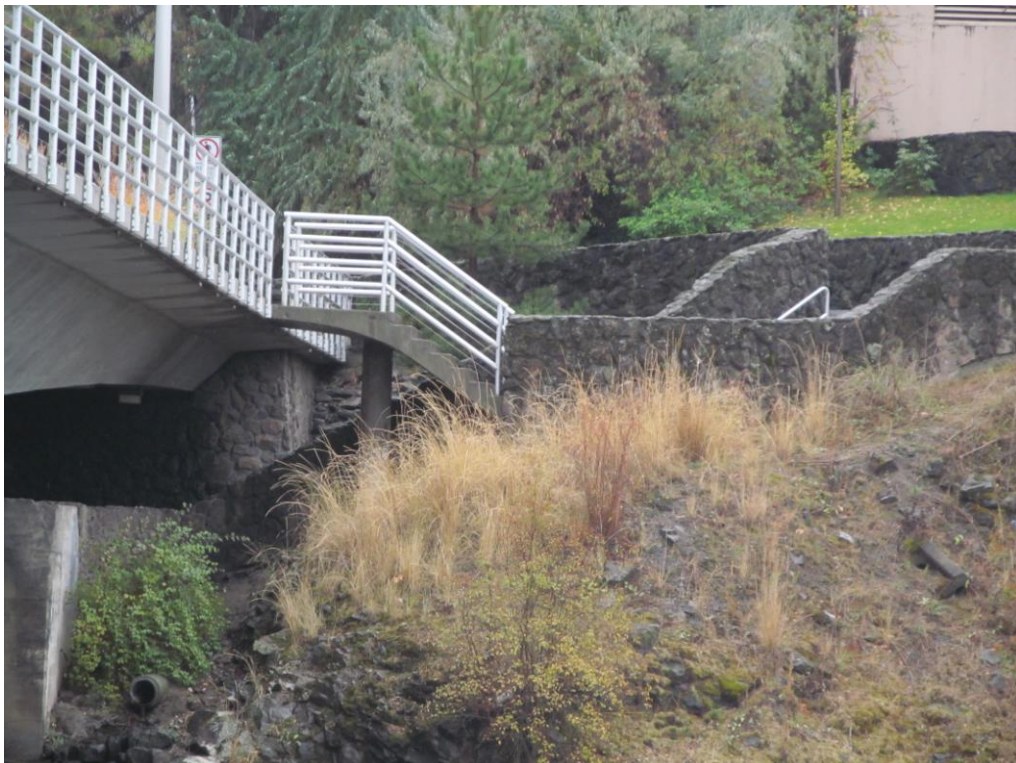
Photo 4 – Stairs at Southwest Corner of Bridge and Location for New Abutment
