# **Riverfront Park**

# Pavilion Facilities Conditions Assessment Report

Integrus Project No. 21134.01

June 4, 2012

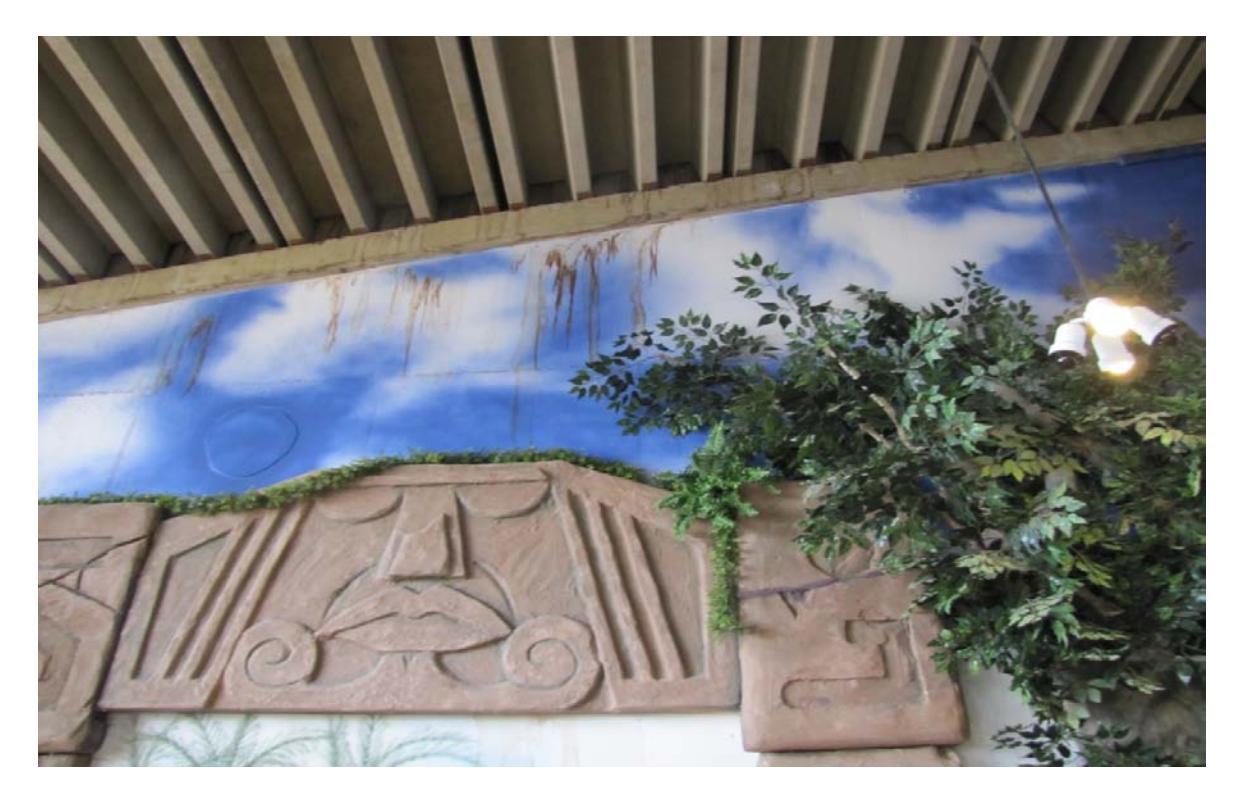
Administration Building – Photo 2-1

Interior observations were made at both the ground and Mezzanine levels. The underside of the precast roof structure is exposed through a majority of the facility. This structure appears to be in good condition, with no visible damage, decay or deterioration. In the mini-golf area, some discoloration and staining was observed immediately below the roof, on the surface of the precast roof deck panels, the concrete support frames and the interior walls (see Photo 2-1.) Some minor cracking was observed in the cast-in-place concrete walls, and in the stairwells at each end of the facility.

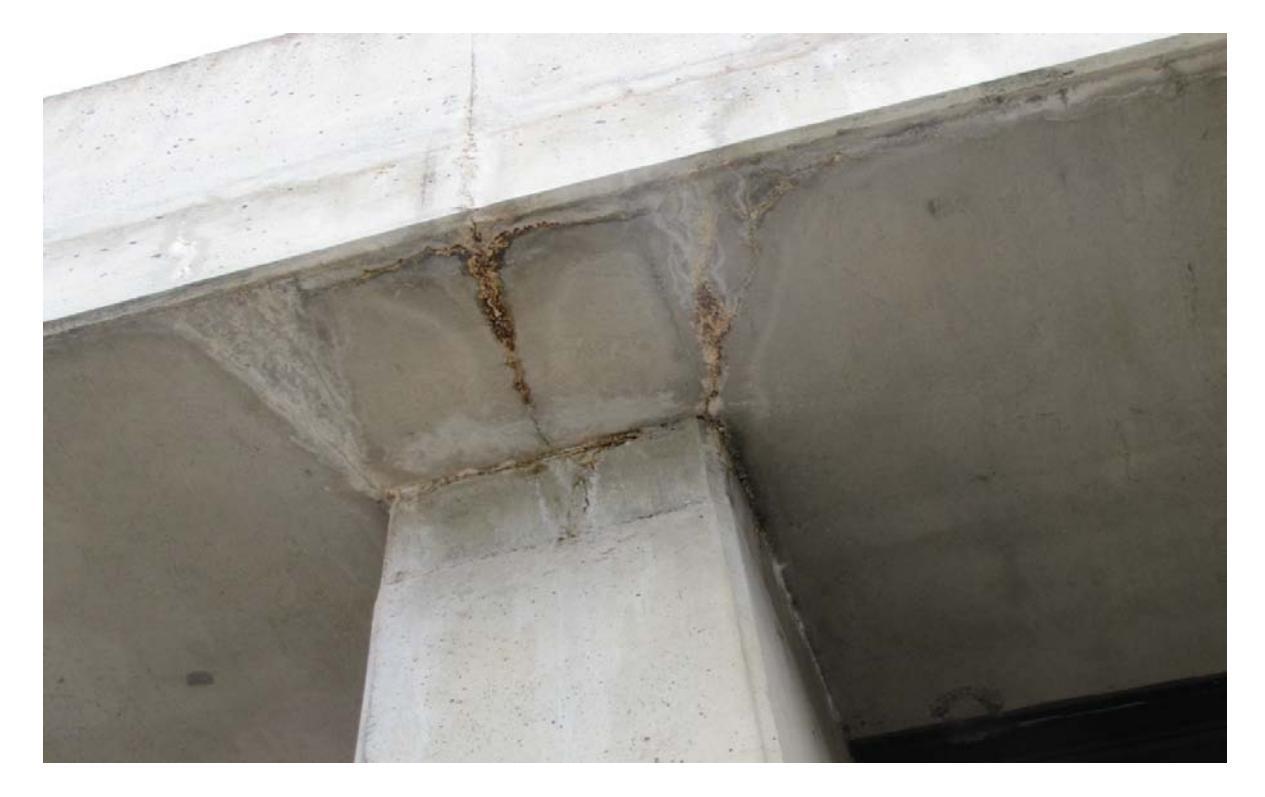
Administration Building – Photo 2-2

The exterior face of the west parapet wall also had some minor discoloration and staining (see Photo 2-2).

The overall condition of the structure is good. There was staining observed on the underside of the roof structure that would indicate water infiltration. In addition, the west roof parapet, which forms the low side of the roof, appears to be weeping moisture. This is likely caused by standing water at the low point of the roof. This water appears to have migrated through the exposed concrete and left residual mineral stains on the opposite side of the parapet wall.

- At the joint between the parapet wall and the concrete roof located on the west side of the building at the low end of the roof slope, it appears that water is leaking through this joint (see Photo 2-2). There is mineral staining and discoloration to the concrete at multiple spots along the length of this joint
- We recommend installation of a new roofing system that wraps up the parapet wall to prevent water from penetrating this joint.
- All the exterior windows installed in this building appear to be single pane windows. This system does not
  meet current energy code requirements.

It will be important to eliminate the water infiltration into the building interior as well as the exterior concrete in order to alleviate potential damage due to expansion from freeze – thaw cycles as well as corrosion of reinforcement.

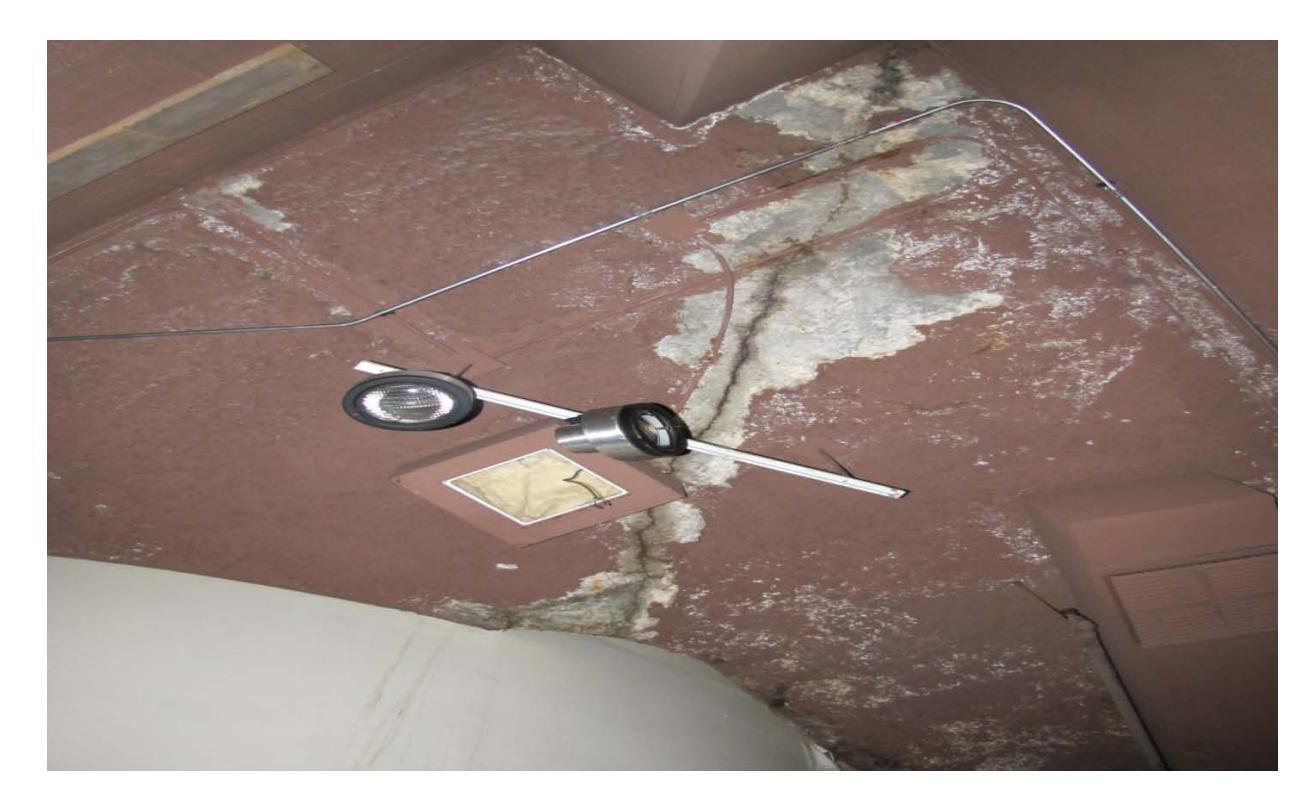
East Pavilion – Photo 3-1

Interior observation began at the west facility entrance, in the building lobby. The light through the exterior windows and doors allowed viewing of the ceiling and interior walls. Interior walls were non-structural partition walls while exterior walls appeared to be CMU. Walls and ceiling were painted. The finished ceiling in this space was a rough and irregular coating spray applied to the bottom of the structure. The coating was painted brown and was covered with white stains throughout. In isolated locations the ceiling coating was missing, exposing cracks in the concrete structure above. The concrete adjacent to the cracks appeared to be damp (see Photos 3-1 and 3-2).

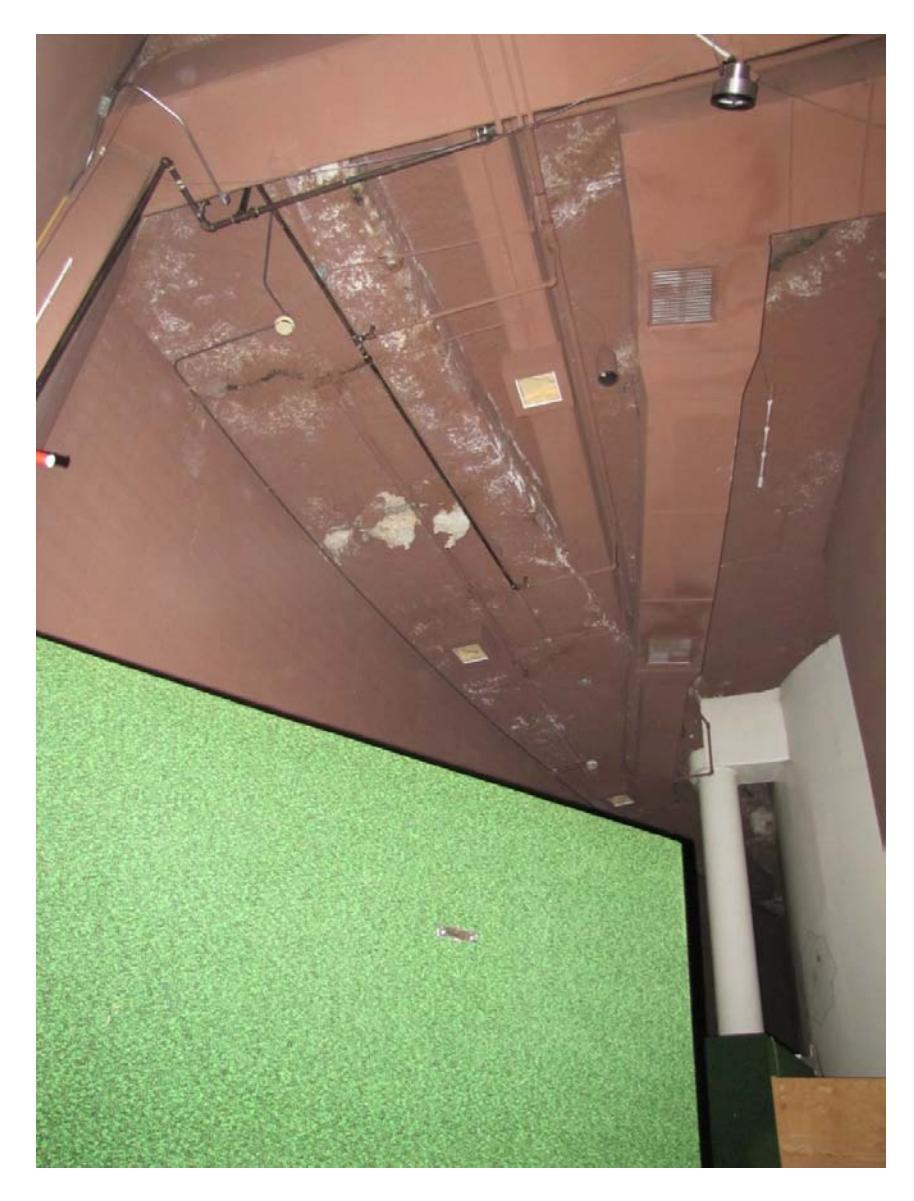
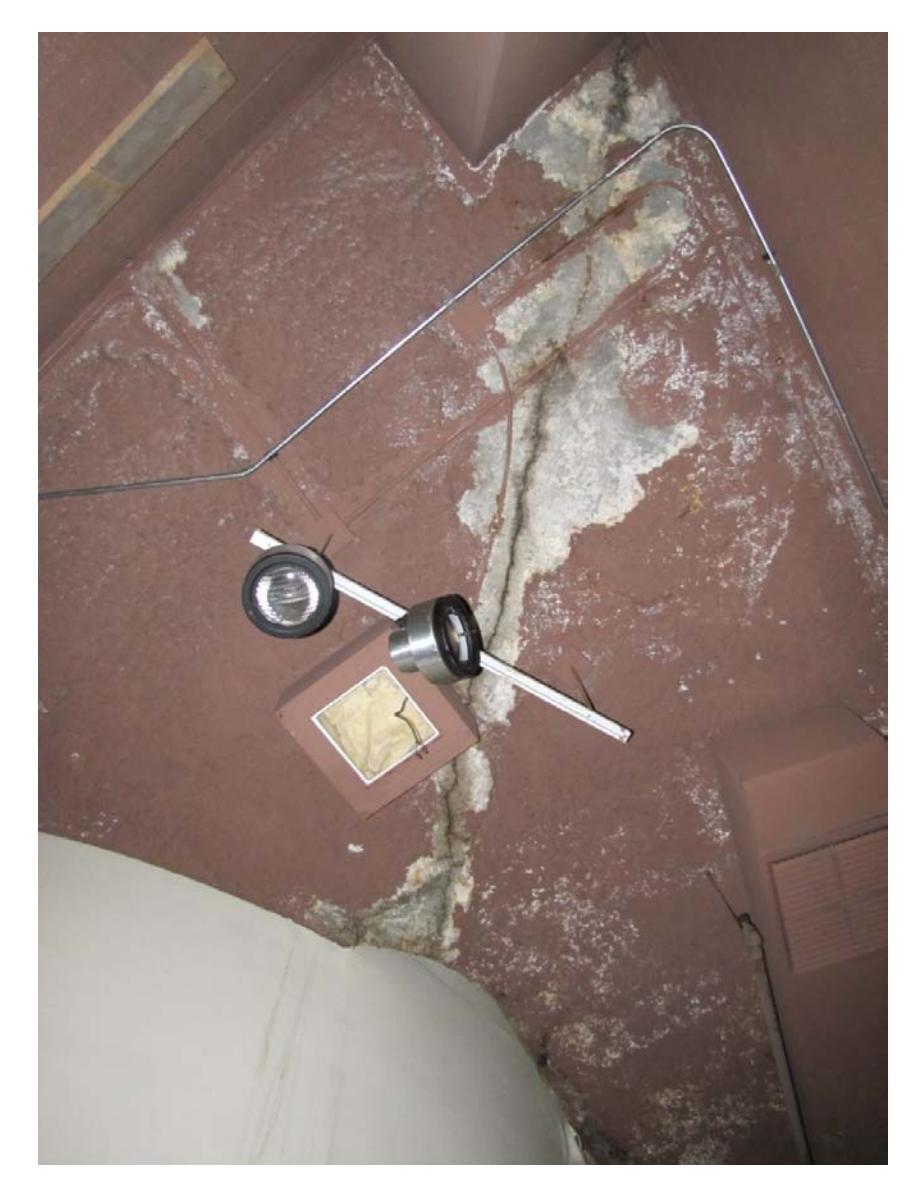
• The roof over this building is a low sloped roof with exposed, bare concrete. There are some visible remains of what appears to be a spray on roofing system, although based on the water infiltration noted on the interior of the building, the system has completely failed (see Photos 3-4 and 3-5).

We recommend that the existing spray on roofing system be stripped down to the structure and a new roofing system be installed to prevent further water damage to the interior of the building. We also recommend that an investigation be done to determine the extent of the water damage to the interior.

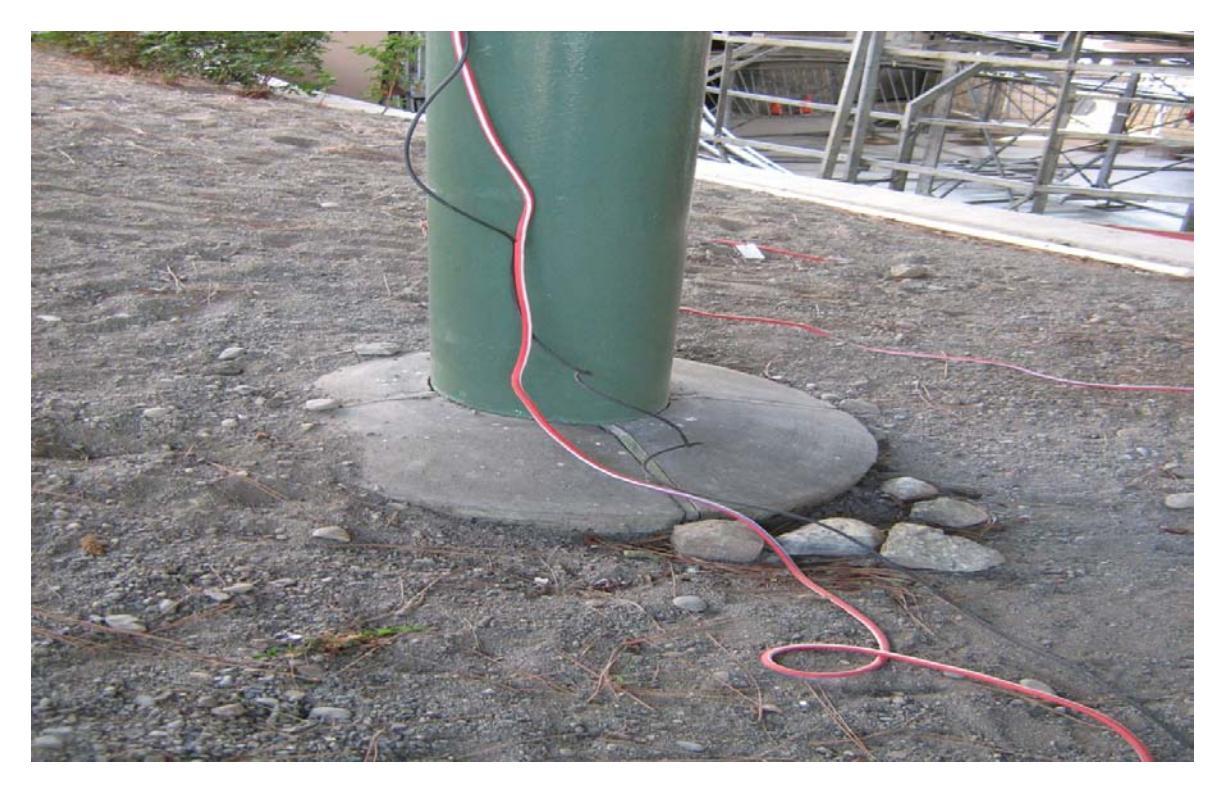
Ice Rink Roof - Photo 4-1

Pipe columns appear freshly painted and showed no signs of deterioration or damage. A concrete base (see Photo 4-1) was observed at the bottom of all the columns except one located on the north side of the structure (see Photo 4-2). This column appears to be surrounded by fill material that has covered the concrete base.
