RIVERFRONT PARK BRIDGES

INSPECTION AND ANALYSIS

SOUTH SUSPENSION BRIDGE

NOVEMBER 14, 2014 | Final Report

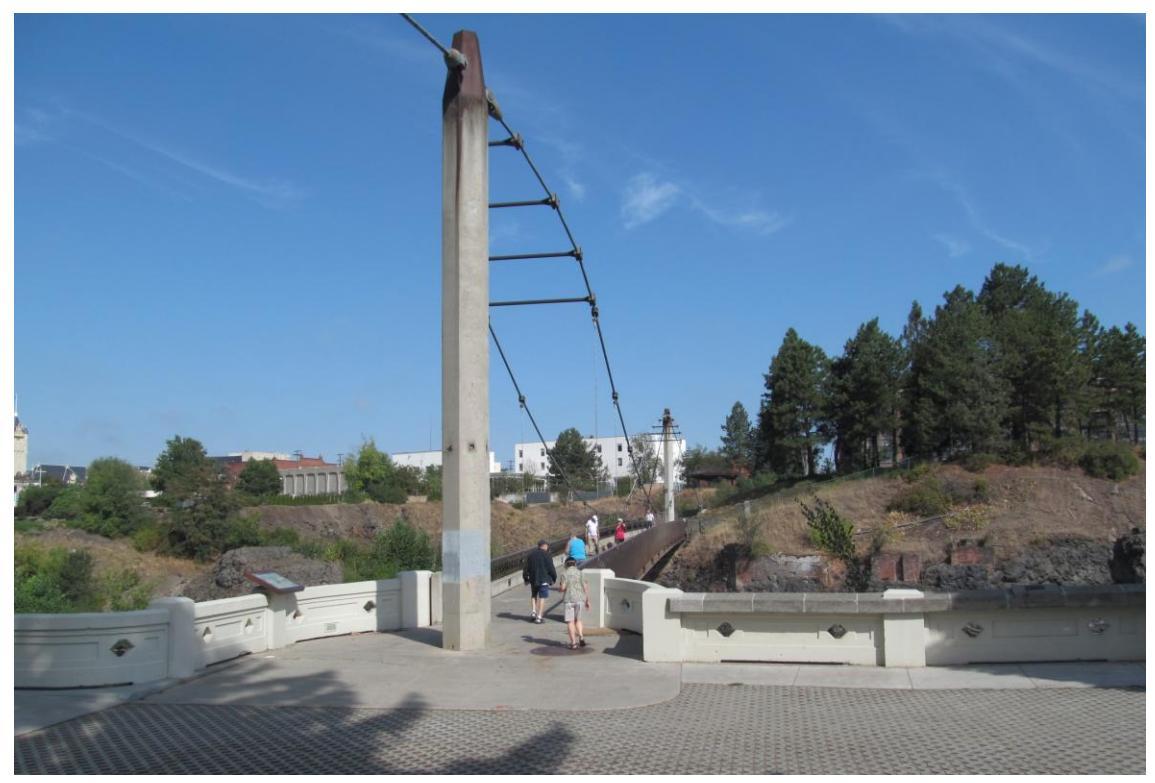
Photo 1 –South Suspension Bridge Deck (Looking North)

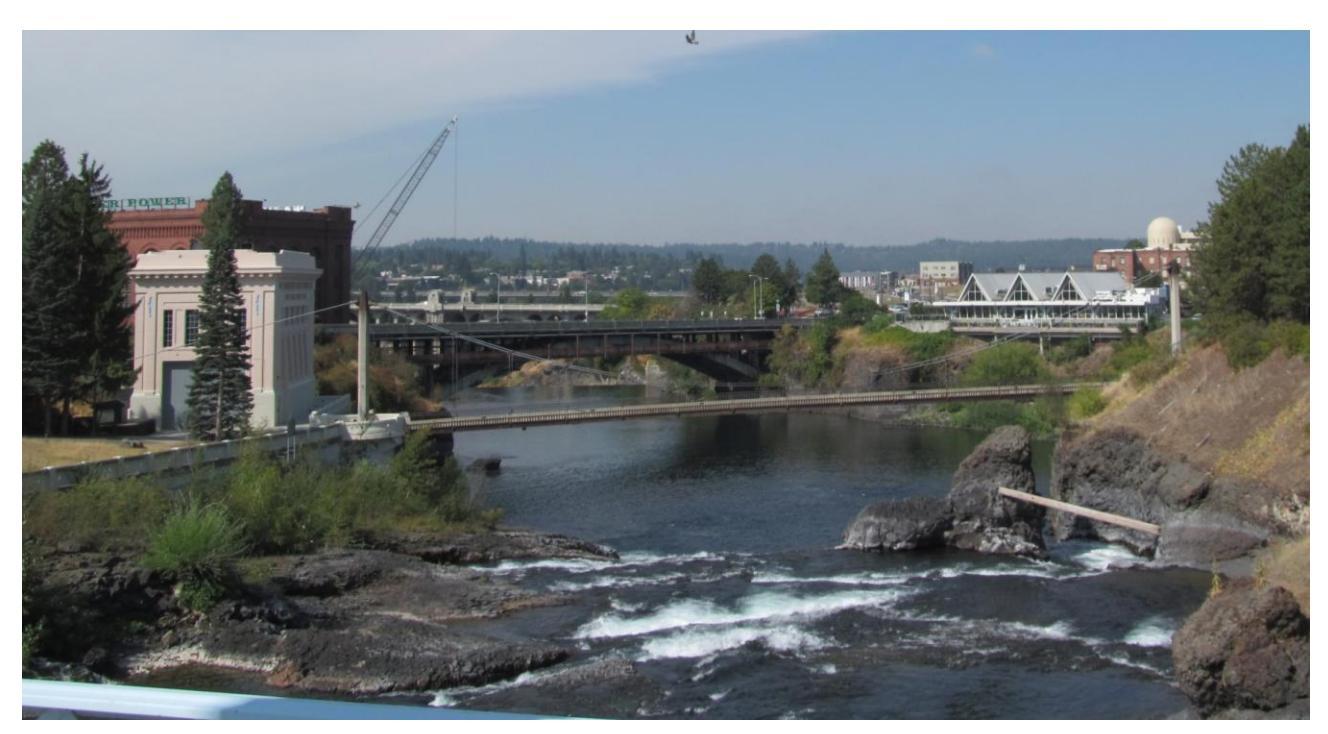
Photo 2 – South Suspension Bridge Elevation (Looking West)

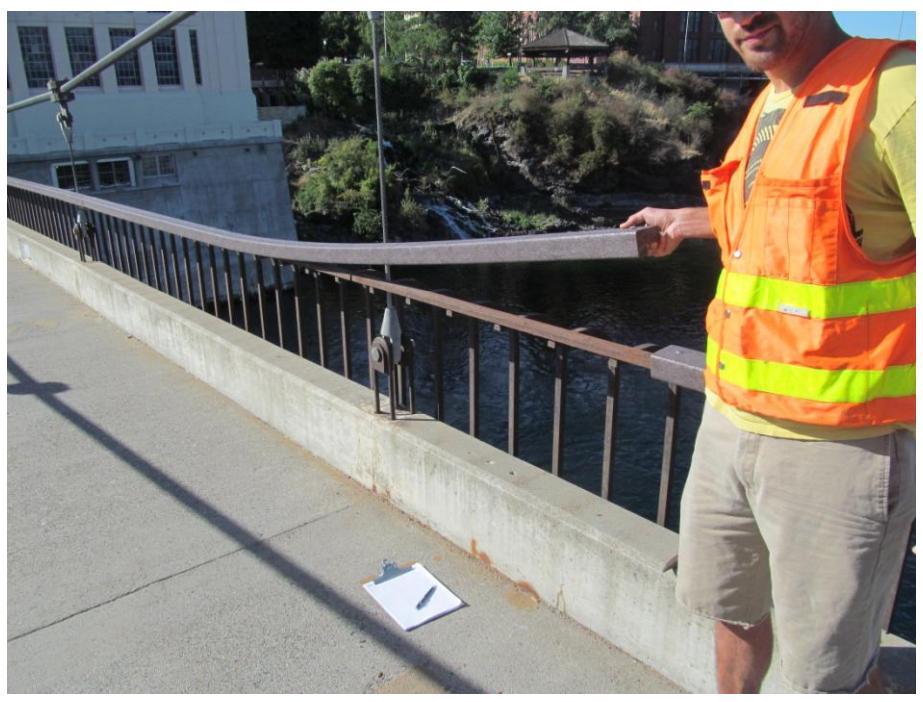
Photo 3 – Loose Cover Plate on Handrail

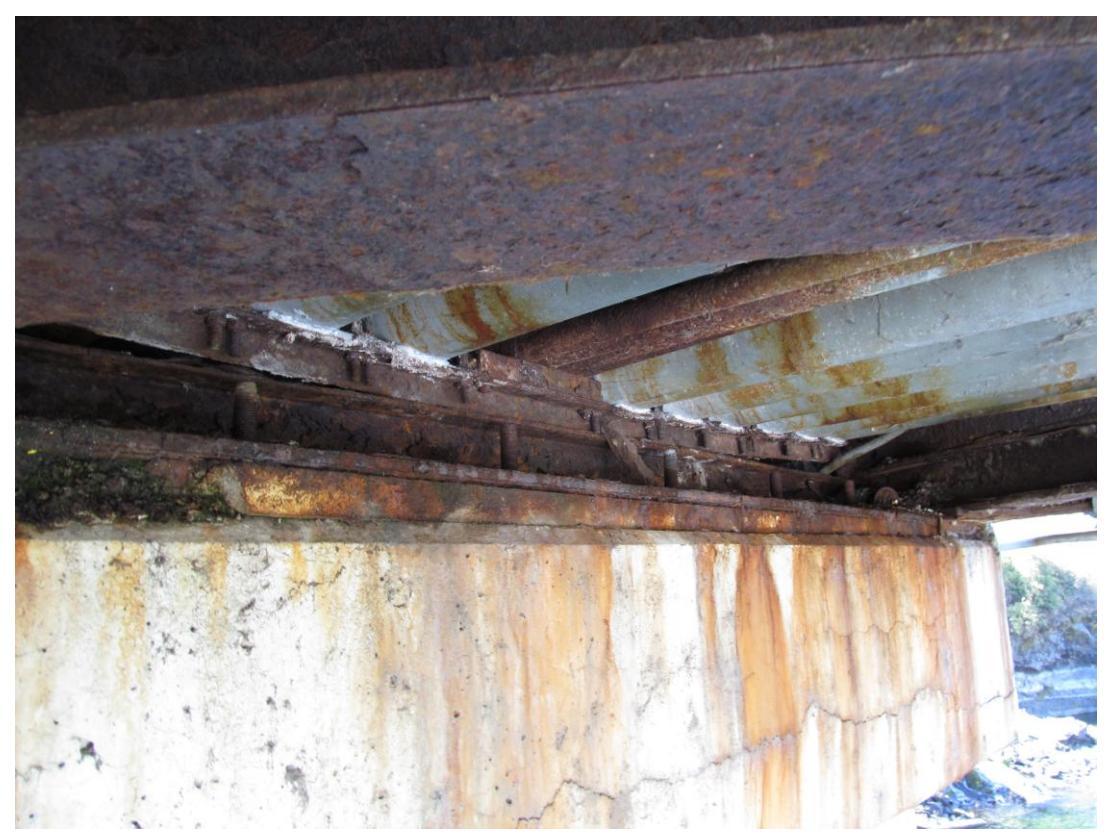
Photo 4 – Heavy Corrosion at Pier 1/Floorbeam 1-1

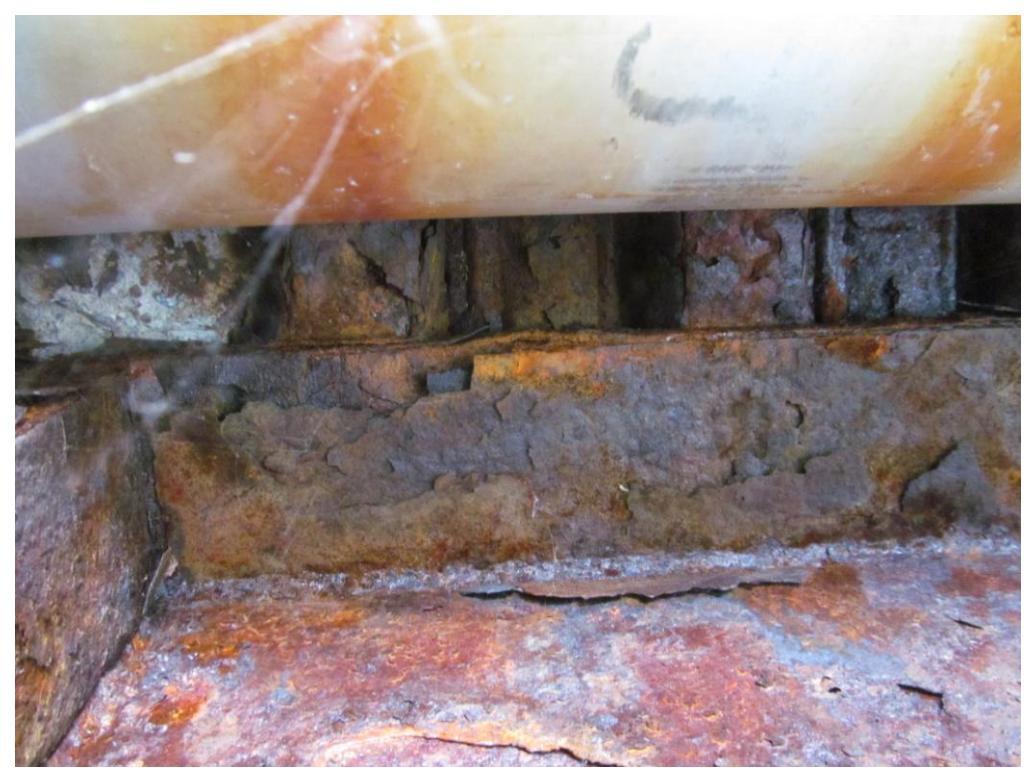
Photo 5 – Top Flange of Right Girder near H6, ~1/4" measured section loss

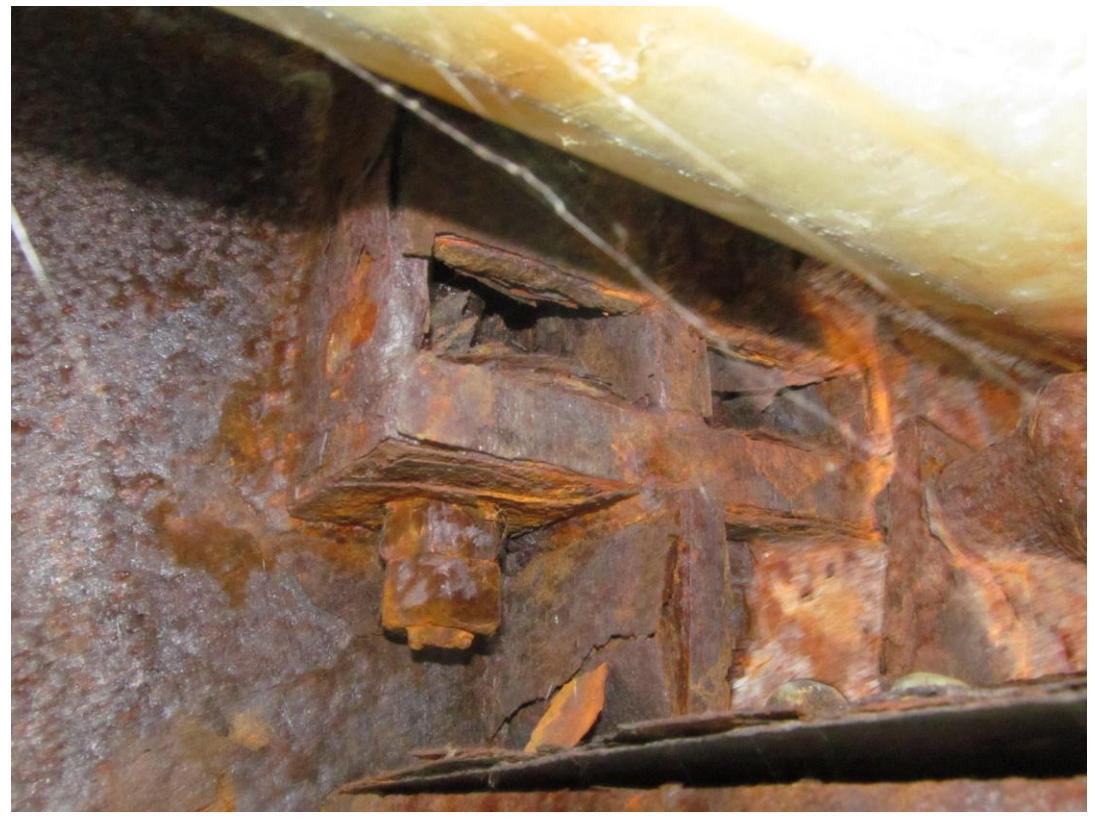
Photo 6 – Heavy Corrosion at H6 RT Suspender Cable Interior Hanger Connection

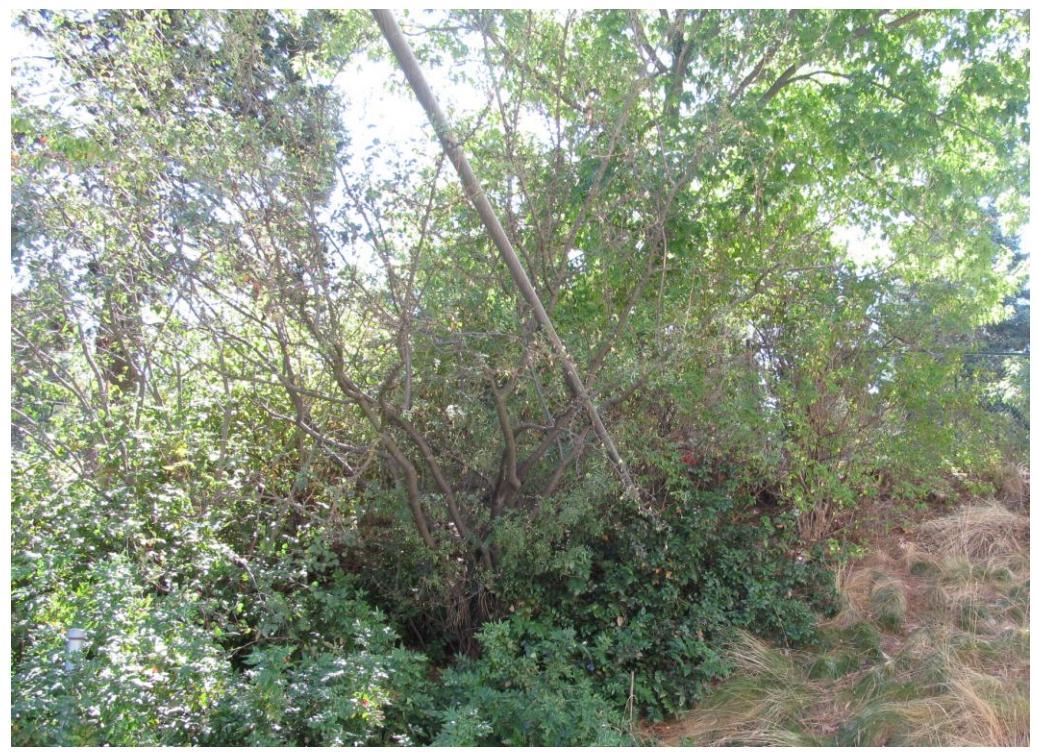
Photo 7 – Remove Tree Branches around South Cable Anchorage

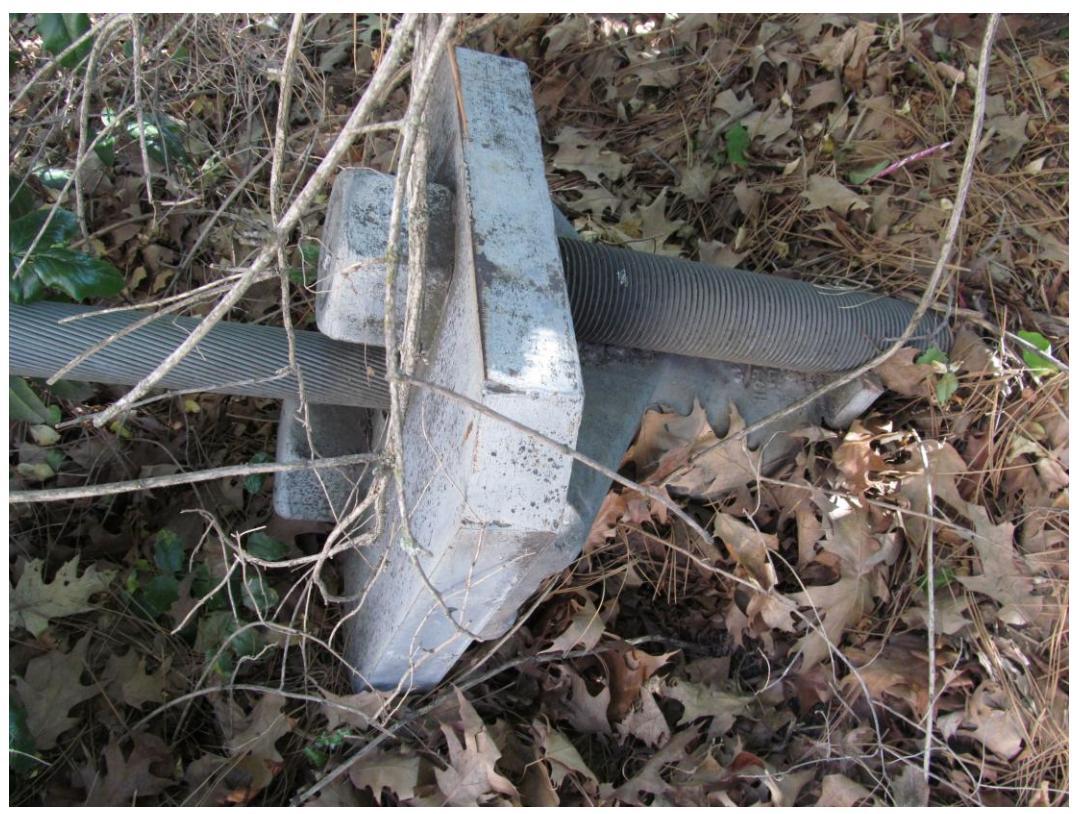
Photo 8 – Tack Weld Lock Nut at Northwest and South Cable Anchorage, Remove Soil around South Anchorage block

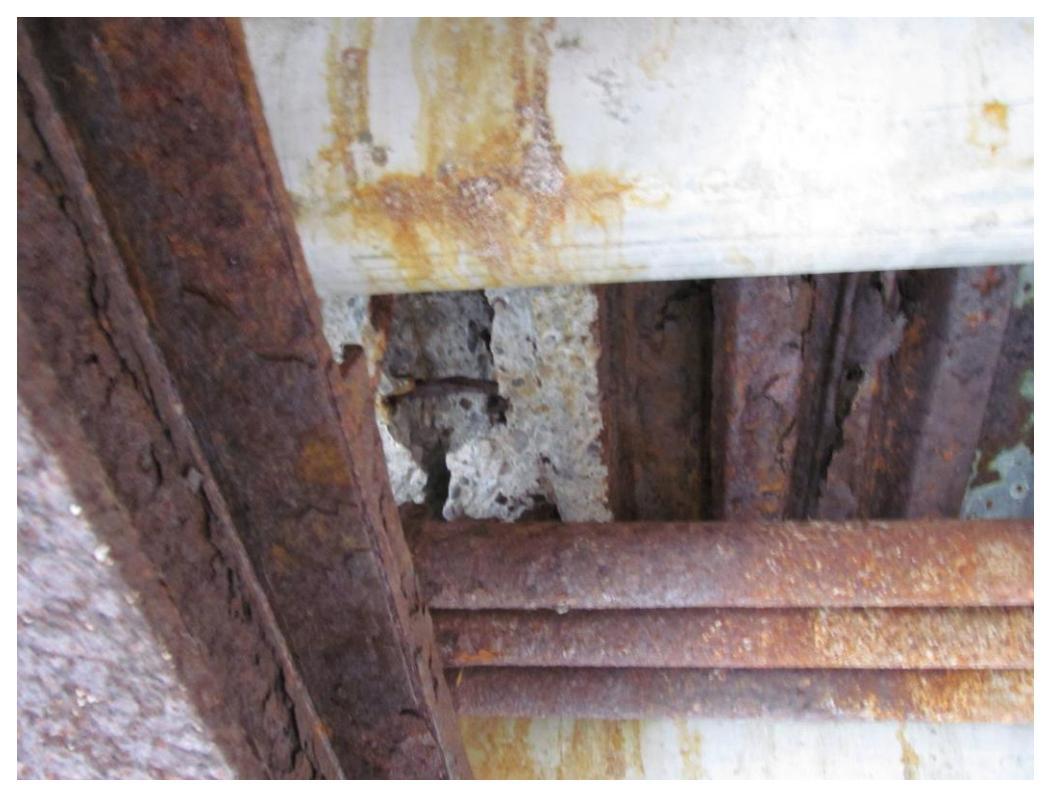
Photo 9 – Corroded/Missing Stay-in-Place Formwork above Floorbeam (Typical)

Due to the heavy corrosion of the SIP forms and the numerous areas of delaminations in the concrete, the deck and curb should be replaced. The new deck should have an improved drainage system to prevent future corrosion of the superstructure. A drainage channel could be added along the curb. The deck should receive a waterproofing sealant.

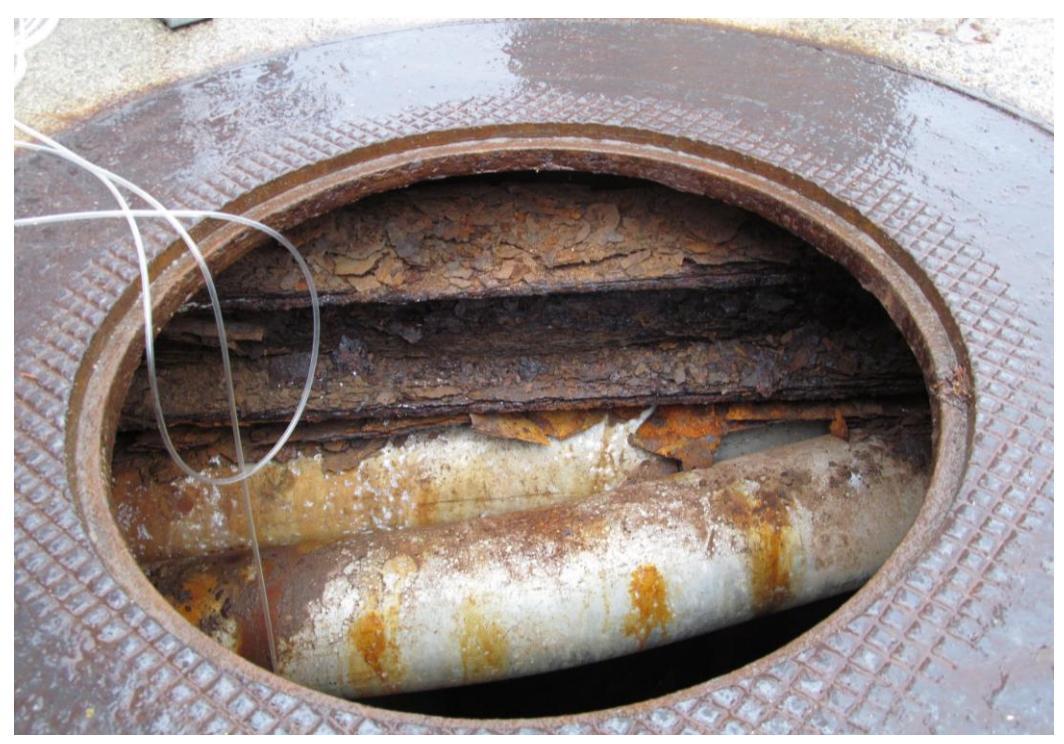
Photo 10 –Vault No. 1: Severely Corroded Beam

The deck and the steel framing in the vaults should be replaced and additional framing around the manhole opening should be provided. The conduits should be removed during construction, and the new deck should be constructed with removable formwork. The sidewalk around the vaults should also be replaced. A compression seal should be installed at the expansion joints to prevent the large intrusion of water at the joint.

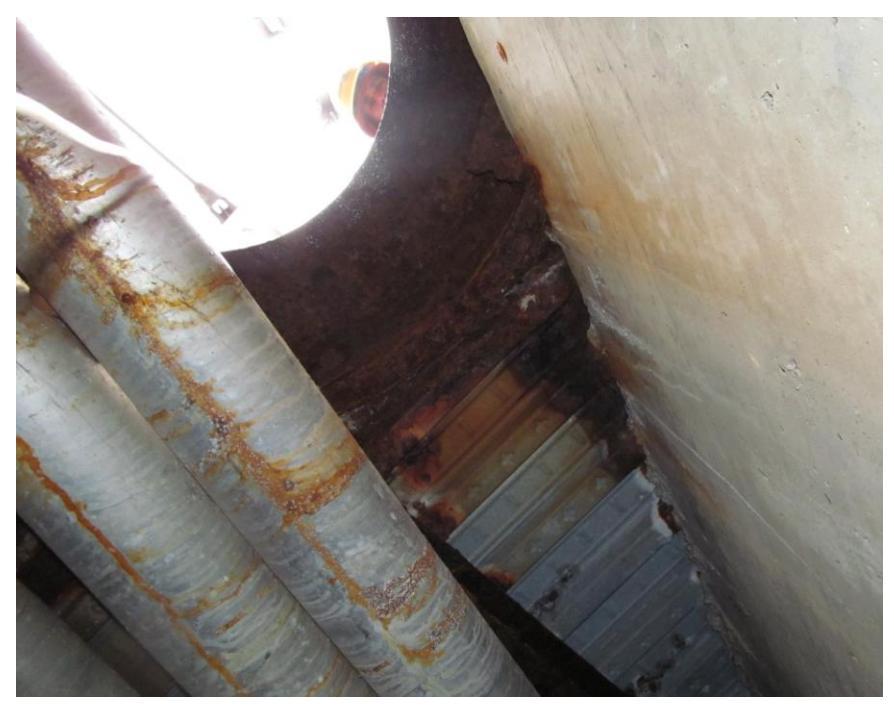
Photo 11 – Vault No. 1: Corroded Stay in Place Formwork around Manhole

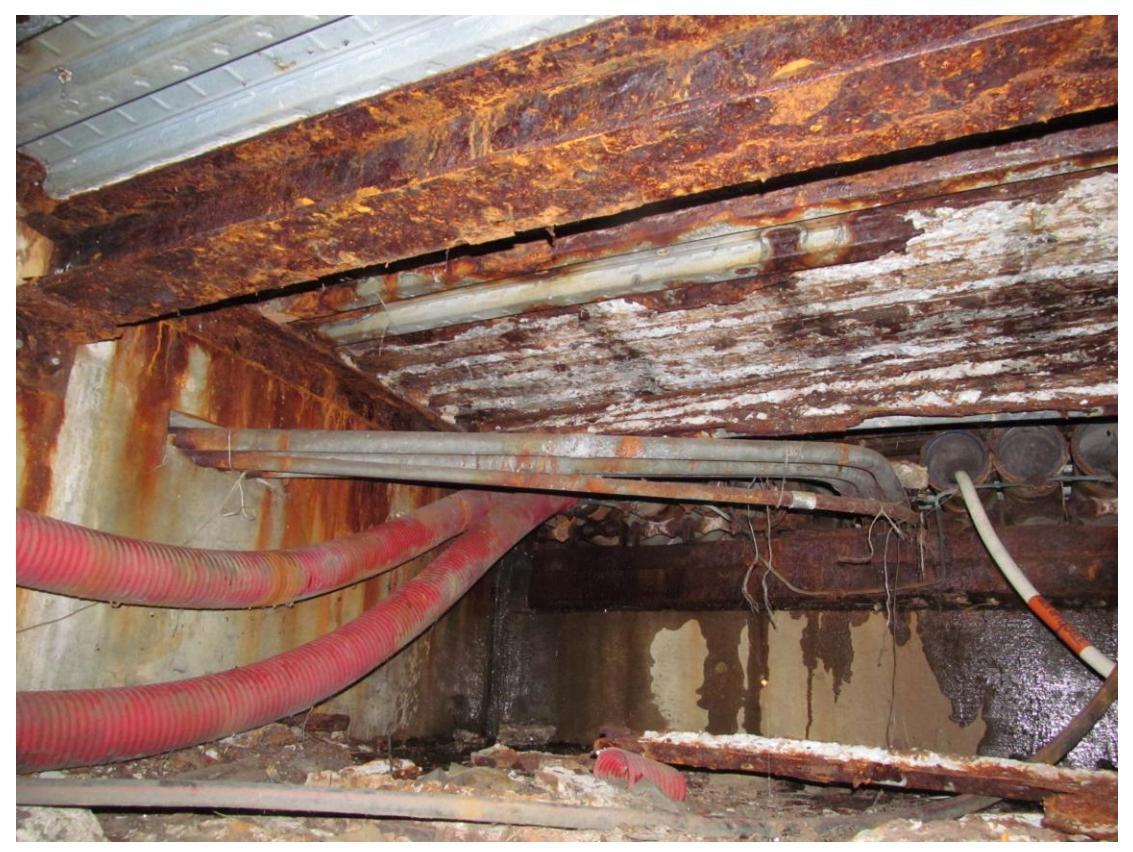
Photo 12 –Vault No. 2: Missing Stay in Place Formwork and Corroded Beam/Angle near Abutment
