Sharp Avenue Permeable Pavement Project

Transportation Commission

June 18, 2025

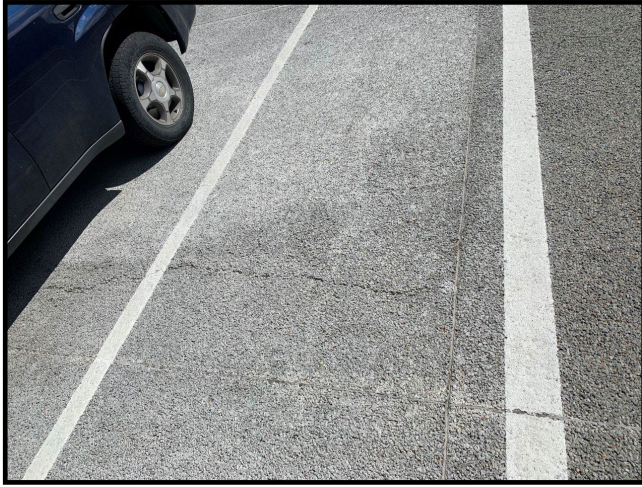
Linear Cracks

| Pavement | Comments | Apr-19 | Oct-20 | Oct-21 | Nov-22 | Oct-23 | Oct-24 |
|--|---|---|---|---|---|---|---|
| Pervious Concrete (WB Lane & Parking) | 2 Linear Cracks | 98 | 98 | 96 | 90 | 84 | 84 |
| Pervious Concrete (Intersection) | 6 Light Linear Cracks 3 Light Patches 10 Medium Scaling | 100 | 100 | 100 | 95 | 89 | 89 |

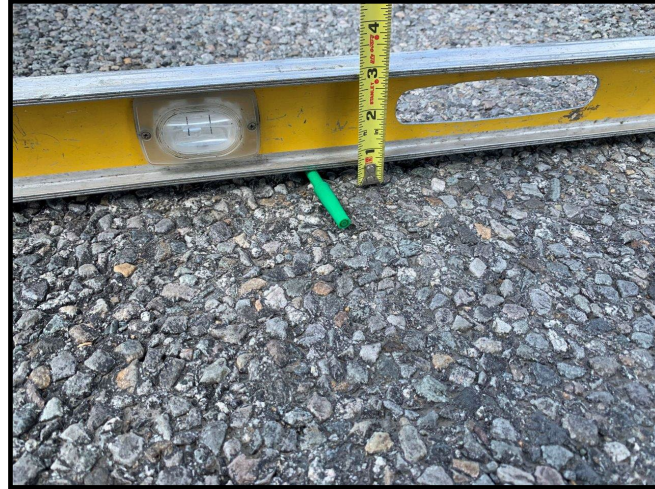
Light Rutting

| Pavement | Comments | Apr-19 | Oct-20 | Oct-21 | Nov-22 | Oct-23 | Oct-24 |
|--|---|---|---|---|---|---|---|
| Porous Asphalt (WB Lane) | Light Rutting | 100 | 82 | 82 | 79 | 79 | 79 |
| Porous Asphalt (EB Lane) | Light Rutting | 100 | 82 | 82 | 79 | 79 | 81 |

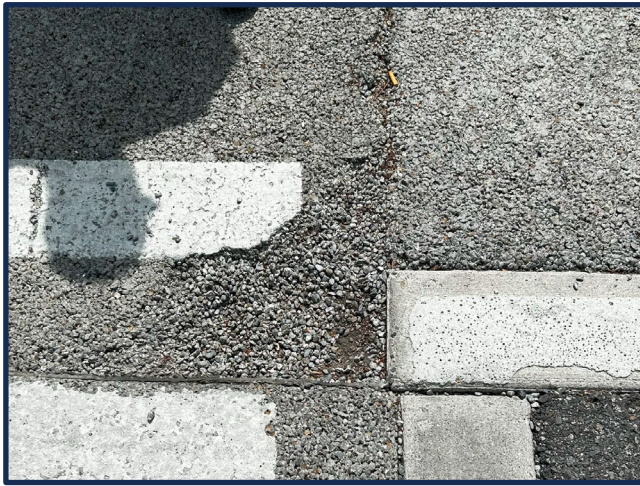
Unraveling

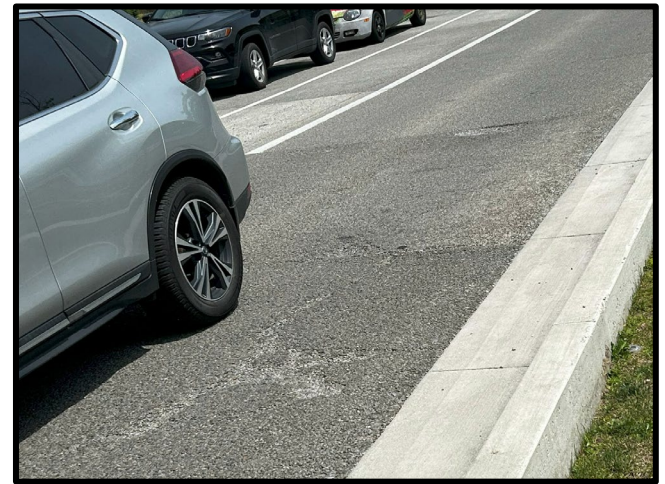
Spalling
