**RE: Geotechnical Evaluation
Bethany Presbyterian Church Housing
2607 South Ray Street, Spokane County Parcel Number 35273.0618
Spokane, Washington**

ALLWEST Project Number: 224-068G

GEOTECHNICAL EVALUATION
BETHANY PRESBYTERIAN CHURCH HOUSING
2607 SOUTH RAY STREET, SPOKANE COUNTY PARCEL NUMBER
35273.0618
SPOKANE, WASHINGTON

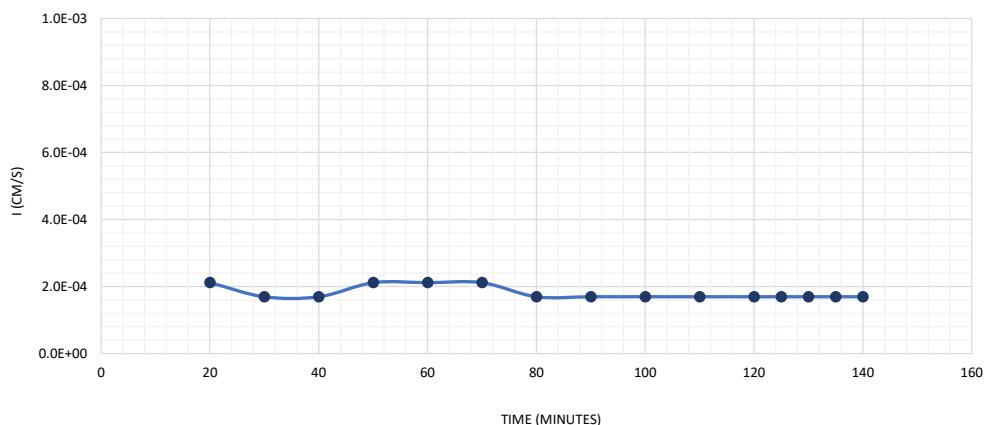
INFILTRATION RATE

Recommended Factor of Safety:
2.5

A single-ring falling head infiltration test was performed adjacent to test pit TP-07 at a depth of approximately two feet. The test was performed by pushing a 12-inch diameter steel casing approximately 8-inches into undisturbed soil. The soil in the casing was saturated for one hour prior to conducting the infiltration test. An infiltration rate of 0.24 inches per hour was measured.
