**Channel Migration Zone Delineation**

**JRP Land Company, Hangman Creek**

Spokane, Washington

September 27, 2016

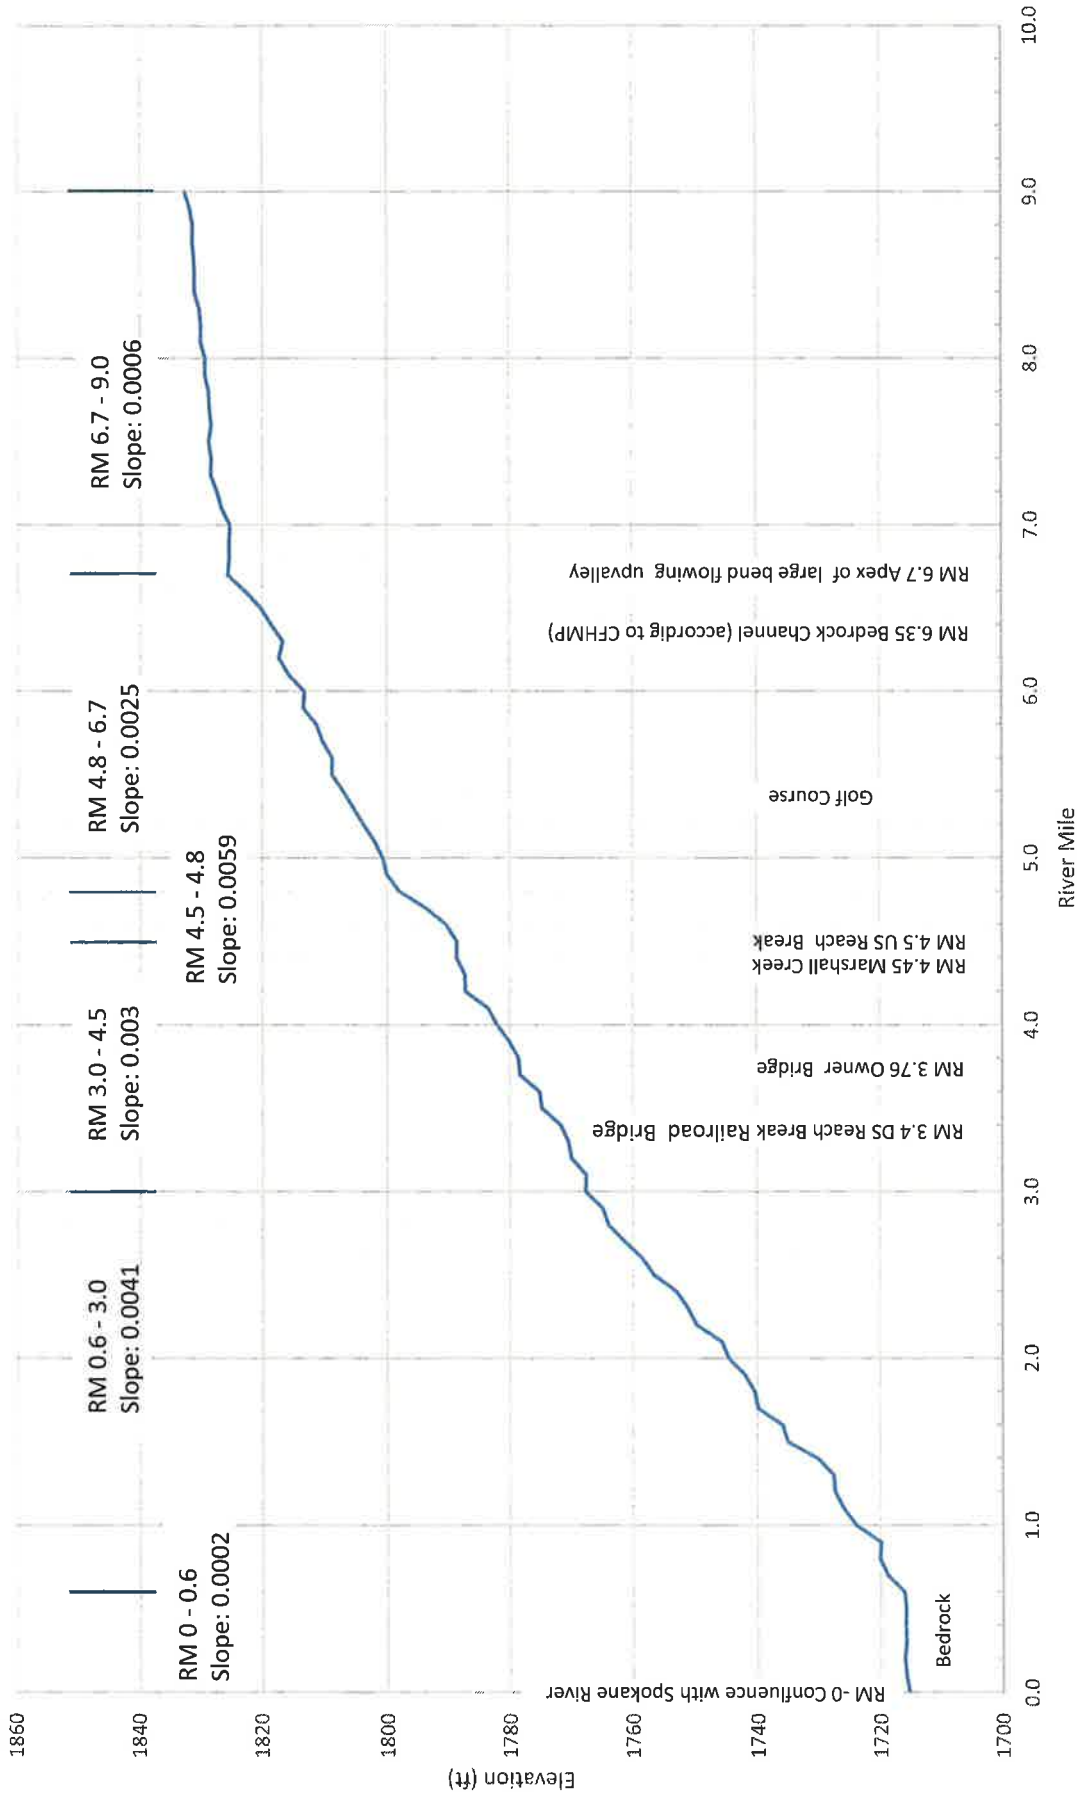
Figure 3

Based on 2015 LiDAR. Points sampled every tenth of a mile.

Longitudinal Profile - Hangman Creek
