**PHASE I
ENVIRONMENTAL SITE ASSESSMENT
REPORT**

**2420 East 29th Avenue
Spokane, WA**

TECHCON, INC.

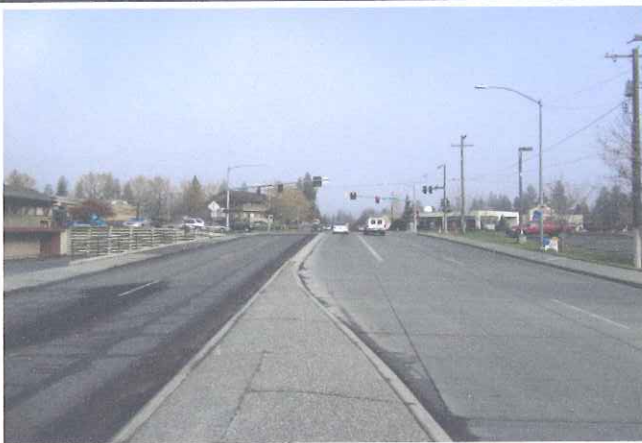
2

3.7.3 East Adjoining Property - The east boundary of the subject site is paralleled by Southeast Boulevard (see photograph 2), an asphalt-paved City of Spokane arterial roadway. Beyond Southeast Boulevard to the east are a retail center and a *Bank of America* branch. A visual survey of these areas did not reveal conditions of environmental concern to the subject site.

View looking north along Southeast Boulevard, the east boundary of the subject site.

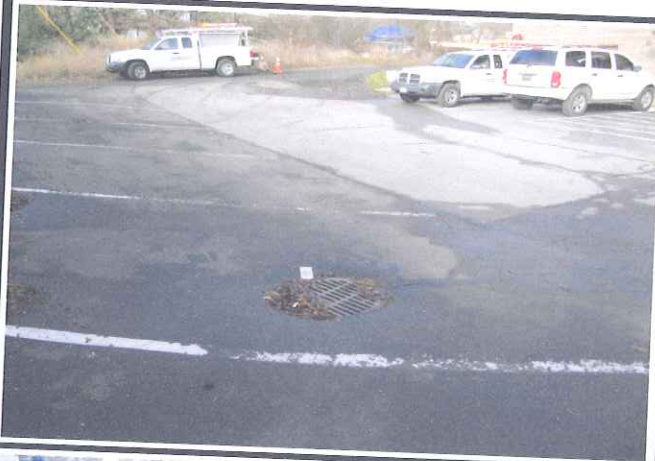
10

Two stormwater collection drywells were observed, one in the north parking area (see photograph 11) and one in the south parking area (see photograph 10). Neither of the observed drywells had visible staining or any odors that would indicate possible contamination or environmental compromise.

**Stormwater collection
drywell in the south
parking area.**

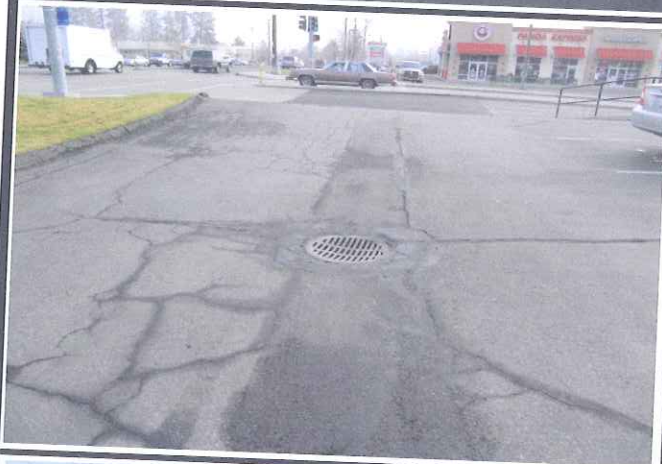
11

**Stormwater collection
drywell in the north
parking area.**

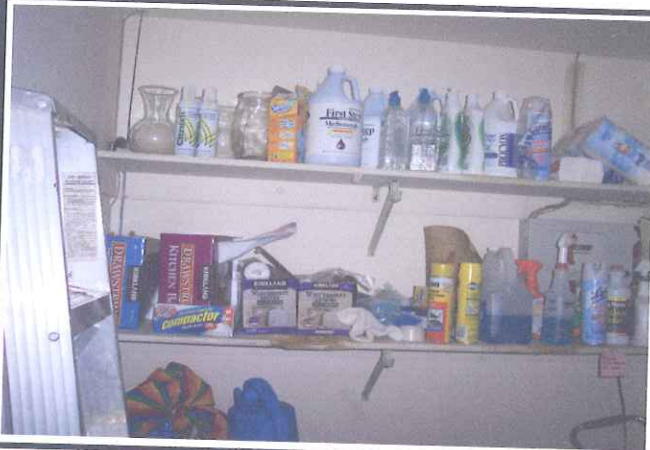
16

Maintenance supplies storage on the upper level.

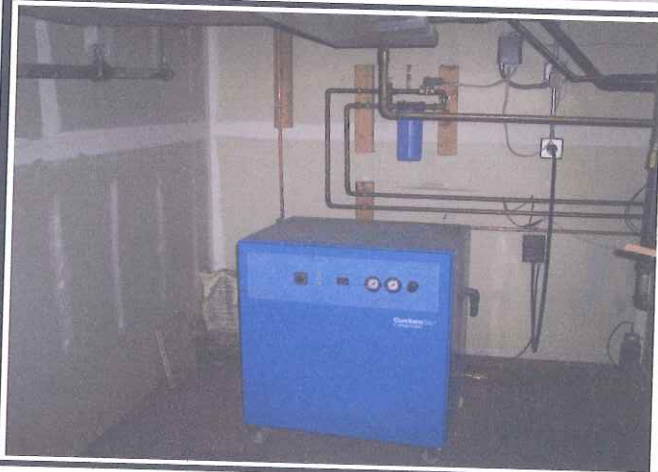
21

Interior of the mechanical room on the lower level showing the air compressor.
