Bridge Material Testing Reports

**Petrographic Examination of a Concrete
Core Sample from Latah Bridge, Spokane,
Washington**

Petrographic Examination of a Concrete Core Sample from Latah Bridge, Spokane, Washington

STRUCTURE: Concrete Arch Bridge
LOCATION: Spokane, Washington

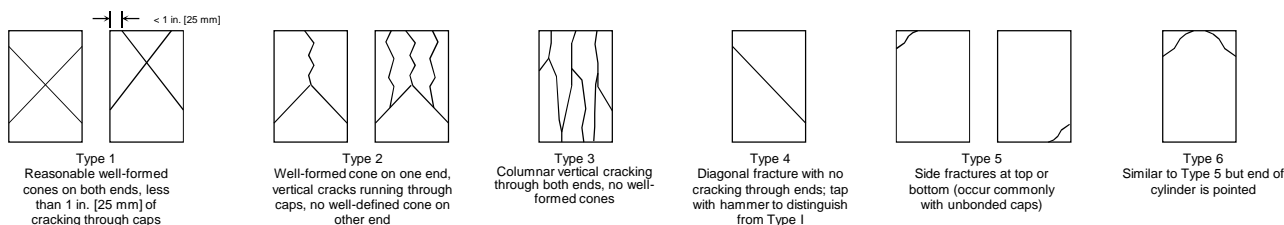
Schematic of Typical Fracture Patterns

Maximum Load, lb	102,400	121,500
Uncorrected Compressive Strength, psi	9,130	10,830
Ratio of Capped Length to Diameter	1.57	1.93
Correction Factor	0.97	1.00
Corrected Compressive Strength, psi	8,860	10,830
Fracture Pattern	Type 1	Type 1

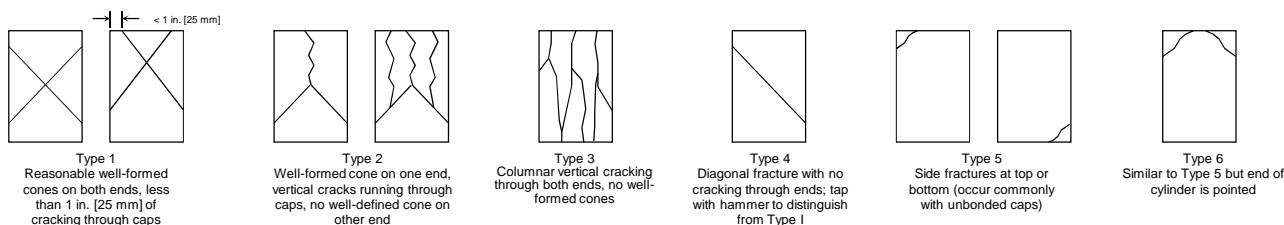
Schematic of Typical Fracture Patterns

Maximum Load, lb	82,800	105,000
Uncorrected Compressive Strength, psi	7,380	9,310
Ratio of Capped Length to Diameter	1.70	1.79
Correction Factor	0.98	1.00
Corrected Compressive Strength, psi	7,230	9,310
Fracture Pattern	Type 2	Type 1

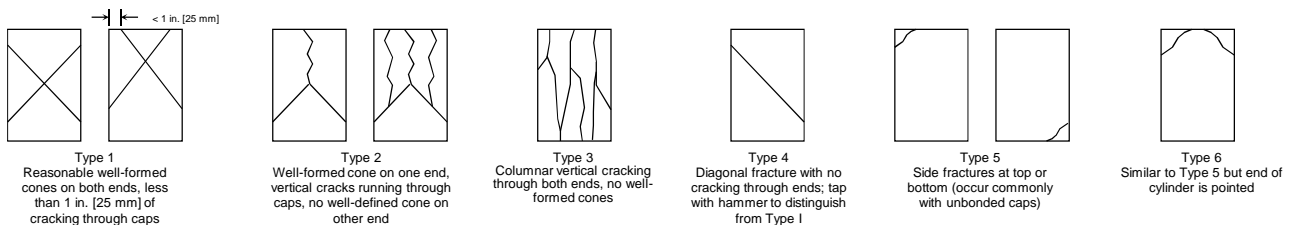
Schematic of Typical Fracture Patterns

Maximum Load, lb	96,400	115,400	113,400
Uncorrected Compressive Strength, psi	8,590	10,290	10,110
Ratio of Capped Length to Diameter	1.69	1.22	1.57
Correction Factor	0.98	0.92	0.97
Corrected Compressive Strength, psi	8,420	9,470	9,810
Fracture Pattern	Type 2	Type 1	Type 2

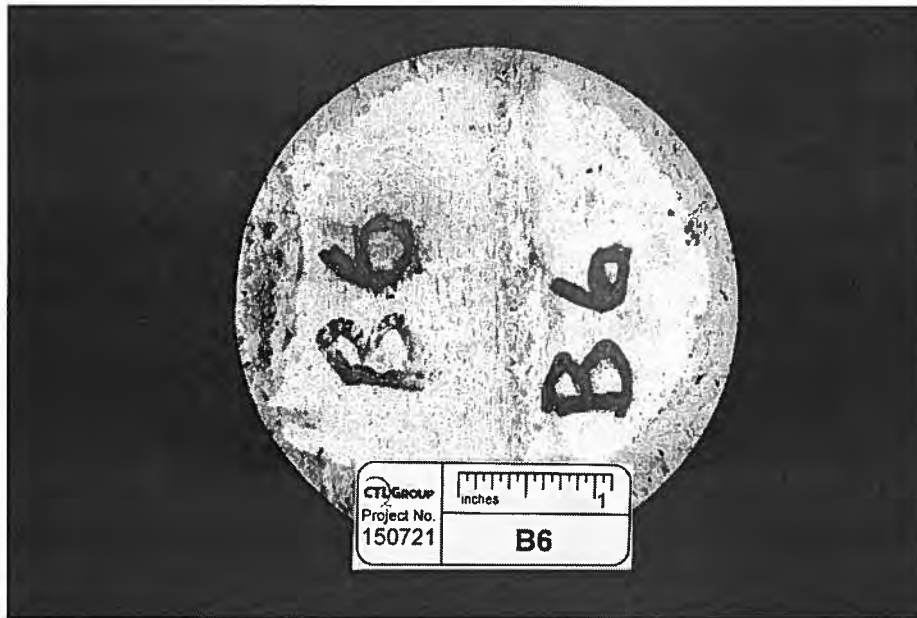
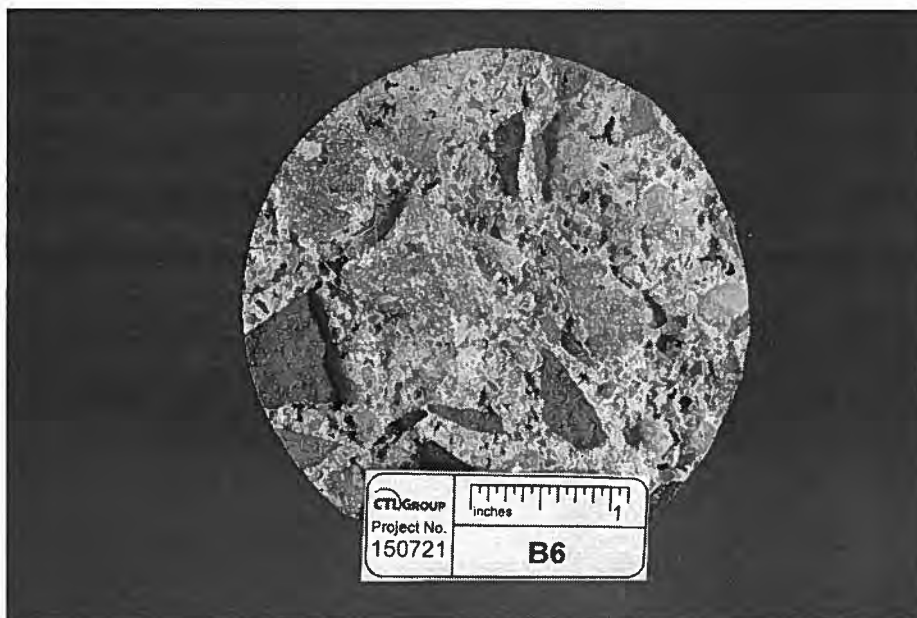
Fig. 1 End surfaces of Core B6, as received.

1a. Exterior surface.

1b. Interior surface.

Exterior End: Relatively flat and slightly rough surface, covered with white paint.

Interior End: Rough and uneven, fractured surface. Paste is light to medium beige and hard.

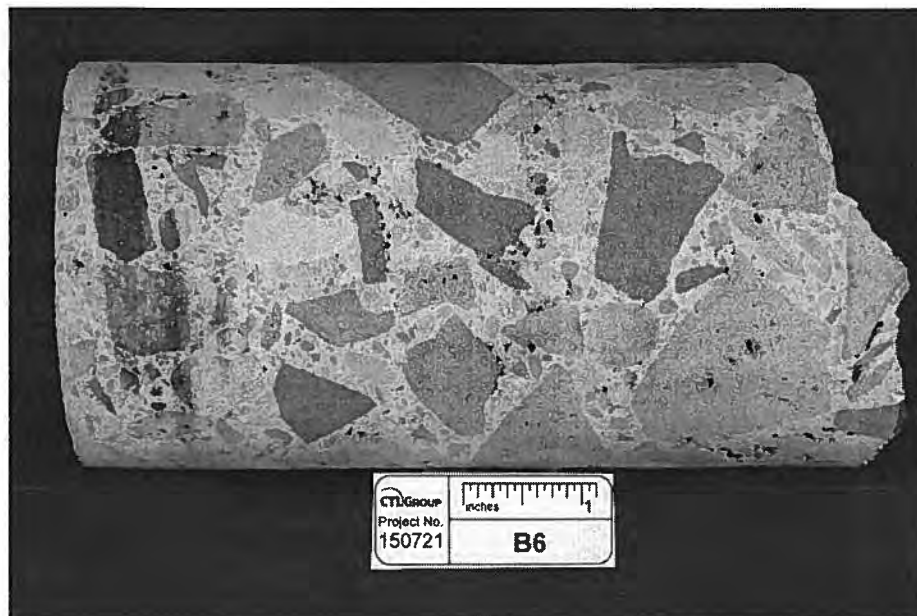
Fig. 2 Side view of Core B6 as received. Exterior surface at left.

Dimensions: Core diameter = 96 mm (3.8 in.). Core length = 155 to 183 mm (6.1 to 7.2 in.); partial rib thickness.

Cracks, Joints, Large Voids: Several irregularly-shaped voids are noted, measuring up to 17 mm (0.7 in.) long and 4 mm (0.2 in.) wide. No major cracks or joints are observed.

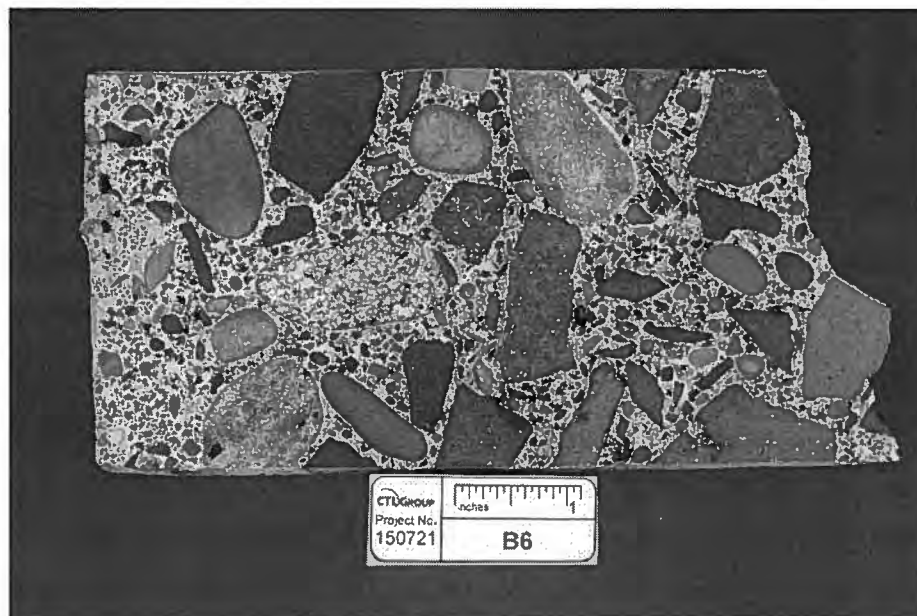
Fig. 3 Cut and lapped section of Core B6. Exterior surface at left.

The concrete is well consolidated and exhibits no aggregate segregation (Fig. 3). Additional findings and descriptions of the core are provided in the attached petrographic examination data sheets.

The aggregate in the core is comprised of siliceous gravel coarse aggregate and natural sand fine aggregate. The coarse aggregates are hard and dense, comprised of sandstone, quartzite, basalt, and other igneous and sedimentary rocks. The fine aggregates are also hard and dense, comprised of similar rock types as the coarse aggregate. The coarse aggregate in the core appears somewhat unevenly graded to an observed top size of 30 mm (1.2 in.); the volume of intermediate-sized aggregate appears relatively low.

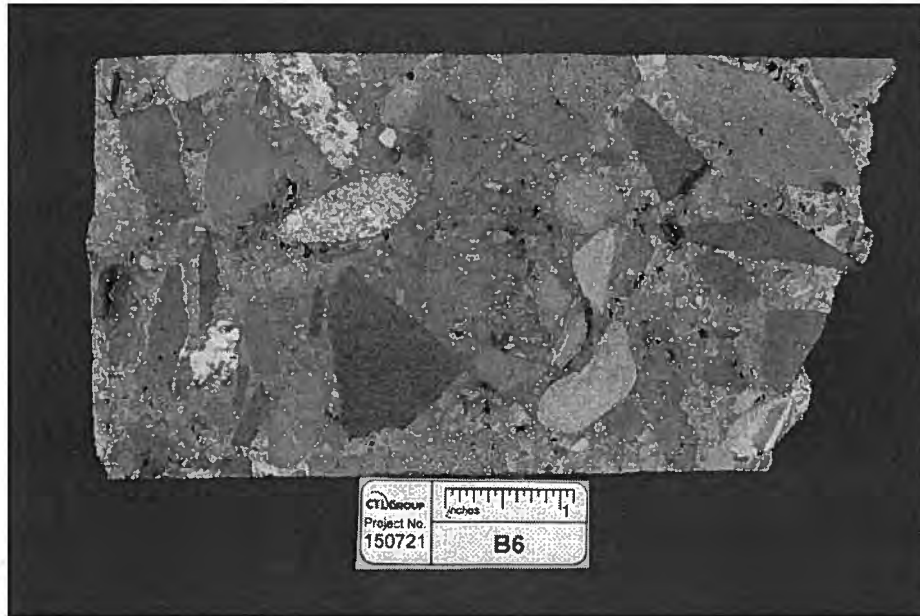
Fig. 4 Saw-cut cross-section of Core B6, exterior surface at left, stained with pH indicator (phenolphthalein) solution. The solution imparts a deep magenta stain to high pH, non-carbonated paste. Carbonated paste does not change color.

Core B6		
Location Within Core	Munsell Notation	Descriptive Name
Subsurface	2.5Y 7/1	Light gray
Near-surface	2.5Y 8/2	Pale yellow
Body	5Y 8/1 overall; locally 5Y 7/1 or N9 around some agg. particles	Yellowish gray overall; locally light gray or white around some agg. particles
Depth of carbonation	Approximately 1 mm (0.04 in.) along much of the exterior surface, locally as deep as 13 mm (0.5 in.) near sub-surface voids and microcracks (Fig. 4)

Depth of Carbonation: Approximately 1 mm (0.04 in.) along much of the exterior surface; locally as deep as 13 mm (0.5 in.) near sub-surface voids and microcracks.

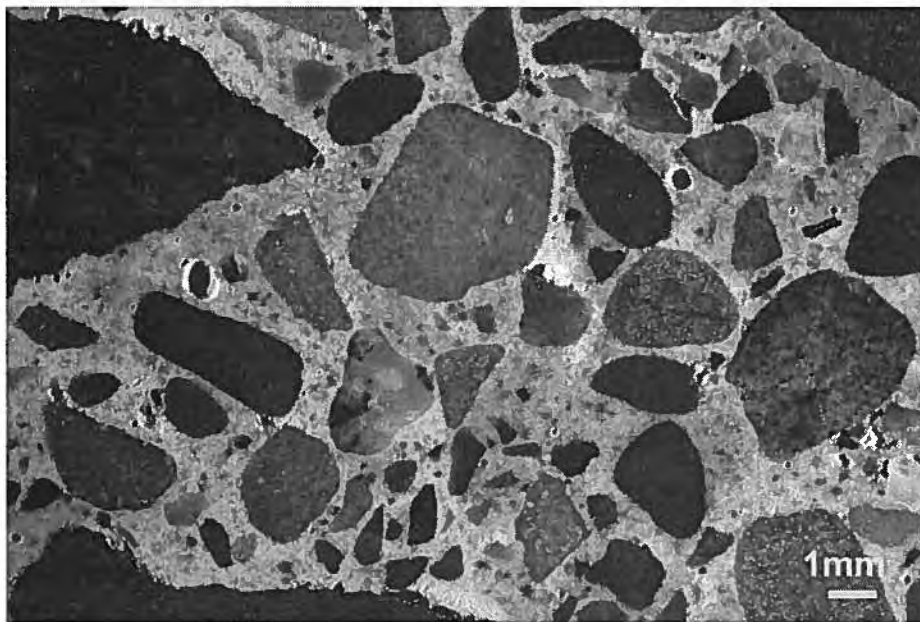
Fig. 5 Close-up view of lapped section of Core B6, showing non-air entrained concrete.

The concrete is not air-entrained, based on the scarcity of small, spherical voids in the hardened cement paste. Air content is estimated at 1 to 2% (Fig. 5).

Air Content: Estimated 1 to 2%. Concrete is not air-entrained, based on the scarcity of small, spherical voids in the hardened cement paste.

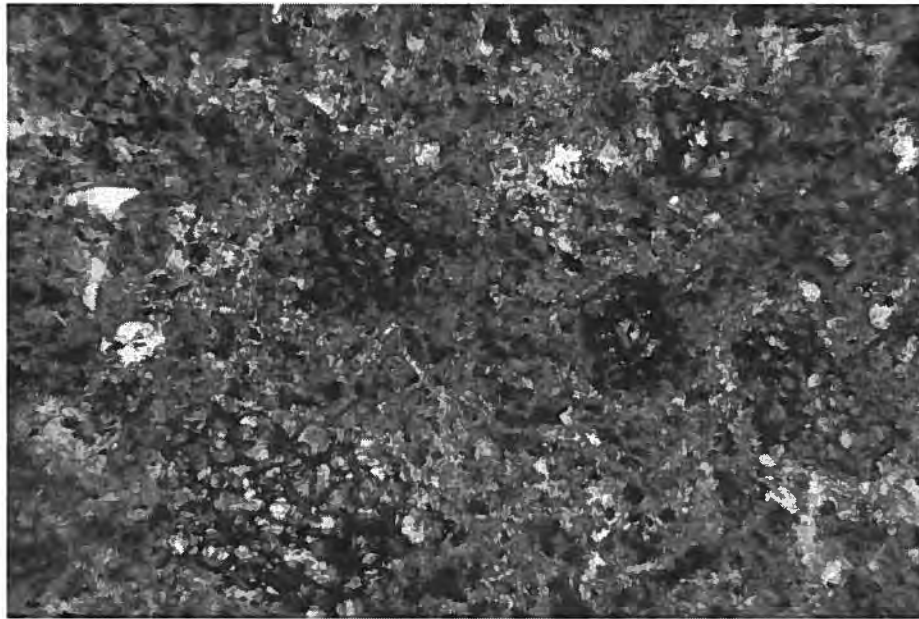
Fig. 6 Transmitted light photomicrograph of Core B6, showing paste microstructure. Red arrows indicate coarse unhydrated and partially hydrated portland cement clinker particles. Field of view is approximately 0.7 mm (0.03 in.). Plane-polarized light.

A small amount of unhydrated and partially hydrated portland cement clinker particles, estimated 2 to 4% by volume, is observed in the cement paste. The particles are very coarse, measured up to 0.2 mm (0.008 in.) across (Fig. 6). Belite nests (clusters of rounded belite crystals in an aluminoferrite matrix) are also observed in the paste. Relics of in-situ hydrated cement clinker particles are common. The coarse-ground nature of the cement and presence of belite nests are consistent with portland cement commonly used prior to the 1940s. The observed scarcity of medium-sized unhydrated clinker particles, frequency of relic cement grains, and paste properties that are better than thin-section observations would suggest, indicate that the cement likely continued to hydrate with exposure to moisture through life of the concrete structure. Estimated water-cement ratio (w/c) is moderate to moderately high (0.50 to 0.60), based on the microscopical and physical paste properties of the hardened cement paste. However, the estimation is speculative due to the advanced hydration of cement in the concrete. Paste in the core is hard overall, and locally soft around some aggregate particles, with subvitreous luster and moderately low to low water absorbency overall. Paste-aggregate bond is moderately tight.

Residual Portland Cement Clinker Particles*: Estimated 2 to 4% unhydrated and partially hydrated portland cement clinker particles. The size of the particles is somewhat coarse, measured up to 0.2 mm (0.008 in.) across. Relics of in-situ hydrated clinker particles are common.
