# Latah Bridge Rehabilitation Study

## VOLUME 1 Baseline Conditions Summary

City of Spokane

February 2012

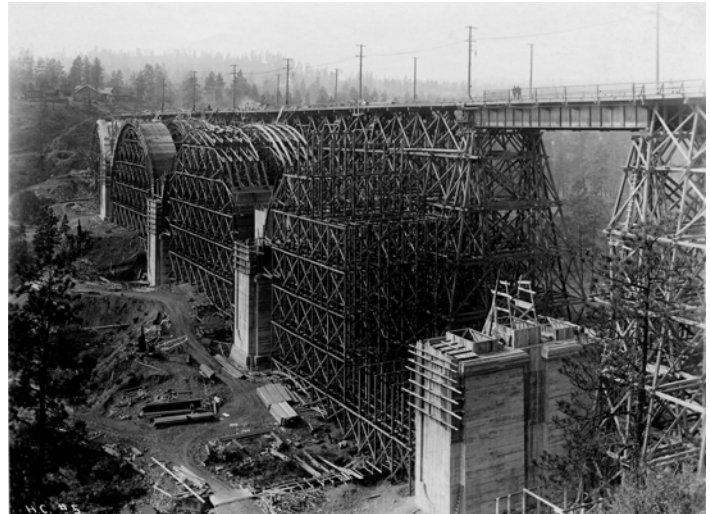
*Construction progress, 1912. Photo courtesy of Washington State Digital Archives.*

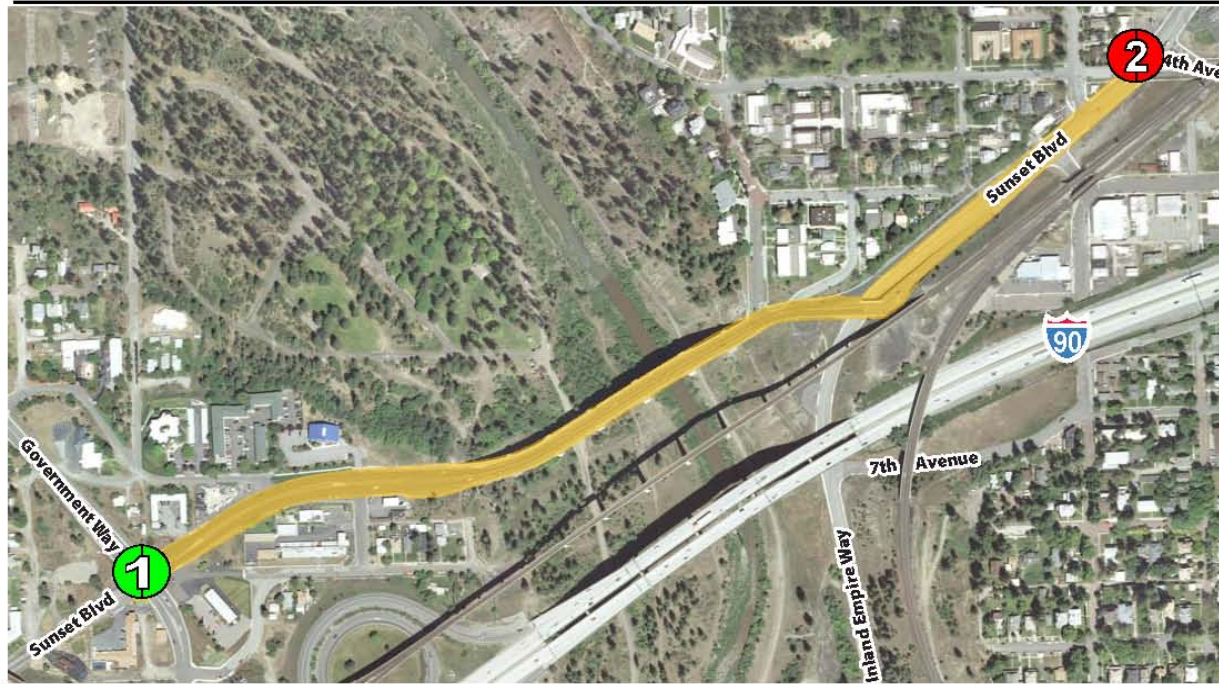
1 W. Sunset Blvd & S. Government Way	2 W. Sunset Blvd & W. 4th Avenue*
<p>LOS Delay</p> <p>2011 Existing B 19</p> <p>2030 No Build C 22</p>	<p>LOS Delay</p> <p>2011 Existing F 85</p> <p>2030 No Build F &gt;300</p>
<p>365 250 260</p> <p>70 90 220</p> <p>275 195</p> <p>695 585</p> <p>110 20</p>	<p>20 0 5</p> <p>20 0 5</p> <p>10 10</p> <p>800 585</p> <p>365 340</p>
<p>200 205</p> <p>330 340</p> <p>60 80</p> <p>10 95 40</p> <p>160 155 55</p>	<p>15 15</p> <p>590 1260</p> <p>30 45</p> <p>120 XXX 80</p> <p>165 XXX 110</p>
<p>S. Gov't Way</p> <p>W. Sunset Boulevard</p>	<p>Sunset Grocery</p> <p>W. Sunset Boulevard</p> <p>W. 4th Avenue</p>

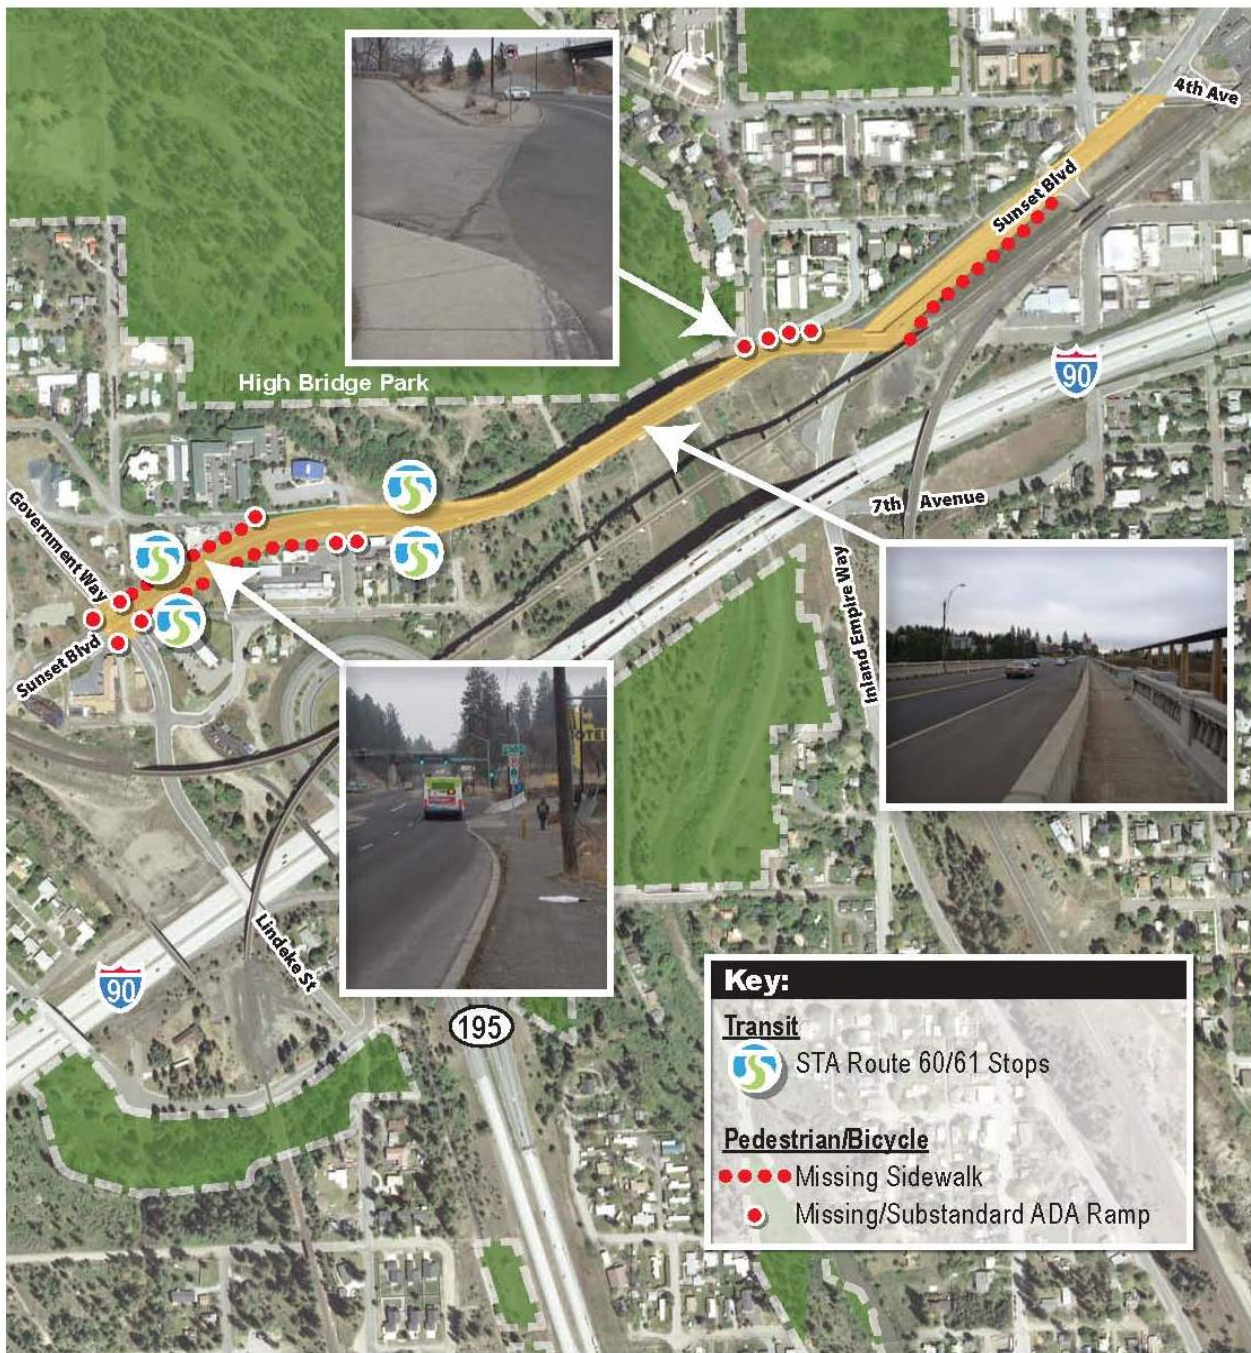
EXHIBIT 2-20  
NON-MOTORIZED AND TRANSIT  
OPERATIONS  
*Latah Bridge Rehabilitation Study*

Exhibit 2-20 illustrates the four bus stop locations on Sunset Boulevard within the project limits. In the east-bound direction, the first stop is east of the Government Way intersection. The second east-bound stop is approximately 60 feet west of the west end of the Latah Bridge, between the bridge end and Lindeke Street. In the west-bound direction, the first stop is at the intersection of Sunset Boulevard and Lindeke Street. The second west-bound stop is east of the Government Way intersection.

Within the project limits, Sunset Boulevard has intermittent sidewalks on both sides of the street. Exhibit 2-20 depicts the nonmotorized facilities and associated deficiencies. Sidewalks are missing from Government Way to 7th Avenue along both sides of Sunset Boulevard. East of 7th Avenue, 5-foot sidewalks are on both sides of the street all the way to the Latah Bridge. East of the Latah Bridge, a 5-foot sidewalk runs along the north side of Sunset Boulevard to the east project limit at 4th Avenue. No sidewalk exists for approximately 470 feet, between the Inland Empire overpass, and Cannon St.

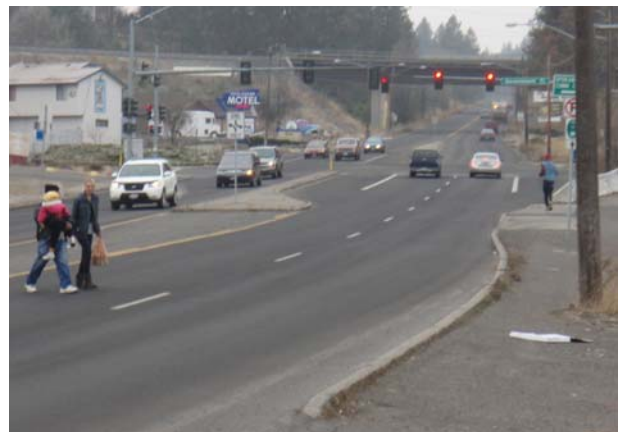
*Intermittent sidewalks along Sunset Boulevard*

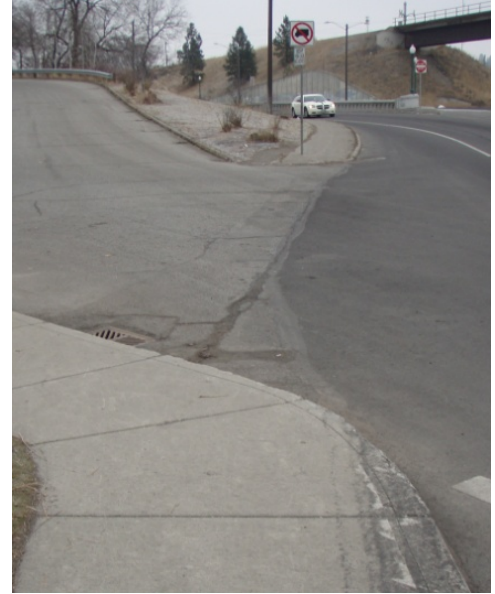
*Curb ramps are missing from the intersection of Coeur d'Alene Street and Sunset Boulevard.*

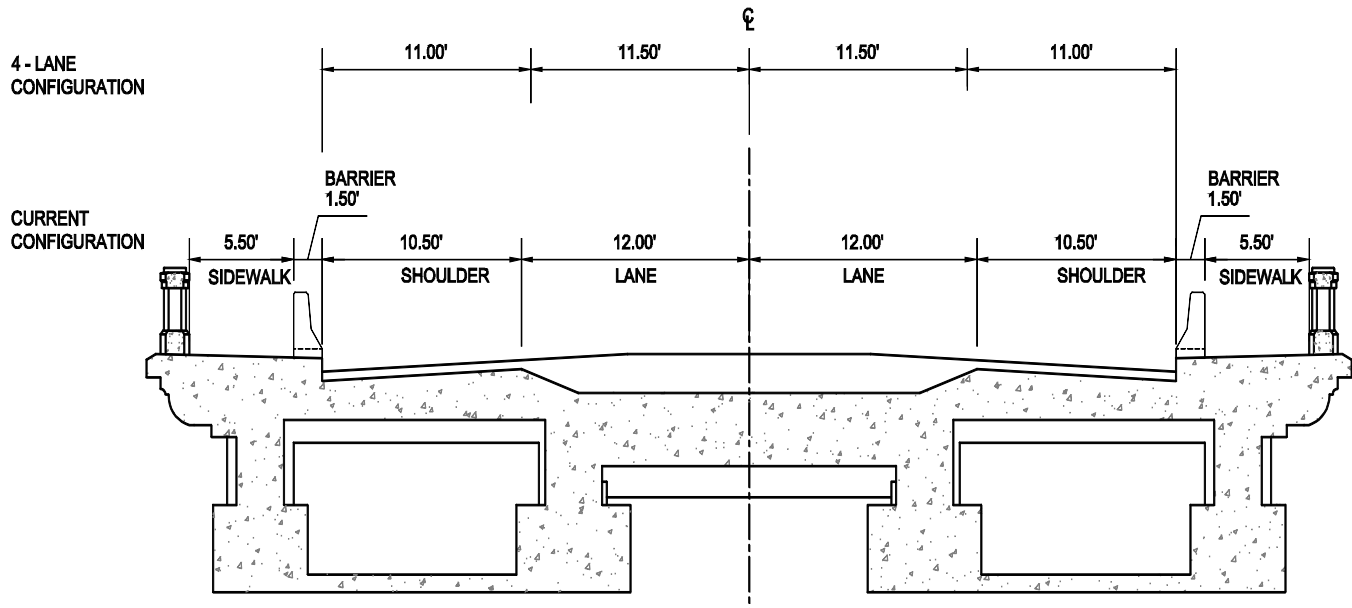
EXHIBIT 2-23. *Bridge Roadway Section*

The Latah Bridge roadway section is shown in Exhibit 2-23. The curb-to-curb width is 45 feet. In modern times, the bridge deck has supported four traffic lanes (four-lane configuration)—two 11-foot (minimum) lanes in each direction. Because of deteriorating structural conditions and capacities, the City has limited the bridge to two travel lanes (current configuration)—one 12-foot lane in each direction. Large shoulders currently provide space for bicyclists to traverse the bridge outside of roadway travel lanes.
