Project: G22084

Project: Beard-Grandview Subdivision, Spokane County, WA
Subject: Results of Geohazard Evaluation

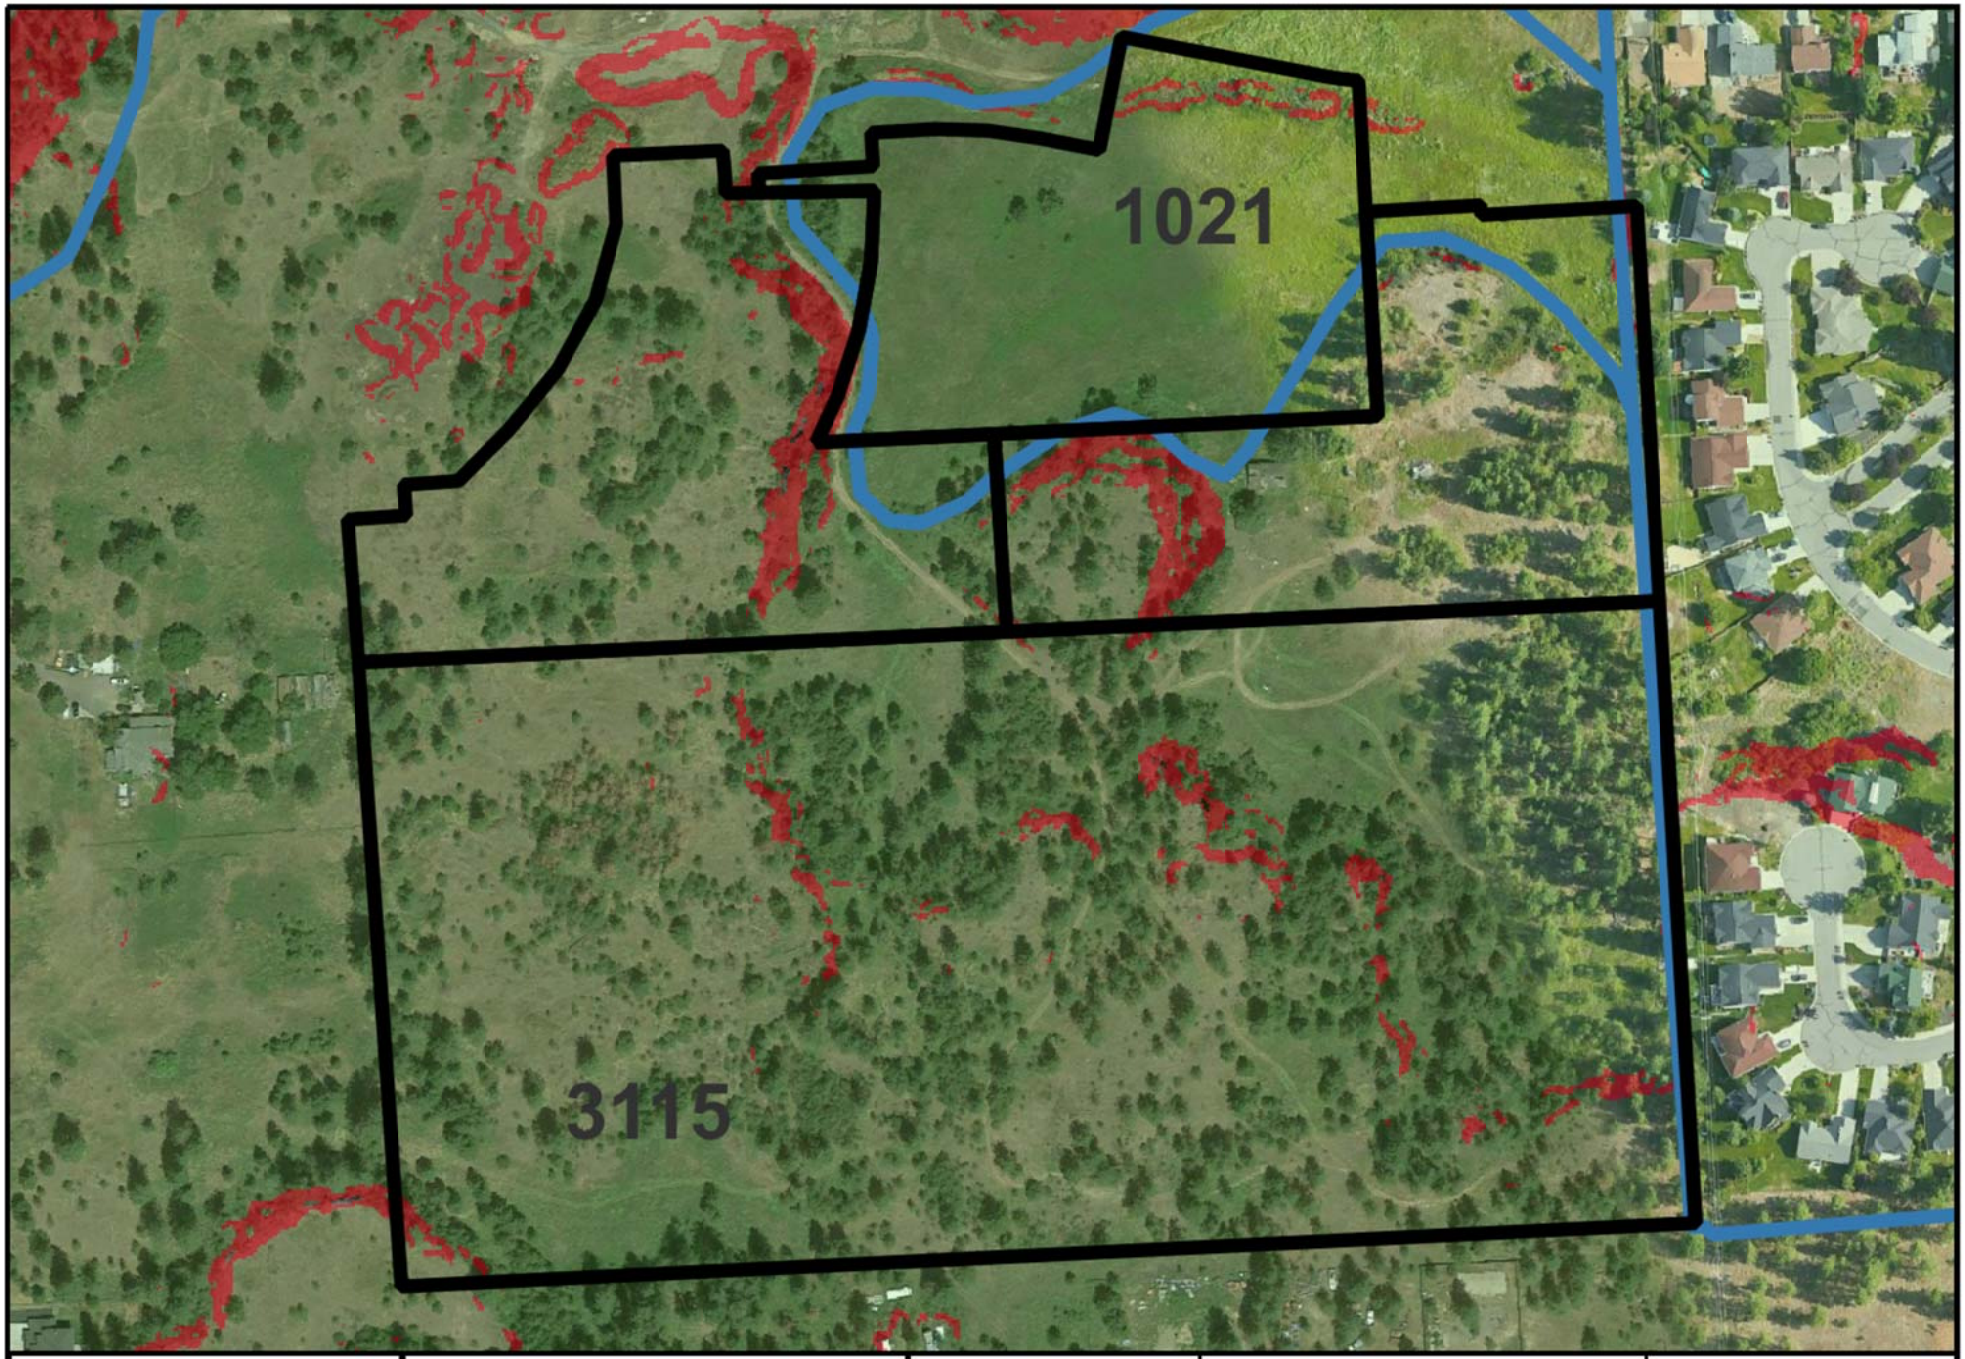
FIGURE 2

a. A slope of 30 percent or greater;
b. Soils identified by Natural Resource Conservation Service (NRCS) as posing a severe potential for erosion (see Section 11.20.090L Appendix L);and,
e. Areas of uncompacted fill;

Geologic hazards were delineated in *Figure 2* utilizing GIS data obtained from the Washington State Department of Natural Resources and Spokane County. We used the modified version of Universal Soil Loss Equation (USLE) outlined in Section 11.20.090 L Appendix L in the CAO which *states "The index is a product of K times the average slope of the map unit (K*ave slope). Slight has an index of less than or equal to 3.0 (less than 5 tons/acre/yr.), moderate has an index of 3.0 to 4.0 (5 to 8 tons/acre/yr.), and severe has and index greater than 4.0 (greater than 8 tons/acre/yr.)"* to determine whether soils pose a severe potential for erosion. Based on K Factors in the table above, slopes greater than 6.2 percent in NRCS map unit 1021 and 26.7 percent in NRCS map unit 3115 pose severe potential for erosion. It is our opinion that severe potential for erosion is not likely at the site due to the lack of slopes steep enough and the presence of basalt near the ground surface in NRCS map unit 3115.

Special considerations will need to be addressed by civil and structural engineers with respect to designing utilities, roads, and buildings on and directly adjacent to highly erodible soils and seasonal ponding water.

Typical construction Best Management Practices and preservation of natural drainages are anticipated to be adequate to address soil erosion issues. Dust abatement will likely be necessary during grading activities and dry periods.

Berms of undocumented fill will likely need to be removed during initial site grading.

We recommend retaining qualified professionals to complete erosion and sediment control plans, civil engineering and stormwater design, and geotechnical exploration and analysis.
