**RE: Hazardous Materials Survey Services (Asbestos / Lead Based Paint / Mold)
Gonzaga Haven
NE of North Foothills Drive and North Hamilton Street
Spokane, Washington
ALLWEST Project No. 219-211E**

ALLWEST is pleased to present this Hazardous Materials Survey report for the above referenced Site.

Site Photographs
Site Name: Gonzaga Haven
ALLWEST Project No. 219-211E
Date Taken: September 4, 2019

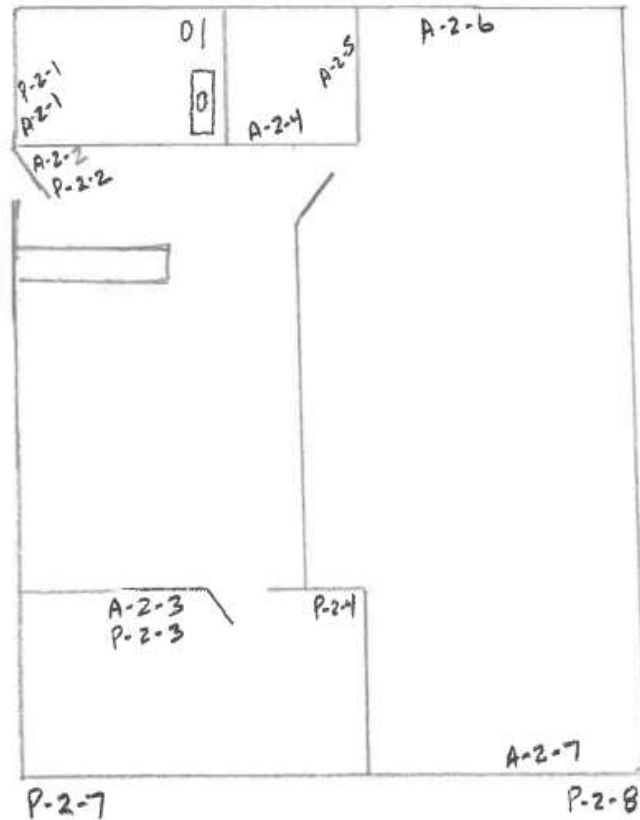
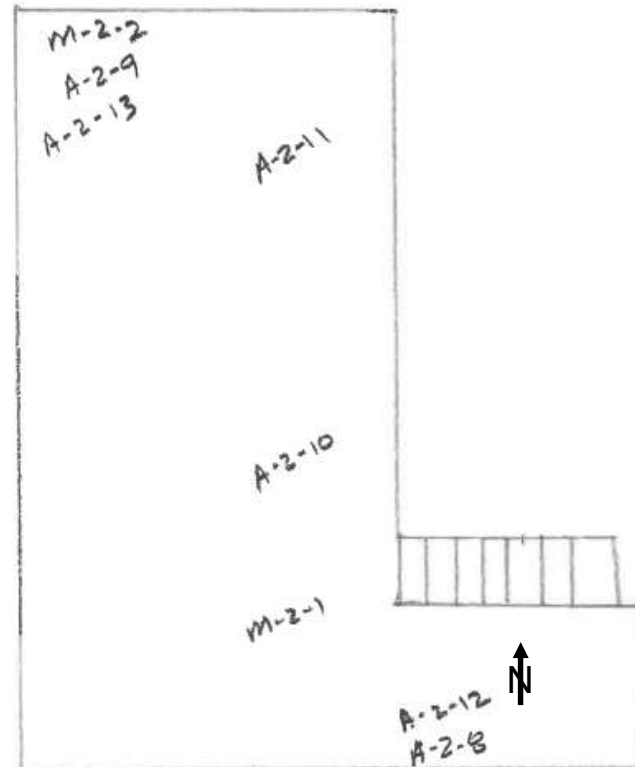
FIGURE 2B —SAMPLING LOCATIONS BUILDING 2

- Visible indications of microbial growth (discolored or stained areas) were observed in all three buildings. The most extensive mold observed was in the loft

area of building #2 at 2828 North Nevada Street. The mold appears related to water intrusion as seen on photos three (3) and four (4) on the Photolog attached to this report. The remaining mold observed appeared less extensive and was located in the breakroom (wall & air duct) and window seal (2nd floor) in building #1 at 920 East Wolverton Court. In addition, mold was identified in the loft and utility room in building #3 at 2824 North Nevada Street. We also observed mold in the shop area of building #3 as seen on photo 8 on the attached Photolog.

- We recommend that mold be removed by a licensed contractor experienced in mold removal. All federal, state and local regulations should be followed during removal.
