January 10, 2022
Revised from December 29, 2021

Project G19903

PROJECT: Kosta Plat – 60-lot Subdivision – Nettleton and Cochran, Spokane, WA
SUBJECT: Geohazard Evaluation (Revision 1)

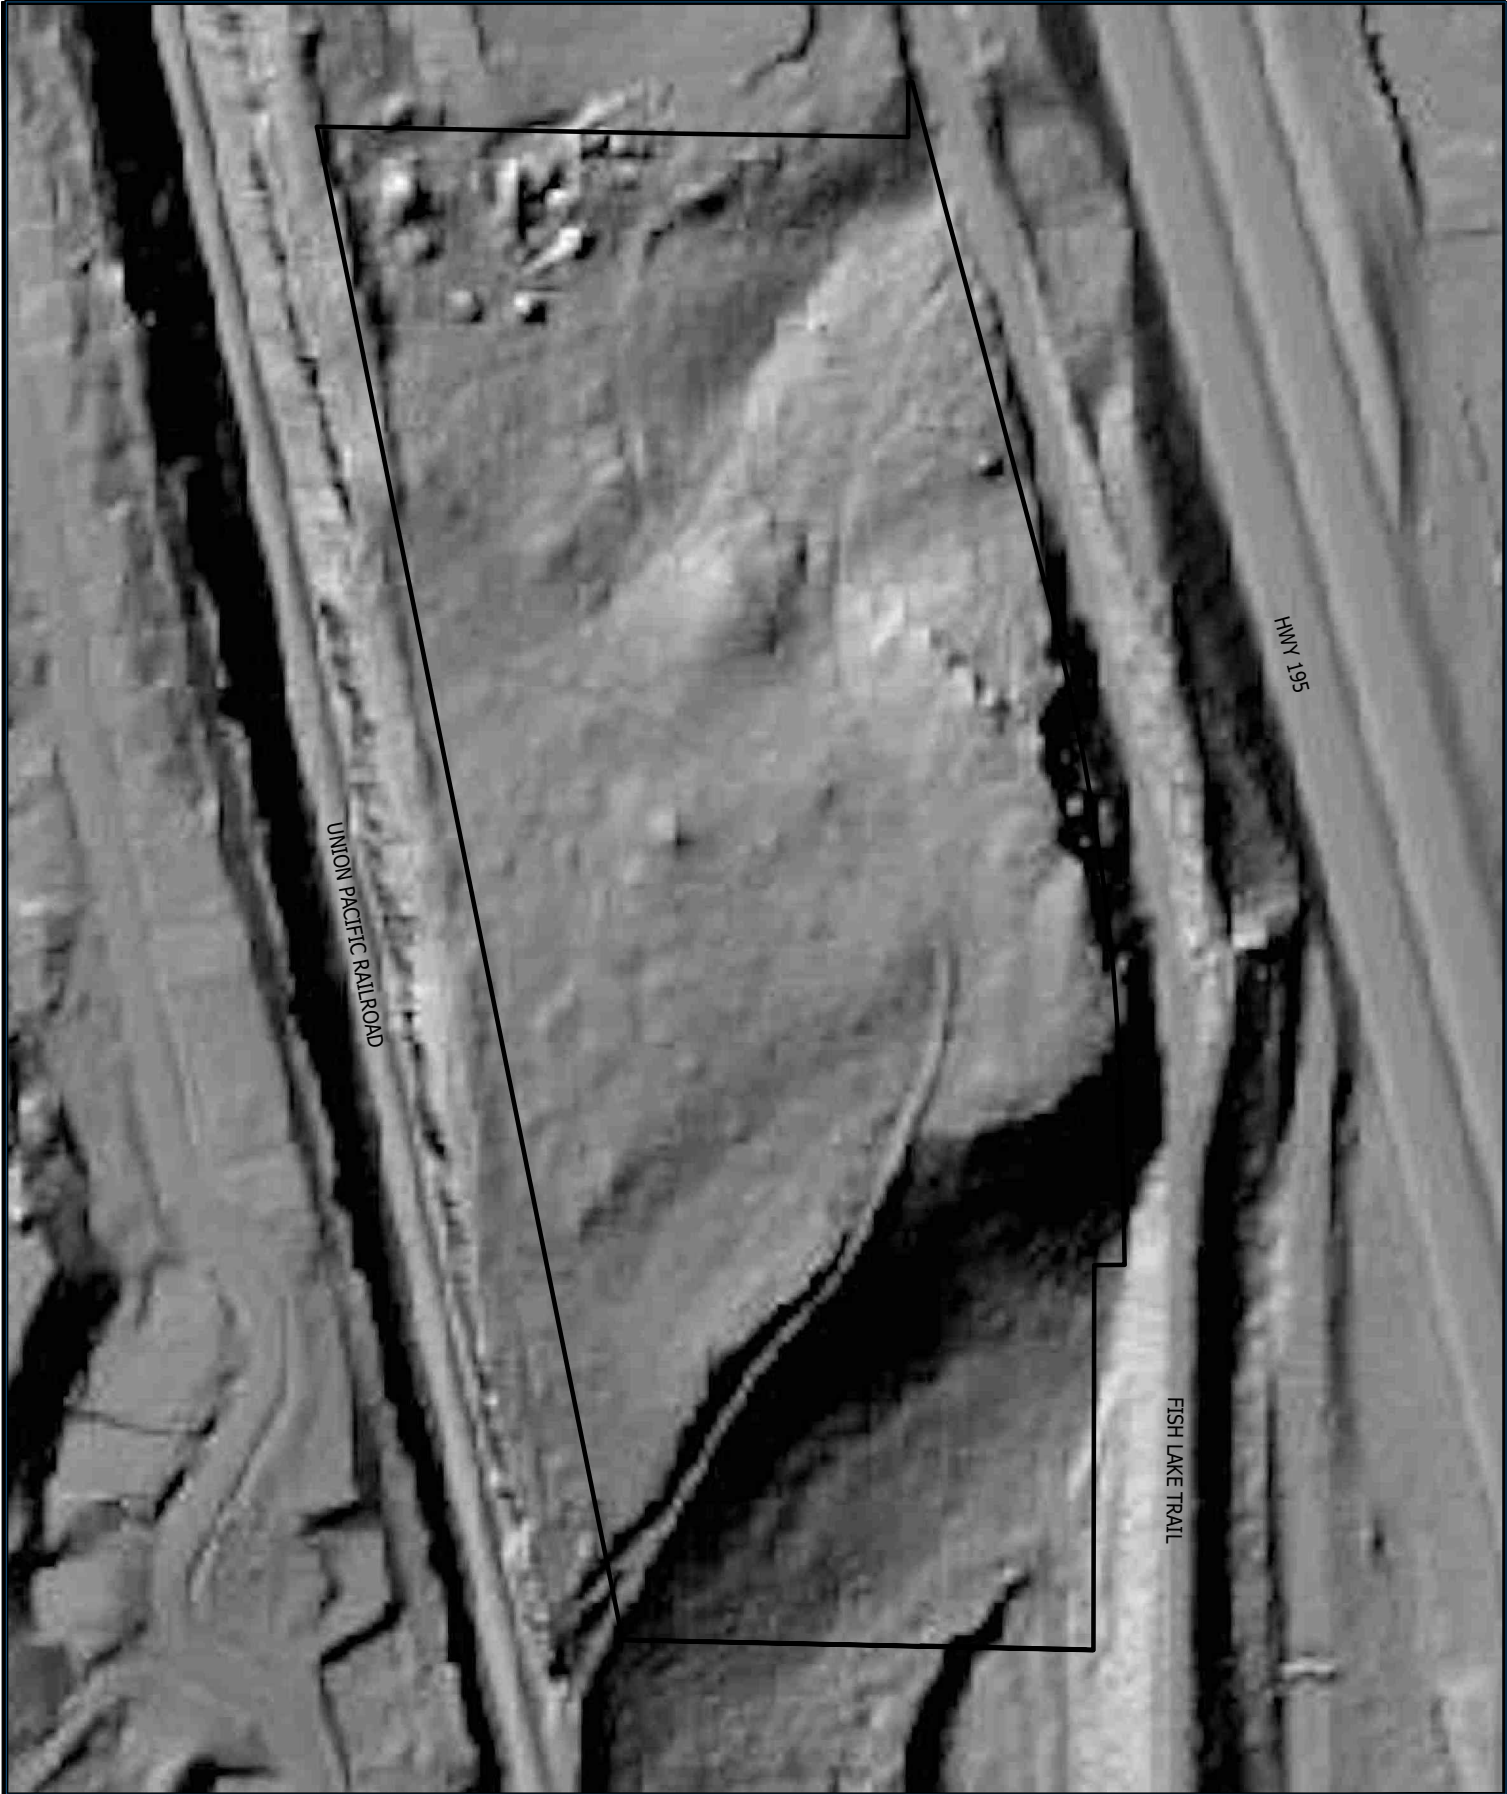
Figure 3-1

Photo 1 – Basalt bluff on east property boundary

Permanent constructed slopes should be limited to a maximum inclination of 2H:1V unless designed by an engineer registered in the State of Washington. Vertical rock cuts exist which pose risks from falling rock. Ice wedging continuously causes highly fractured basalt to spall from rock faces which accumulate as talus. Talus slopes should be left undisturbed or inclined to maximum slopes of 1.75H:1V.
