RIVERFRONT PARK BRIDGES

INSPECTION AND ANALYSIS

SOUTH SUSPENSION BRIDGE

NOVEMBER 14, 2014 | Final Report

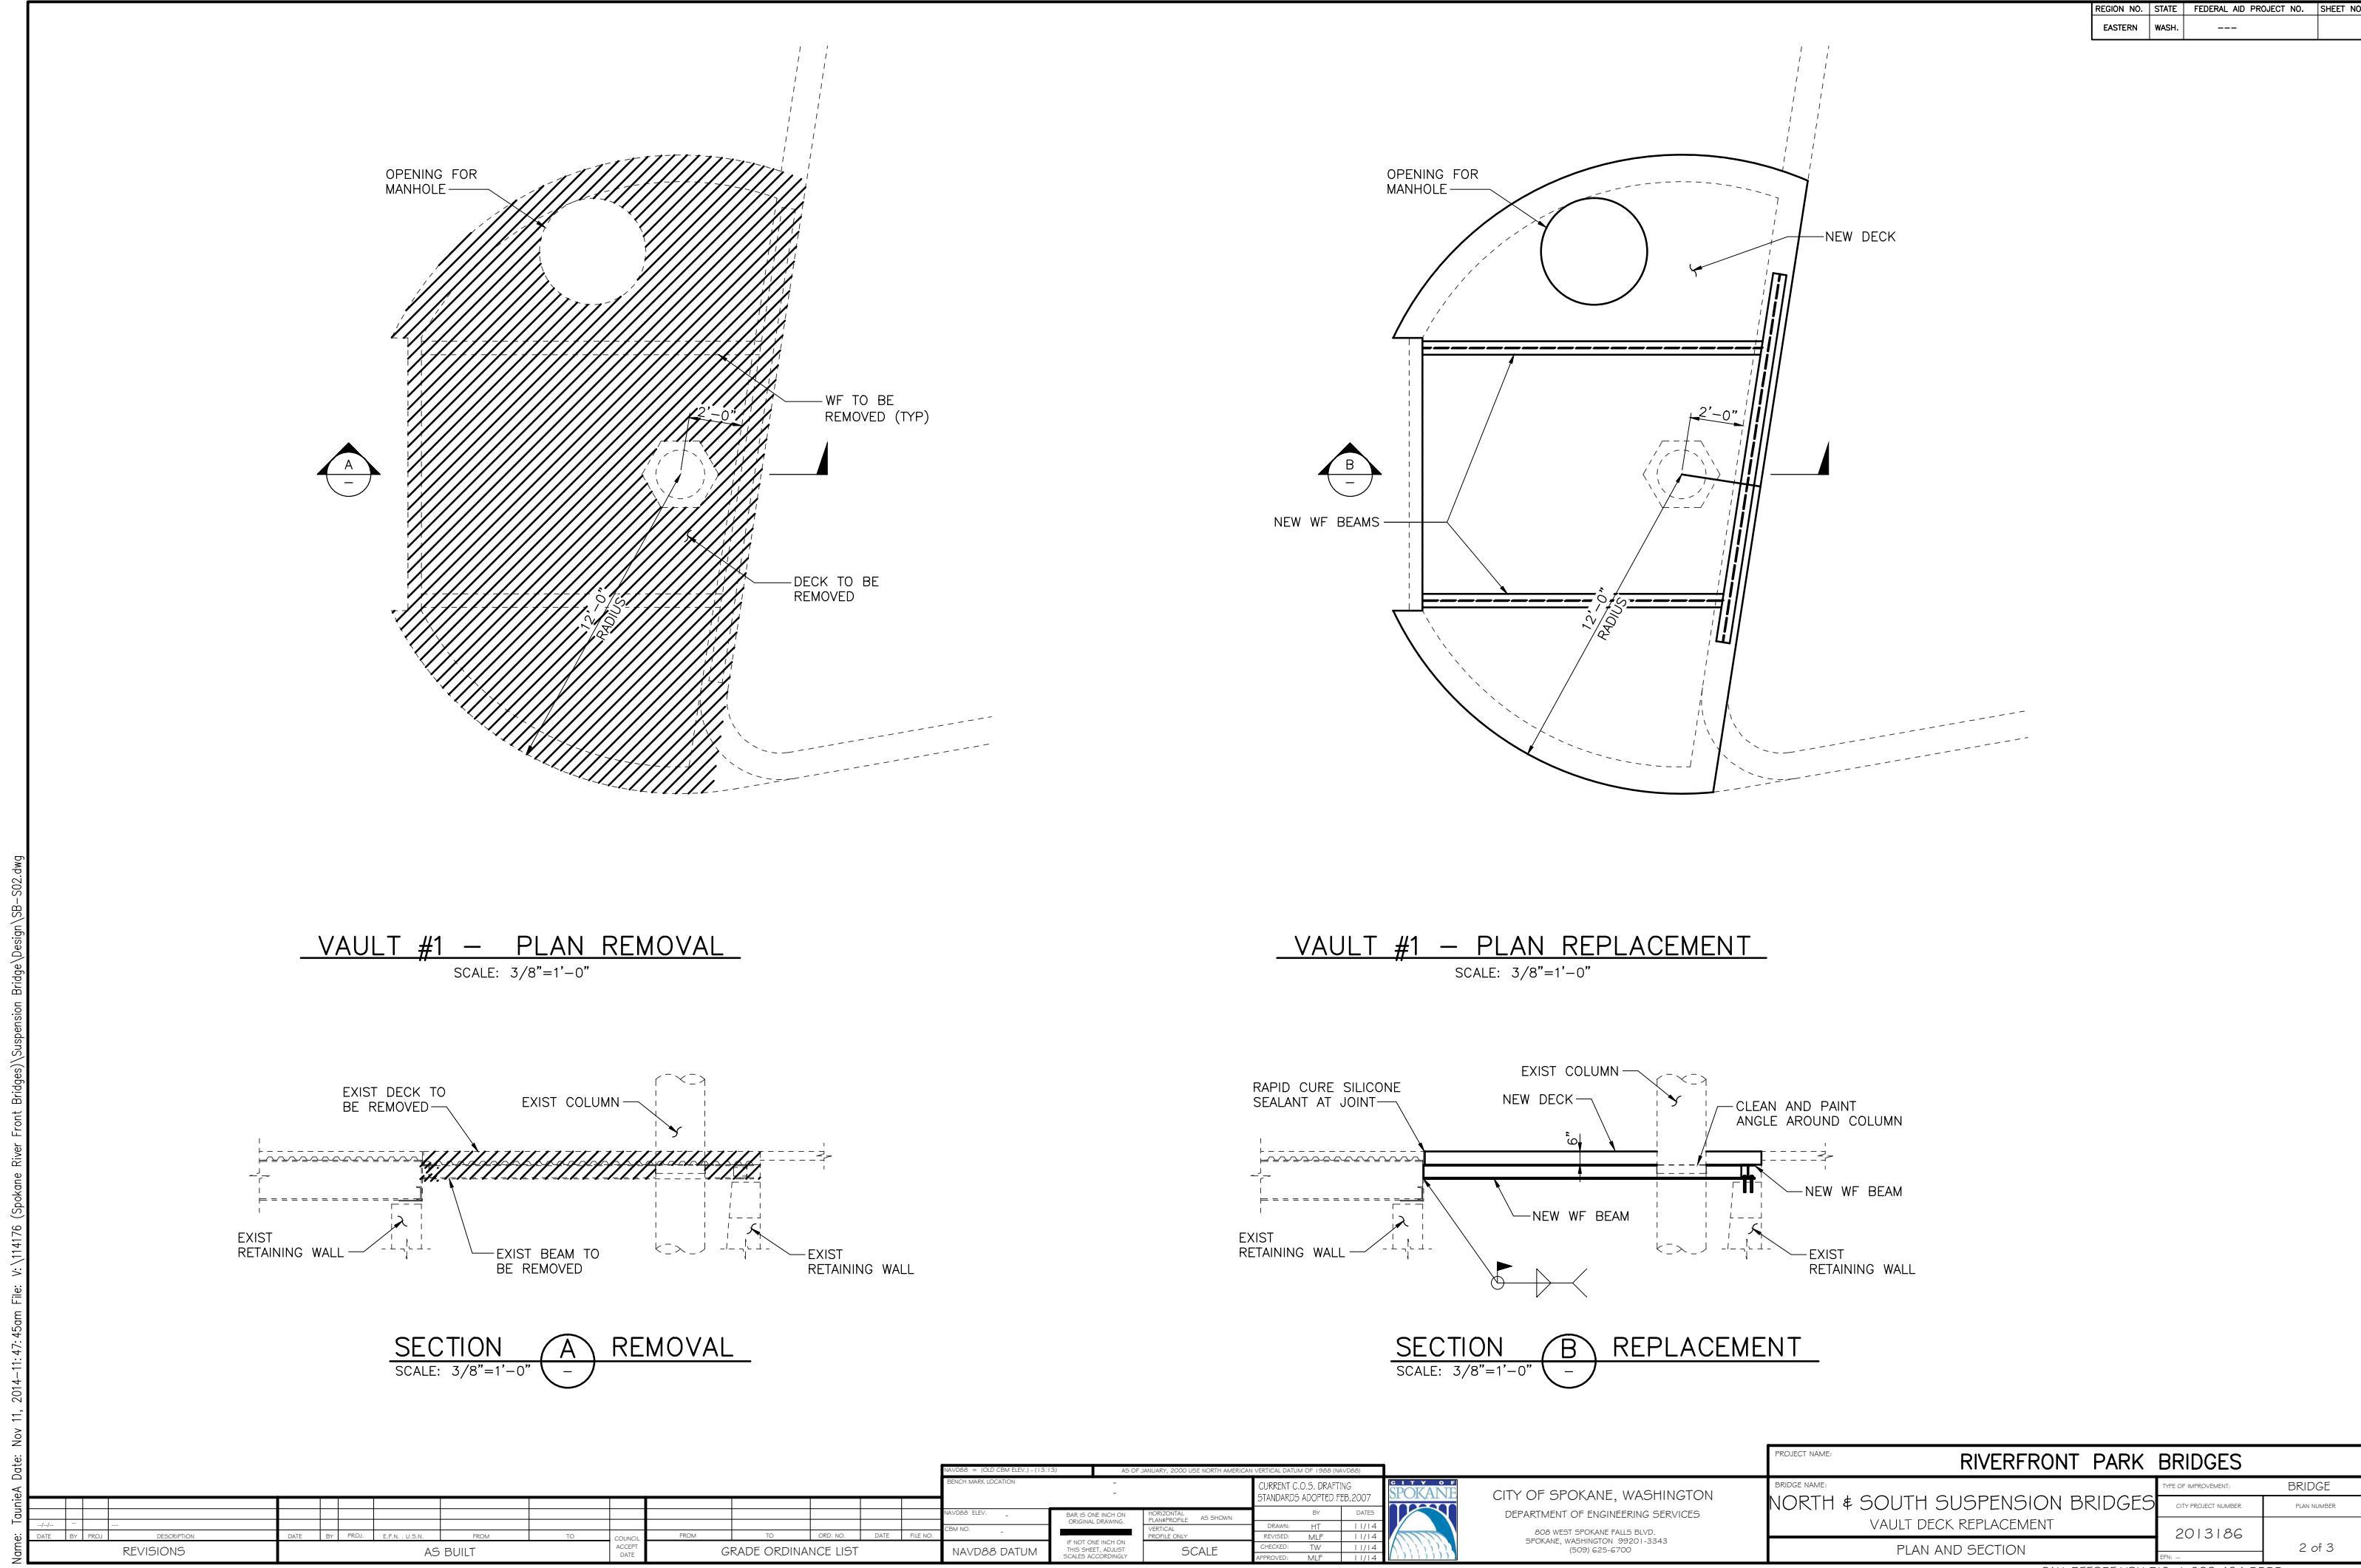
PROJECT NAME: RIVERFRONT PARK	BRIDGES	
	BRIDGE NAME:	TYPE OF IMPROVEMENT:	BRIDGE
	NORTH & SOUTH SUSPENSION BRIDGES	CITY PROJECT NUMBER	PLAN NUMBER
LIVIOLO	VAULT DECK REPLACEMENT	2013186	
43	PLAN AND SECTION	EFN:	2 of 3

The SIP forms and steel supports in the vaults are severely corroded. The heaviest corrosion occurs at the locations were water can penetrate from the top of the deck which are: around the manhole, around the concrete tower, and at the expansion joint at the bridge abutments. A large section of the SIP formwork is no longer is place near the bridge abutment.

The deck and the steel framing in the vaults should be replaced and additional framing around the manhole opening should be provided. The conduits should be removed during construction, and the new deck should be constructed with removable formwork. The sidewalk around the vaults should also be replaced. A compression seal should be installed at the expansion joints to prevent the large intrusion of water at the joint.
