PRE-DEMOLITION REGULATED & HAZARDOUS MATERIALS ASSESSMENT

FORMER YWCA FACILITY ADDRESSED AT 829 WEST BROADWAY AVENUE SPOKANE, WA 99201

Project No: 17-032.1

Prepared for The Falls, LLC

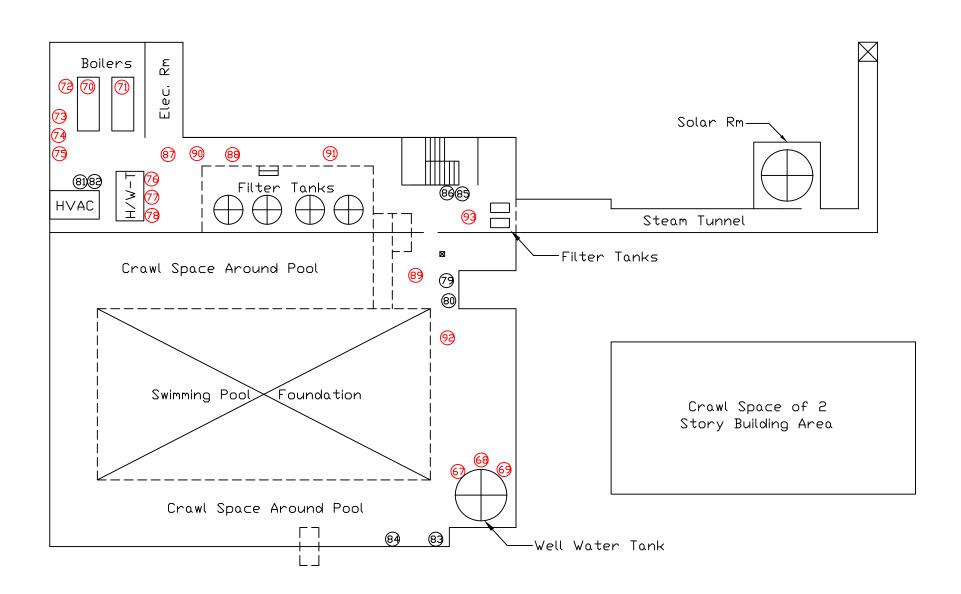
APPENDIX C ASBESTOS BULK SAMPLE LOCATION DRAWINGS

- Location of Interior Bulk Material Samples
- Location of Exterior Bulk Material Samples

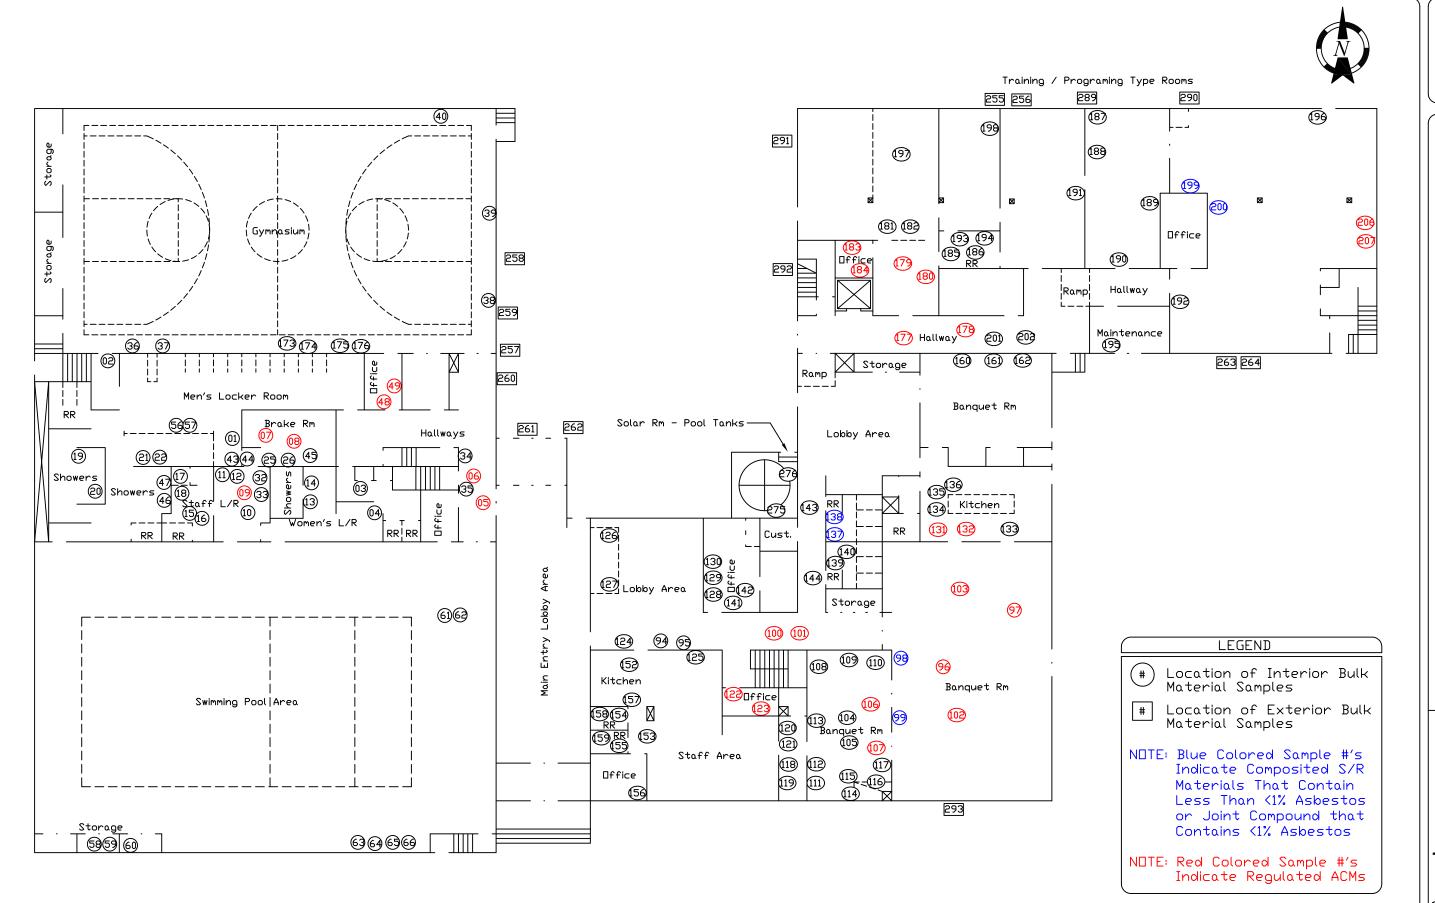
DRAWING No 2 2 DF 4 DRAWINGS

SITE DRAWING SPOKANE, WA SCALE DRAWING NOT PRE-DEMOLITION ASBESTOS SURVEY; BULK SAMPLE LOCATIONS FORMER YWCA BUILDING; 1ST FLOOR; 829 W. BROADWAY AVE;

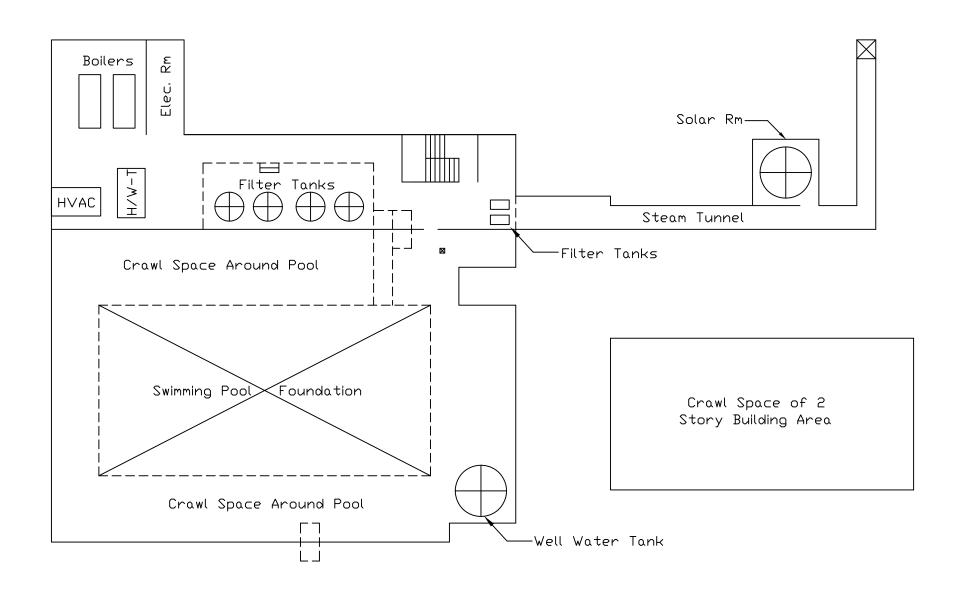
- Location of Interior Bulk Paint/Coating Samples
- Location of Exterior Bulk Paint/Coating Samples

NOTE: All Coatings Present Are With Steel Recyclable Components Throughout Basement & Crawl Spaces

PRE-DEMO LEAD COATINGS SURVEY, BULK SAMPLE LOCATIONS SITE DRAWING FORMER YWCA BUILDING, BASEMENT, 829 W. BROADWAY AVE, SPOKANE, WA DRAWN BY: S. BAILEY

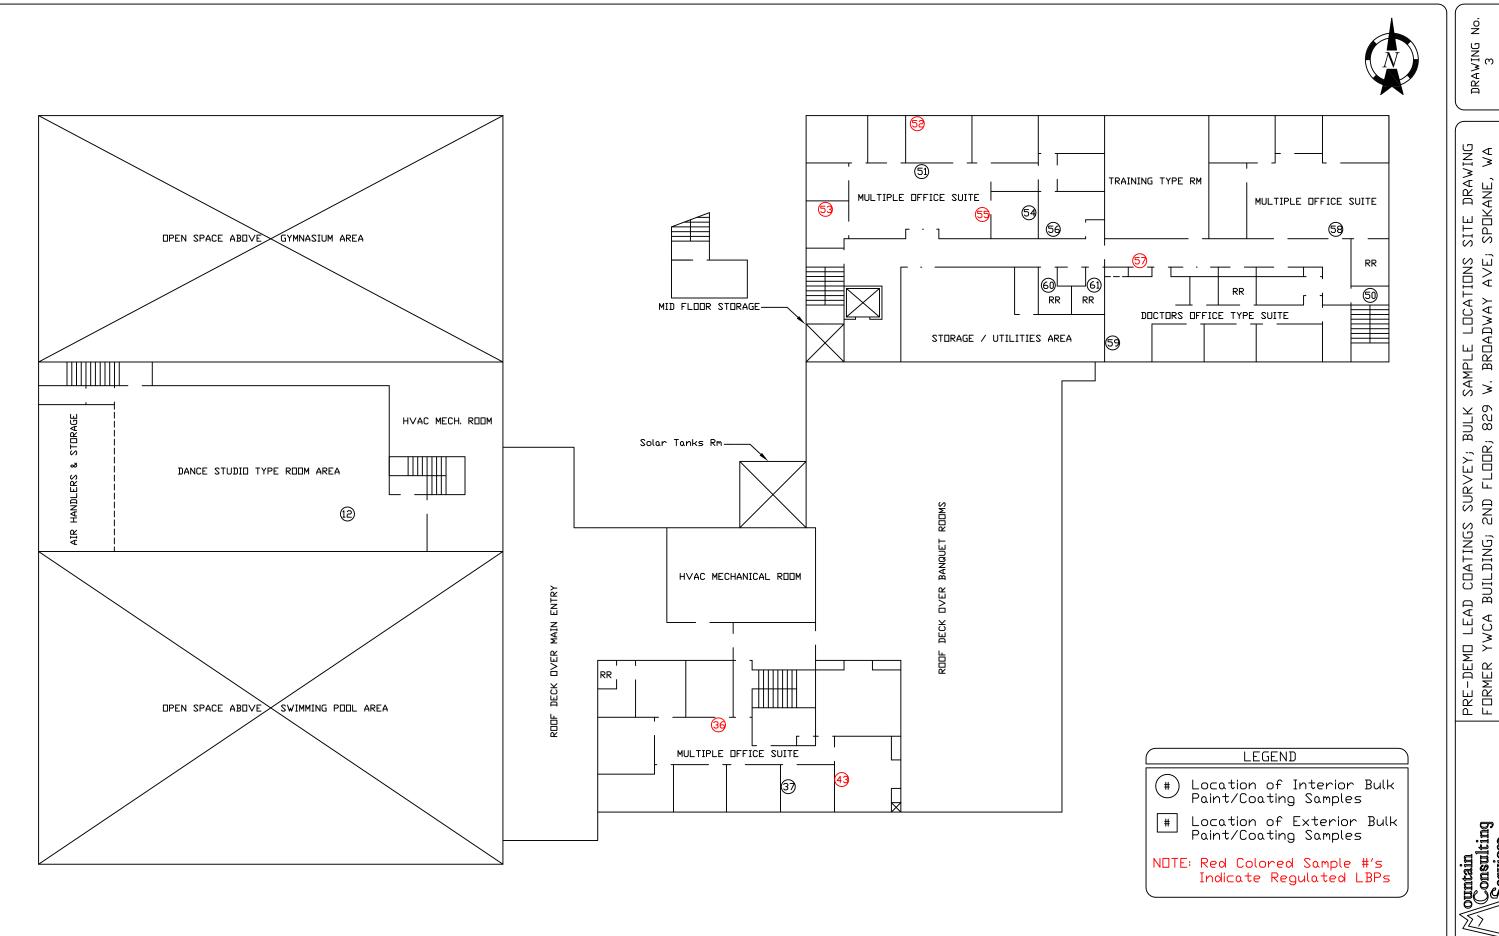
DRAWING No.
3
0F
4
DRAWINGS

SITE DRAWING ; SPOKANE, WA SCALE DRAWING NOT SAMPLE LOCATIONS . W. BROADWAY AVE,
